Visual defects of painted surfaces on ABS/PC injected parts

Eponine Raynaud, Evelyne Darque-Ceretti, Bernard Monasse, Philippe Duquesne, Frédéric Georgi

Eponine Raynaud, Evelyne Darque-Ceretti, Bernard Monasse, Philippe Duquesne, Frédéric Georgi. Visual defects of painted surfaces on ABS/PC injected parts. MATERIALS & SENSATIONS 2008, Oct 2008, Pau, France. hal-01444604

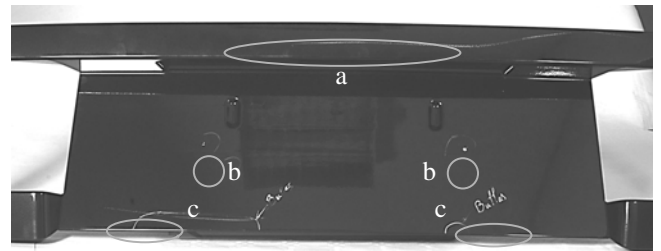
Figure 1. A cap of registration plate (five defective zones are bordered)

More than 99% of the painted surface is glossy with a homogeneous color. The defects appear only very small zones located always at the same location for each geometry (fig. 1, 2): near the mold-gate (fig. 1a), at the contact of weld-lines (fig.1b) and at the end of filling zone (parting-line) (fig. 1c, 2). The weld-line results from a bypass of an obstacle in the mould by the molten polymer. All these locations are tightly connected to process geometry. They appear on flat surface with a complex flow (fig. 1b) and on regions with a very small radius curvature (fig. 1a, 1c, 2). For optical reasons they are more visible on a flat surface than on a small radius.

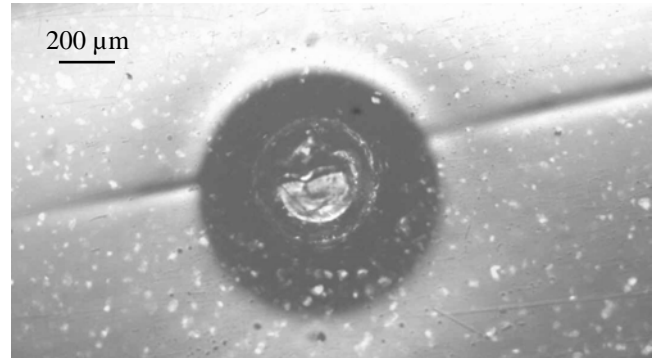
Figure 4 : A bubble (dot) observed by optical microscopy on a line defect

The bubble is centered on the parting-line and its size varies from 50 μm , for the smallest, up to 400 μm . Their size is sufficiently large to be observed, 60-70 μm is the norm for a detection of an isolated detail (1'' arc) with naked eye. Hypothetic individual bubbles with a size smaller than 10 μm could be undetected following the industrial test of quality. The size of the defect and their correlation (alignment) are crucial for their detection. The dark ring around a bright circle including some details results from a protuberance of the surface which produces this optical effect (dark-field reflection) (fig. 4). The blue pigments inside the basecoat can be also observed as clear dots on figure 4. The bubbles can be observed in more detail with SEM (FEI/Philips XL30ESEM) (fig. 5).

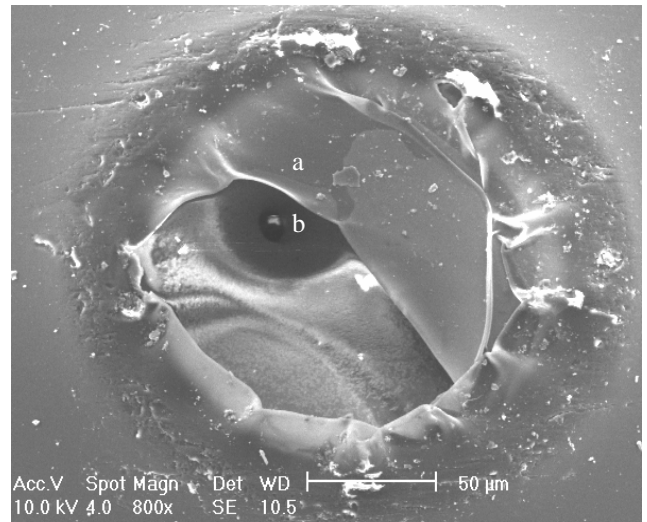
Figure 5: SEM observation of a bubble with a broken foil a) and a hole b)

A small bubble (diameter $\sim 200\mu\text{m}$) is presented in figure 5 which is significant of all the bubbles observed on the

Painted parts. They are formed by a cavity partly covered by a very thin foil which mainly produces the protuberance observed by optical microscopy. The foil is not complete and has been broken (fig. 5a). A hole is shown out in the bottom of the bubble (fig. 5b). From these observations it is suspected that the bubble is located in the paint layers with no clear evidence of its presence in a specific layer.

The strong correlation between these different experimental facts strongly suggests an explanation. A simple one is to suppose a crack is provoked by some painting solvents which initiate the crack in the polymer. In combination with this primary effect, the solvent diffuses inside the crack. At the end of the industrial process the painted part is heated. The solvent contained inside the crack is vaporized and strongly expands. Gas escape from the crack at the weak points of the primer and basecoat to form holes (fig. 5b). Then the gas inflates the bubble in the topcoat up to the rupture of the thin foil (fig. 5a).

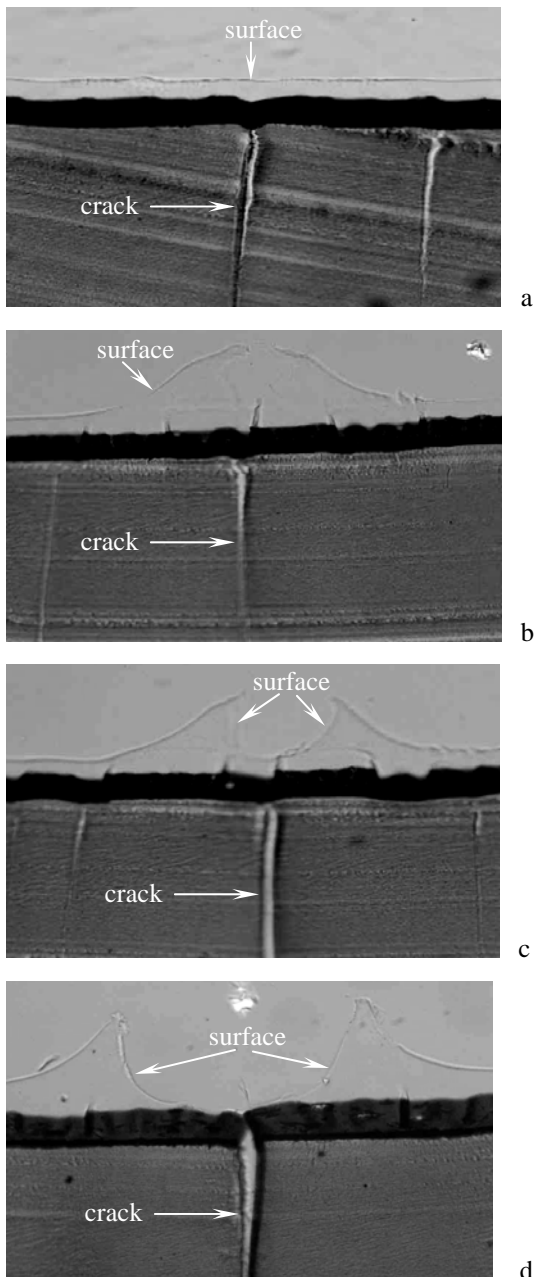
Figure 6: optical microscopy under transmission of thin cuts through half a bubble: from a border (a) to the diameter (d)

The bubble is confined in the topcoat and results from deformation of the material only in this superficial layer. These bubbles and volcanoes have very similar shapes. An observation of superficial part of ABS-PC shows the presence of a crack perpendicular to the polymer surface. This crack is stopped at the boundary with the primer layer (fig. 6a to 6c) aside in the centre of the bubble where the primer and the basecoat are broken (fig. 6d). This rupture is observed as a hole in the bottom of the bubble (fig. 5b). In that point, there is a direct connection between the crack inside the polymer and the bubble.

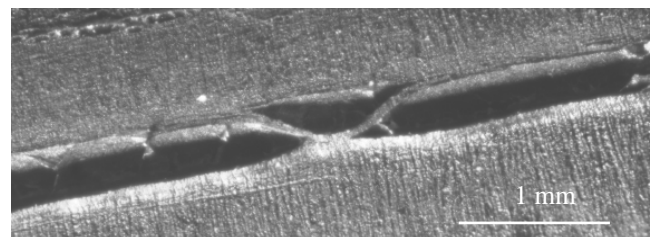
Figure 7: Macrograph of a crack on the surface after immersion inside solvents

The crack appears on the surface along the line defined in figures 3 and 4. The present crack and observed on

Painted polymer have almost the same depth. The result of this experiment confirms the role of solvents to open polymer crack and to form a reservoir for the solvent.

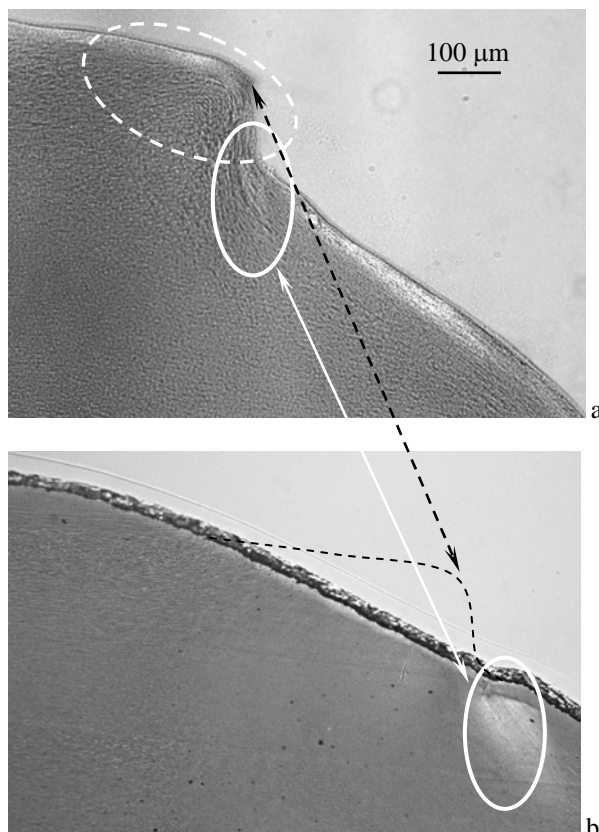
Figure 8: optical microscopy observation under polarization with a lambda plate of thin cuts ($e = 5 \mu\text{m}$) from injected parts before (a) and after polishing (b)

Observation under light polarization shows-out the molecular orientation parallel to the surface (fig. 8a) which is partly erased by polishing action. The orientation is complex in this initial protuberance [4]. It leads to a molecular orientation almost perpendicular to the surface after polishing and an initial crack can be detected in this particular zone (fig. 8b). The diffusion of solvents inside the polymer part is easier as an effect of this initial crack and of molecular orientation which favors the solvent diffusion. The solvent only widens the crack. This effect of a complex orientation on polymer cracks formation is observed on this zone without polishing and on weld-line where a complex orientation is also present. The cracks result from a local molecular orientation in conjunction with contact with solvents. The heating bursts the solvent and highly deforms the topcoat to form the bubbles. This is the critical step for the formation of the visual defect.
