## Geology, Engineering & Humanities: 3 sciences behind the Malpasset dam failure (France, Dec. 2, 1959)

P. Duffaut, Justin Larouzée

P. Duffaut, Justin Larouzée. Geology, Engineering & Humanities: 3 sciences behind the Malpasset dam failure (France, Dec. 2, 1959). Quarterly Journal of Engineering Geology and Hydrogeology, In press, 10.1144/qjegh2018-186 . hal-02278064

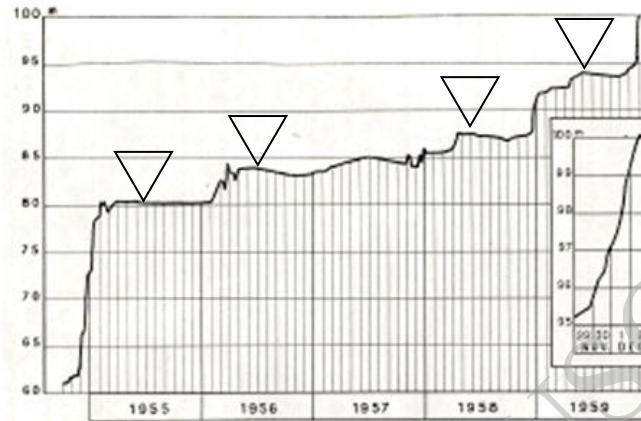
The widened joint was closed on April 22, 1954, thus starting the filling of the dam. Fig. 5 shows the evolution of the reservoir level from this time. Delays in buying some upstream land and the torrential regime of the Reyran prevented a total fill up of the reservoir, thus only a temporary reception was made in August 1956. The reservoir level rose a little every autumn, up to November 1959 when huge exceptional rains made it rise dramatically fast. In mid-November leaks appeared in the right bank (7 metres below the operating level); the bottom valve was kept closed, not to disturb the building site of a motorway bridge on the river that was located about 1 km downstream of the dam. The last 3 metres of the reservoir were filled in less than a day. At around 6 pm on December the 2<sup>nd</sup>, the bottom valve was finally opened after due discussion between the people in charge of the dam and of the bridge, just before the dam overtopped; but it was too late and the dam broke at 9:14 pm.

Fig. 5. Graph of the reservoir level from end of construction up to the failure; the window enlarges the three last days; triangles mark dates of measurements.

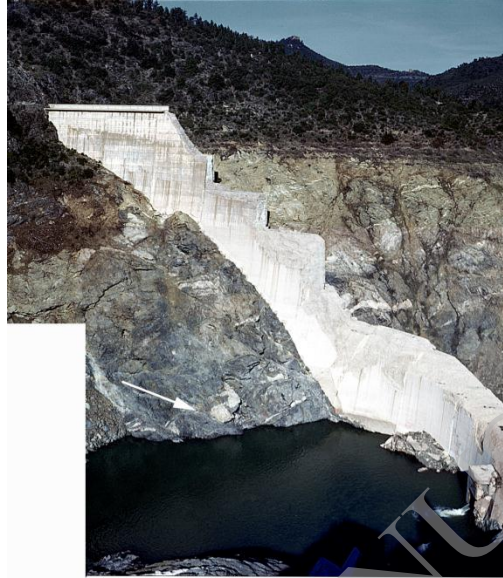
Today, only a part of the dam remains standing on the right bank, up to half of the cantilever JK, as a giant stairs, cut along vertical construction joints and horizontal concrete layers (Fig. 6) conversely, on the left bank only one half of the thrust block remains and a deep excavation was open in the rock at the foot of what had been the dam foundation (Fig. 6)<sup>5</sup>.

Fig. 6. *Remains of the dam on right valley side and valley bottom; the rock appears crisscrossed with white pegmatite dykes; the arrow shows the main fault; the river flow passes through the outlet valve (two assembled photos, J. Duffaut, Dec.20, 1959)*

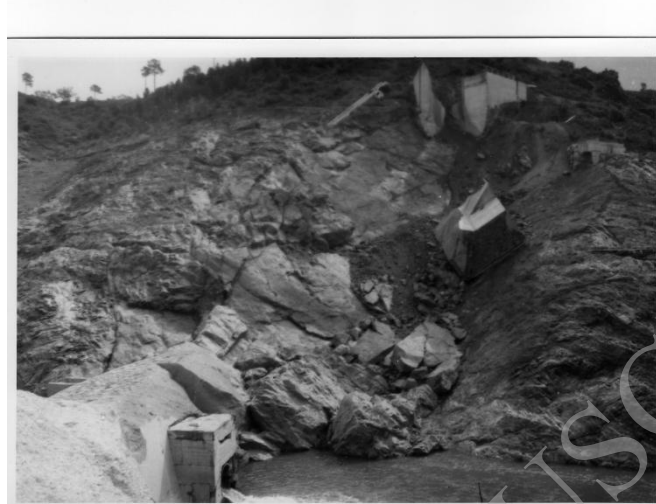
Fig. 7. The "dihedron", a deep excavation cut inside left valley side at the foot of the dam. The concrete block inside has fallen from the thrust block after the flow (photo P. Duffaut, May 1960)

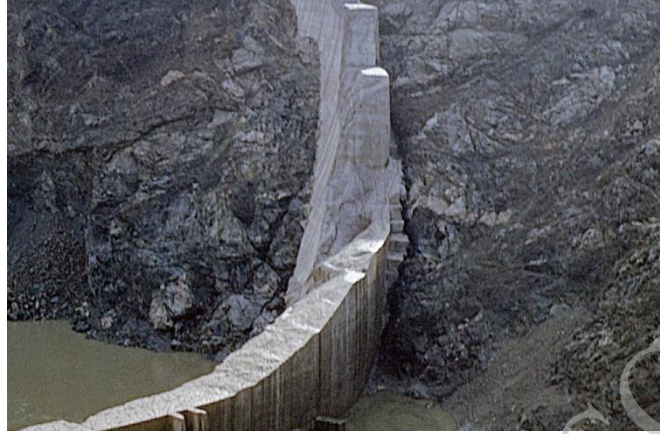
On the right bank (Fig. 8), a wide crevice appeared between the concrete foundation and the rock mass behind the dam, making clear a displacement of the dam of up to 50 cm downstream (see below 2.2). Such a feature had never been reported before anywhere, even though it is mechanically necessary: the dam structure moves forward under the water thrust and the rock mass upstream does not follow. The crevice's width depends on the modulus of the rock downstream. It will be measured few years later at Vouglans dam only a few

Fig. 8. A conspicuous open crevice separates the dam concrete from the rock mass upstream (photo J. Duffaut , Dec. 20, 1959)

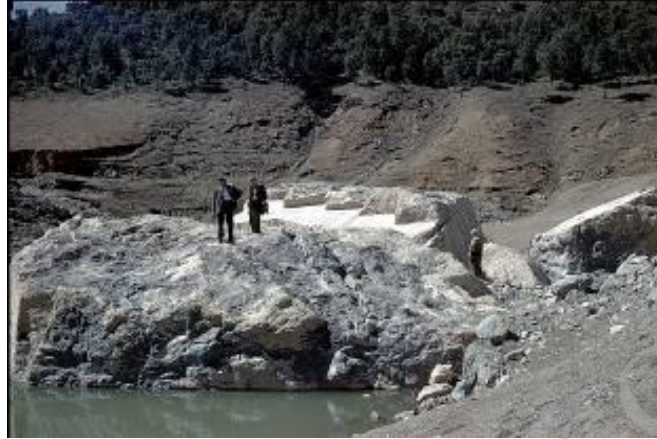
One critical observation was made on the foundation blocks: their lower surface was coated with a slice of rock, proving a failure had happened within the rock mass, just below the concrete structure and not at the interface or within the concrete .

Fig. 9. *The two main concrete blocks, 600 m downstream of the dam: on the one overturned, the foundation rock keeps adherent to concrete (photo J. Duffaut, 20 Dec. 1959)*

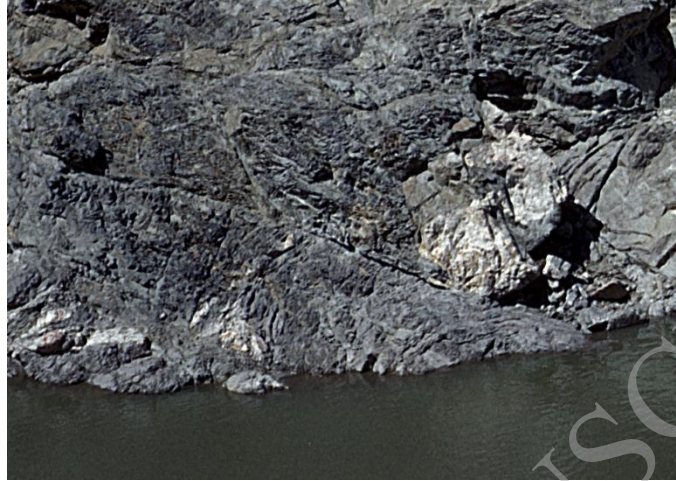
lower part of the right bank and below the overturned concrete block. Its strike being perpendicular to the river, it was easy to find it on the opposite bank although there no topographic indication appeared on the contour lines but the cross section was made visible thanks to the stripping effect of the flow. Its dip, at about 45° north, makes it cross the valley below the stilling basin and pass about 15 metres below the dam foundation. Its thickness was about 1 meter. It comprises two bands of finely crushed rock on either side, 3-5 cm thick, and less crushed material in between (Fig. 10). On the left side of the valley, at the foot of the dihedron, the borders had been eroded and the core looked more like a kind of conglomerate, preserving cobble size pieces of rock.

Fig. 10. *Close-up on the fault cross-section at the foot of right bank; the finely crushed layers are clearly visible on both sides of the fault material (photo P. Duffaut, May 1960)*

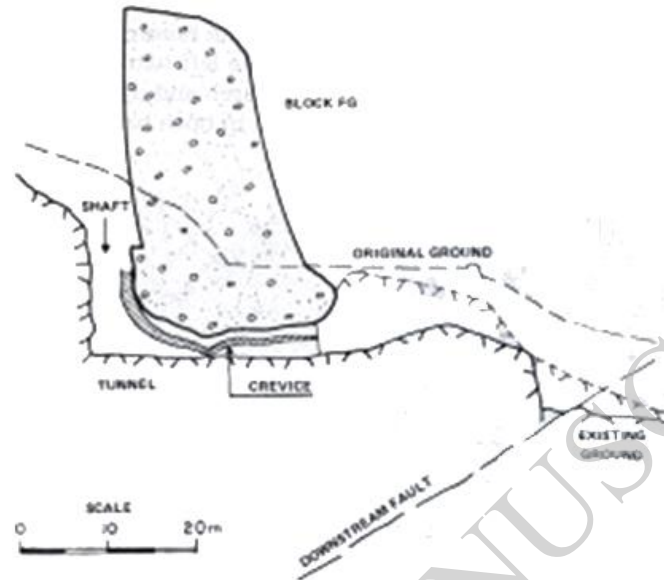
Thanks to a very dry spring in 1962, the water ponds around the dam base dried, giving access to the very foot of the shell; it was possible to bore a small gallery under cantilever FG (Fig. 11). Indeed a water flow below the dam had been suspected from bubbles on the day after the failure and a debris sill formed below the water level by a large discharge during the

Fig. 11. Cross section of the base of cantilever FG showing the investigations performed in late spring 1960 and the crevice discovered; the downstream fault appears also below the dam (from Mary, 1968, the length scale is faulty).

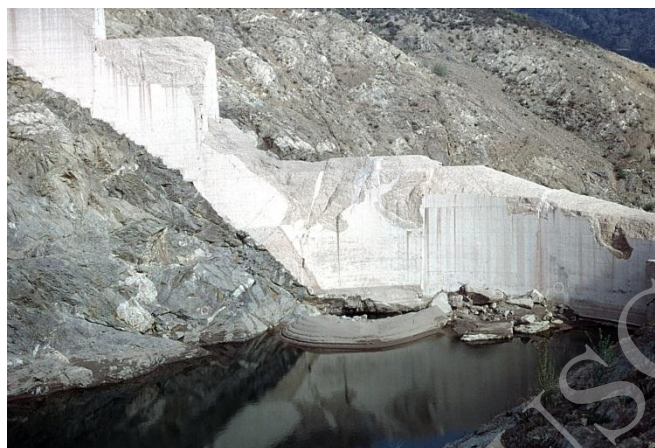
Fig. 12. *The debris sill built under water by the flow below cantilever FG (photo P. Duffaut, May 1960).*

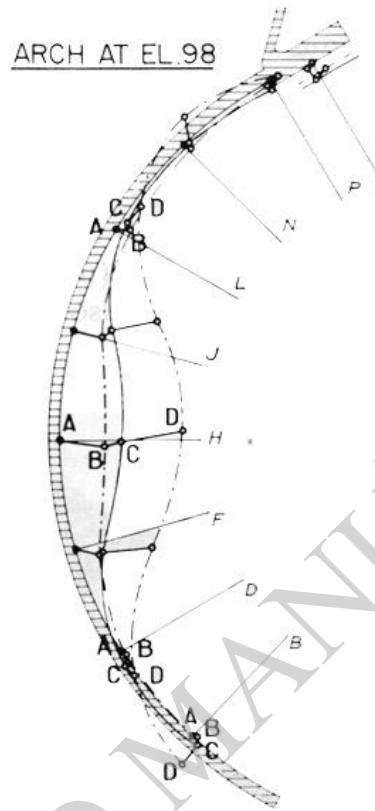
*Fig. 13. Displacement measurements of the arch at elevation 98; bold letters ABCD mark dates of the measurements (4 triangles on fig. 5): the inclination towards left bank of vectors CD is conspicuous.*

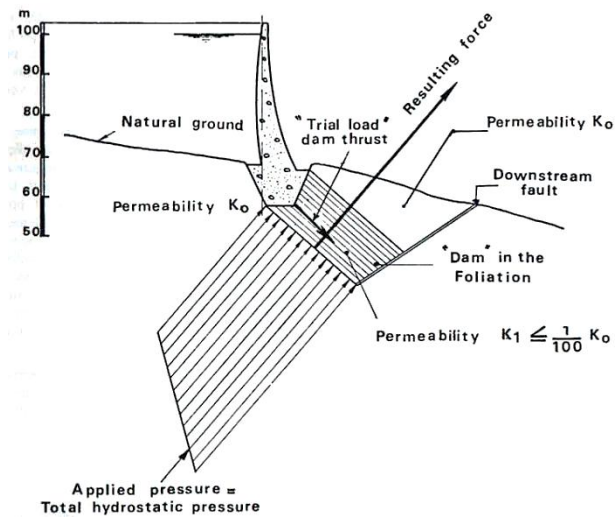
- i. Due to the thrust of the dam, the permeability of the foundation rock was reduced by a factor of ten or even much more, so building a true underground dam.
- ii. Such thrust may move the dihedron along the fault, both upwards and towards left; the cantilevers on the left bank could no longer take support from the dihedron and the whole shell tried to obtain support from the thrust block.
- iii. Since the thrust block had not enough weight, it gave up after a 2 metres displacement, which ended any arch effect.
- iv. The whole dam shell burst, some parts in horizontal bending some other ones in vertical bending.

Fig. 17. Cross-section of the dam and foundation at mid height of left side: the full hydrostatic pressure on the “underground dam” created by the arch dam thrust can push the dihedron upwards along the fault (adapted from Mary, 1968)

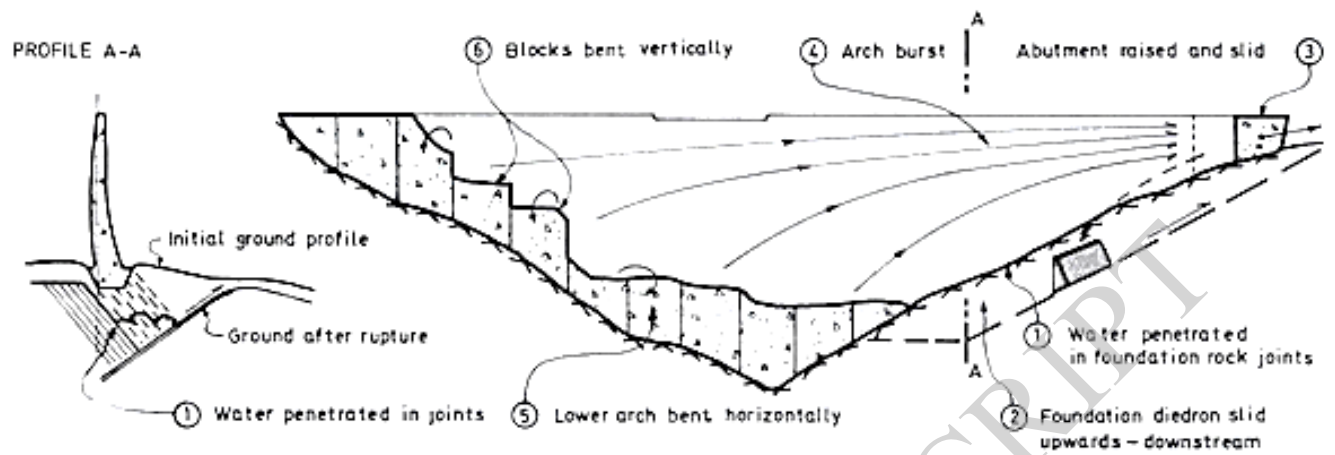
Three different enquiry commissions have worked on the trial, the first one commissioned by the government, both others by the tribunal, altogether involving 18 experts. The third commission was named because the first two could not agree on the issue of the failure's predictability. The new investigations in spring 1962 helped to make progress: Jean Bellier (1967) and Marcel Mary (1968) proposed the following mechanism (schematized Fig. 17 and 18), compatible with all investigations:

Fig. 18. *Phases of failure on downstream view and profile A-A. (1) Water penetrates in the traction fissure along the dam heel; (2) the foundation diedron is pushed along the fault, upwards and rightwards; (3) the whole arch thrust concentrates on the thrust block, which cannot afford it and gives way; (4) deprived from arch effect, the shell burst; 5-6: the right bank cantilevers fail in bending.*
