Damage assessment on buildings using very high resolution multimodal images and GIS

A.-L. CHESNEL[†], R. BINET[†], L. WALD[‡]

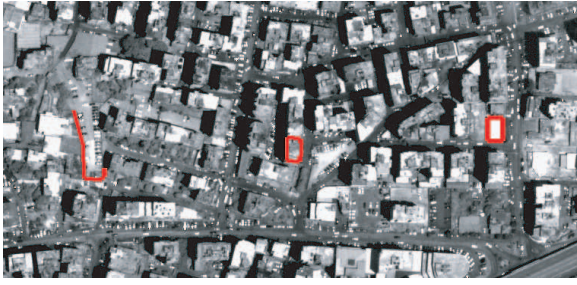
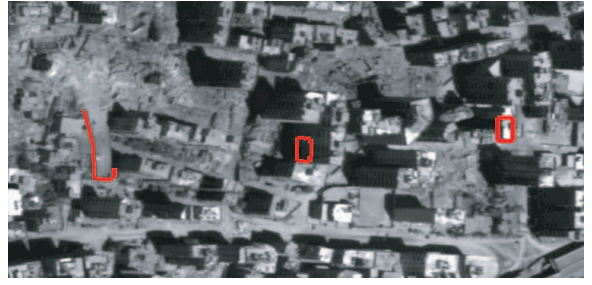
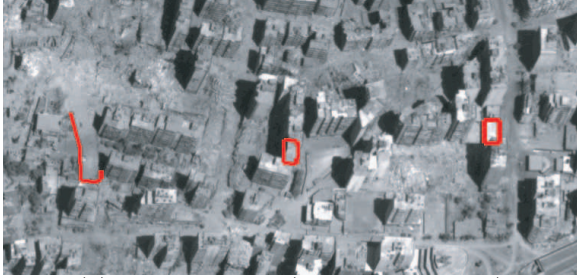
(a) Reference image (19 June 2006)

(b) Crisis image (9 August 2006)

(c) Crisis image (12 August 2006)

Figure 1: In red, three marks are drawn in (a): on the ground (left), on the roof of a high building (centre) and on the roof of a low building (right). They are reported in the crisis images (b and c) using the geographical coordinates. The mark on the ground (left) is correctly registered for both crisis images, whereas the buildings roofs are shifted. – Note in (b) that the low building on the right is hidden by another one.

First, we note that none of the available images have the same acquisition parameters (table 1). This is confirmed by the table 2: the B/H ratio varies from 0.42 to 1.40; it represents absolute difference angles from 24.3° to 80.1°. Note also that the two first crisis images (22 July 2006 and 9 August 2006) present very low elevation angles. This is often the case for the very first images acquired after a disaster, because they are acquired as soon as possible, without waiting for ideal conditions. Figure 2 illustrates the problem of registration with the reference image of 19 June 2006 (a), and the crisis images of 9 August 2006 (b) and 12 August 2006 (c). The three images are registered according to the ground, as confirmed by the red mark on the left: it is at the same location in the three images. A high building in the centre is highlighted: the higher the B/H ratio, the larger the shift between the two images. We also see that a low building (on the right of the images) can be hidden by a higher one (figure 2b), preventing its analysis.

First we register the images according to the ground (image registration). As seen in figure 2, the top of the buildings are still not registered: a method of subpixel registration of the building roofs is then applied, using the GIS (roof registration). The GIS is already registered to the reference image.

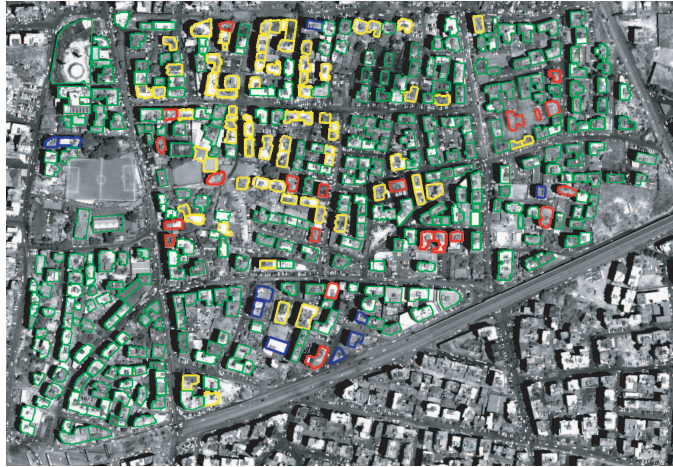
Figure 2: Area of Haret Hreik, in Beirut, Lebanon. Image acquired in 19 June 2006 (reference image). The footprints of the 430 buildings contained in the GIS, used as additional input, is overlaid. The green corresponds to intact or not detectable damage (325 buildings); the yellow to buildings destroyed between the 19 June 2006 and the 22 July 2006 (74 buildings); the red to buildings destroyed between the 22 July 2006 and the 9 August 2006 (21 buildings); the blue is for buildings destroyed between the 9 August and the 12 August 2006 (10 buildings).

The extraction of the building roofs is limited to the reference image; then the same GIS is used with the three pairs of images that correspond to the three crisis images. In this way, a monitoring of a site of interest at successive dates is possible. By comparison with the crisis images, we have identified the buildings of the area that have been destroyed. It will represent a ground-truth to which we will compare the result of our damage detection method. The GIS, overlaid on the reference

image is presented in figure 2.

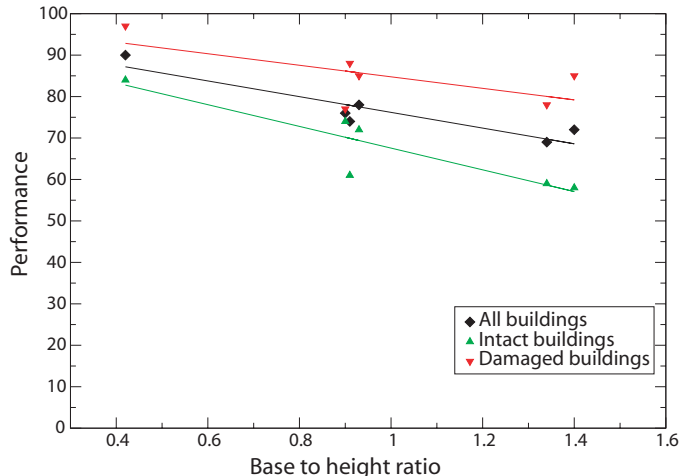
Figure 3: Rate of good classification for the buildings as a function of the B/H ratio. Lines result of a linear regression for intact buildings (green), destroyed buildings (red) and whole dataset (black).

The classification performances are given as a function of the B/H ratio in figure 3. The rates of good classification for the intact buildings and for the damaged buildings appear separately (respectively in green and in red), along with the mean performance (in black).

There is a clear trend of performance decrease when the B/H ratio increases (figure 3). Considering the intact and the damaged class separately, we observe that the damaged class is detected with a better accuracy than the intact one. Moreover, its associated performance is less affected by a high B/H ratio. Few damaged buildings are not detected. The main origin of the classification errors is false-alarms, i.e. the intact buildings that are classified as destroyed. A precise analysis shows that a large part of these errors are due to registration errors, for example buildings that are hidden by another one or located in its shadow. Figure 4 illustrates one of this situation. No information can be retrieve from these occluded buildings. We also point out that a lower satellite elevation leads to a coarser spatial resolution; a large difference of spatial resolution between the reference and the crisis image could also explain a decrease of similarity, even for intact buildings.

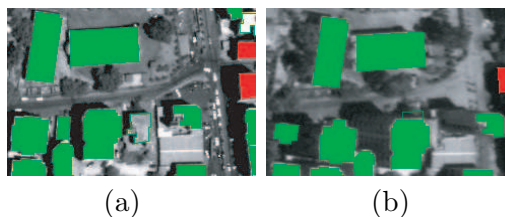
Figure 4: Classification result – Extracts of the 19 June 2006 reference image (a) and the 22 July 2006 crisis image (b). Green corresponds to intact buildings, red corresponds to destroyed ones; Solid fill means correct classification, contrary to the footprint with no fill. The building in the center is intact but is classified as destroyed because it is hidden by another building: an important change is detected.
