Damage assessment on buildings using very high resolution multimodal images and GIS

A.-L. CHESNEL[†], R. BINET[†], L. WALD[‡]

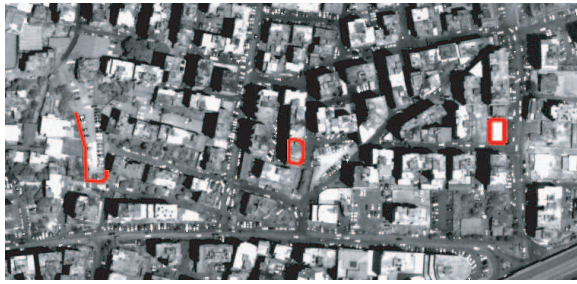
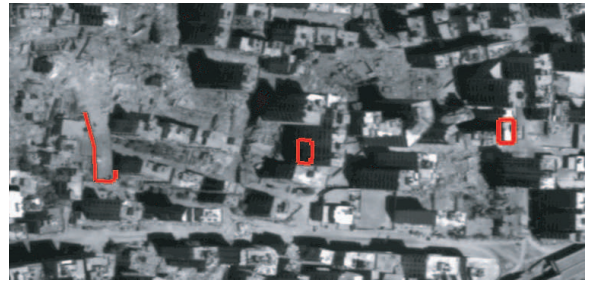
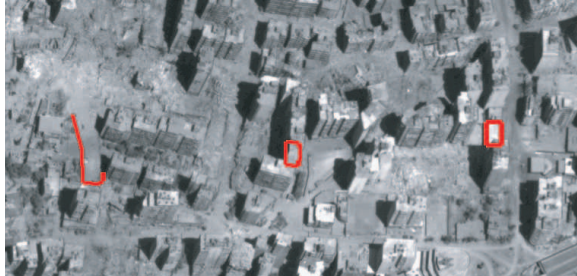
(a) Reference image (19 June 2006)

(b) Crisis image (9 August 2006)

(c) Crisis image (12 August 2006)

Figure 1: In red, three marks are drawn in (a): on the ground (left), on the roof of a high building (centre) and on the roof of a low building (right). They are reported in the crisis images (b and c) using the geographical coordinates. The mark on the ground (left) is correctly registered for both crisis images, whereas the buildings roofs are shifted. – Note in (b) that the low building on the right is hidden by another one.

First, we note that none of the available images have the same acquisition parameters (table 1). This is confirmed by the table 2: the B/H ratio varies from 0.42 to 1.40; it represents absolute difference angles from 24.3° to 80.1°. Note also that the two first crisis images (22 July 2006 and 9 August 2006) present very low elevation angles. This is often the case for the very first images acquired after a disaster, because they are acquired as soon as possible, without waiting for ideal conditions. Figure 2 illustrates the problem of registration with the reference image of 19 June 2006 (a), and the crisis images of 9 August 2006 (b) and 12 August 2006 (c). The three images are registered according to the ground, as confirmed by the red mark on the left: it is at the same location in the three images. A high building in the centre is highlighted: the higher the B/H ratio, the larger the shift between the two images. We also see that a low building (on the right of the images) can be hidden by a higher one (figure 2b), preventing its analysis.

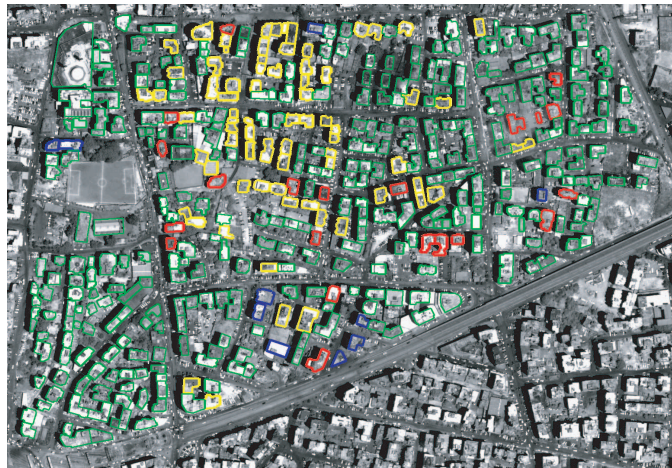
Figure 2: Area of Haret Hreik, in Beirut, Lebanon. Image acquired in 19 June 2006 (reference image). The footprints of the 430 buildings contained in the GIS, used as additional input, is overlaid. The green corresponds to intact or not detectable damage (325 buildings); the yellow to buildings destroyed between the 19 June 2006 and the 22 July 2006 (74 buildings); the red to buildings destroyed between the 22 July 2006 and the 9 August 2006 (21 buildings); the blue is for buildings destroyed between the 9 August and the 12 August 2006 (10 buildings).

The extraction of the building roofs is limited to the reference image; then the same GIS is used with the three pairs of images that correspond to the three crisis images. In this way, a monitoring of a site of interest at successive dates is possible. By comparison with the crisis images, we have identified the buildings of the area that have been destroyed. It will represent a ground-truth to which we will compare the result of our damage detection method. The GIS, overlaid on the reference

image is presented in figure 2.

First we register the images according to the ground (image registration). As seen in figure 2, the top of the buildings are still not registered: a method of subpixel registration of the building roofs is then applied, using the GIS (roof registration). The GIS is already registered to the reference image.

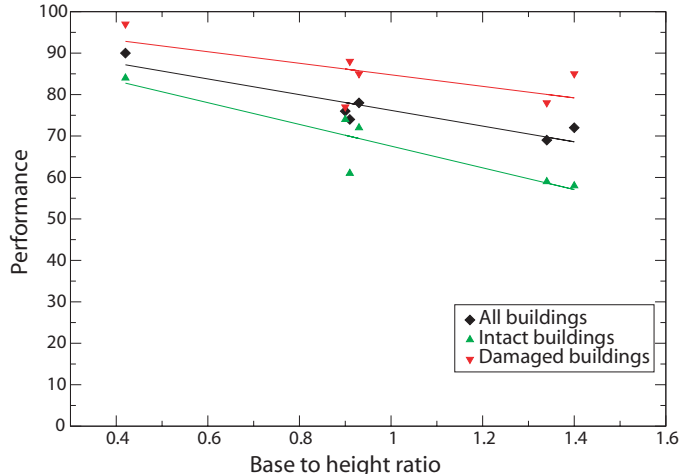
Figure 3: Rate of good classification for the buildings as a function of the B/H ratio. Lines result of a linear regression for intact buildings (green), destroyed buildings (red) and whole dataset (black).

The classification performances are given as a function of the B/H ratio in figure 3. The rates of good classification for the intact buildings and for the damaged buildings appear separately (respectively in green and in red), along with the mean performance (in black).

There is a clear trend of performance decrease when the B/H ratio increases (figure 3). Considering the intact and the damaged class separately, we observe that the damaged class is detected with a better accuracy than the intact one. Moreover, its associated performance is less affected by a high B/H ratio. Few damaged buildings are not detected. The main origin of the classification errors is false-alarms, i.e. the intact buildings that are classified as destroyed. A precise analysis shows that a large part of these errors are due to registration errors, for example buildings that are hidden by another one or located in its shadow. Figure 4 illustrates one of this situation. No information can be retrieve from these occluded buildings. We also point out that a lower satellite elevation leads to a coarser spatial resolution; a large difference of spatial resolution between the reference and the crisis image could also explain a decrease of similarity, even for intact buildings.

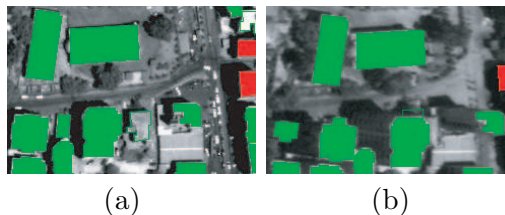
Figure 4: Classification result – Extracts of the 19 June 2006 reference image (a) and the 22 July 2006 crisis image (b). Green corresponds to intact buildings, red corresponds to destroyed ones; Solid fill means correct classification, contrary to the footprint with no fill. The building in the center is intact but is classified as destroyed because it is hidden by another building: an important change is detected.
