# Experimental characterisation of damage in SiC/SiC minicomposites

**Abstract.** SiC/SiC composites are studied for their potential use in the next generation of nuclear reactors. A multiscale approach is under development to construct a predictive modelling of their complex damageable mechanical behaviour due to their heterogeneous microstructure. This paper focuses on the damage characterisation of the composite at the scale of the tow at room temperature, both in terms of its spatial distribution and its chronology. Such observations are necessary to validate a multiscale damage modelling at the microscopic scale. The nonlinear behaviour is related to the accumulation of damages such as matrix cracking, fibre/matrix debonding and finally fibre breaking. Therefore, in-situ tensile tests were carried out on SiC/SiC minicomposites using scanning electron microscopy. Specific procedures could be used to get statistical data on the crack evolution. The first results especially show that the growth of the crack openings over the global strain is related to inter-crack distance. This test was complemented by a microtomographic investigation, conducted at the ESRF, performed on a mini

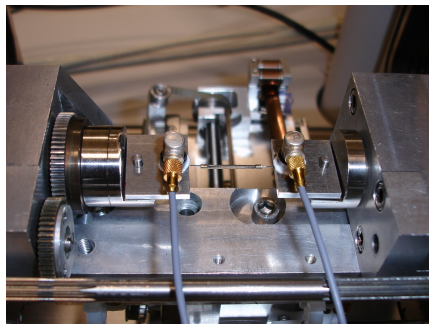
(a) Sample mounted in the in-situ tensile machine

into a Field Emission Gun Scanning Electron Microscope (FEG-SEM). Both sides of the sample were glued into aluminium tabs and the specimen was loaded through pins mounted in the grip regions (see fig.1a). Specimens had a gauge length of 25 mm, which allowed the observation of a significant number of matrix cracks.

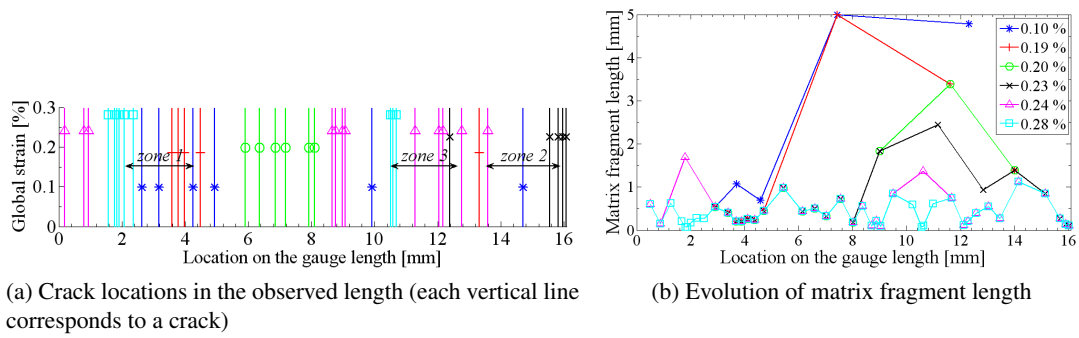
Fig. 2: Cracking evolution of the observed length over the global strain

Cracks appear straight in the transverse direction, so they are easy to localize (see fig.3a). The locations of all cracks along the observed length of the specimen are presented in fig.2a. The strain when each crack was newly observed is also reported – the correspondence between colors and strain levels is given in fig.2b. This figure suggests that cracks appear in groups located in various healthy parts of the minicomposite. The evolution of the matrix fragments (or the crack spacing distance) over the actual strain and the location in the minicomposite, presented in fig.2b, leads to the same remark. The crack spacing distance decreases and tends to stabilize around an average value (378  $\mu\text{m}$ ) along the sample. This distance is higher than the expected average crack spacing distance at saturation (about 200  $\mu\text{m}$ , see section 2), which could be due to the premature failure of the minicomposite.

Openings of cracks localized in the three areas defined in fig.2a (about 2 mm long) were measured using this automatic procedure. Their evolutions against the global strain are presented in fig.4. This figure takes also into account the distance of the nearest neighbouring crack through dot sizes. This figure suggests there are two kinds of evolution as a function of the global strain :

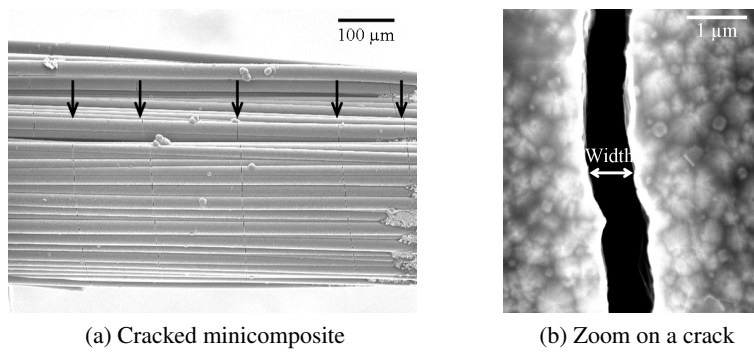
Fig. 3: FEG-SEM images of matrix cracks

The opening of matrix cracks was measured from high magnification FEG-SEM images (see fig.3b) using an automatic procedure. It is based on the detection of the crack width for each row of pixels

of the image by thresholding the grey levels. The threshold is adjusted for each row of the image and the opening is defined as the average of the highest measured widths. The only relevant errors made by this procedure were a few overestimates of the opening in the case of dark artefacts in the image. These overestimates were considerable so they were easily identified and manually corrected.

The tensile test was interrupted at various loads until the ultimate failure. Interruptions were more frequent at low loadings to distinguish as much as possible the crack apparition levels. Acoustic emission were also monitored to detect the beginning of the damage accumulation. At each step, strain was measured using SEM observations of each side of the gauge length. The location of each new crack was also reported along the observed length. The observation was bounded to the central 16 mm of the sample. Finally, in order to study the evolution of the crack opening, a few cracks, distributed into three regions about 2 mm long each, were observed at high magnification (see fig.3b).

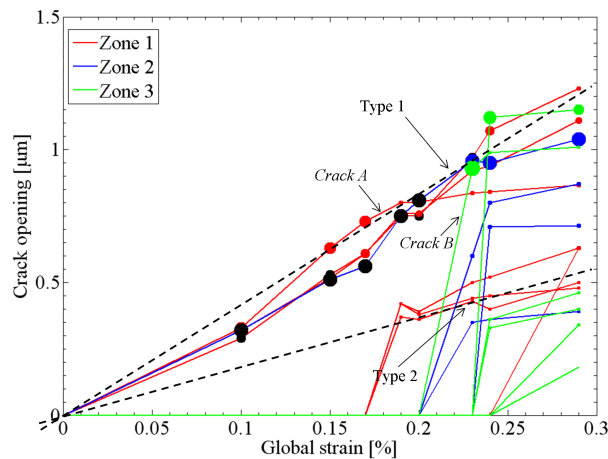
- if the distance of the nearest neighbouring crack is high (large markers, type 1), the evolution is quite linear with a high slope.
- if the distance of the nearest neighbouring crack is small (small markers, type 2), the evolution is also almost linear with a far smaller slope.

Cracks A and B (fig.4) are perfect examples of the link between the crack spacing distance and the slope of the opening-strain curve, for which a sharp change of slope corresponds to a sharp decrease of the nearest neighbouring crack distance. These results are the consequence of the shielding effect associated with matrix cracks (the matrix stress decreases in the neighbourhood of a crack). A lower estimate of the shielding zone length, at the highest load, may be provided from the maximum distance observed for type 2 cracks ( $\frac{0.27}{2} = 0.135$  mm). Similarly, an upper estimate (0.21 mm) may also be obtained from the minimum distance for type 1 cracks.

Fig. 4: Evolution of some crack openings over the global strain of the gauge length (the dot size is proportional to the distance of the nearest neighbour crack; black dots correspond to cracks at the extremities of the observed length, the distance is then equal to the first distance actually measured)

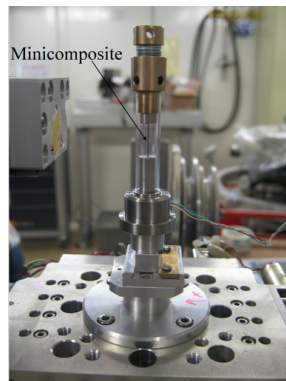
Fig. 5: In-situ tensile machine used on the ID19 beamline

A specific light tensile machine, designed at the INSA Lyon (Institut National des Sciences Appliquées, Lyon, France), was used to load manually the specimen (see fig.5). The minicomposite was glued into aluminium tabs, like for the SEM tests, and had a gauge length of 15 mm. Six loadings were successively applied to the specimen : 50, 68, 74, 86, and 92 N. For each loading, three images (four scans at four different distances by image) were acquired to observe a total length of 1.65 mm of the sample in the central part.

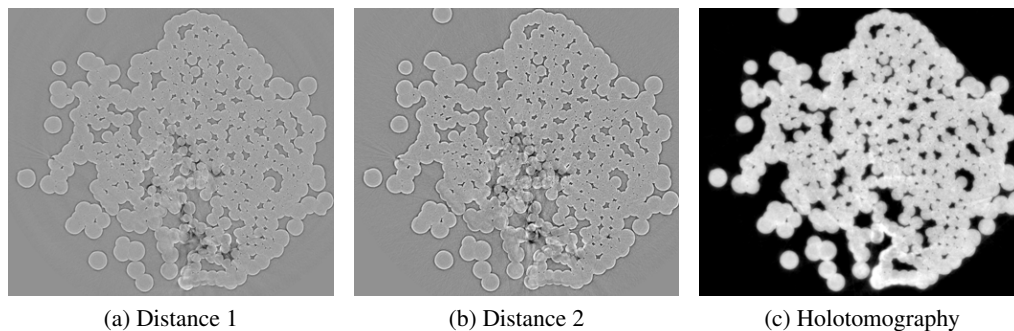
The holotomographic images were reconstructed for all loadings using the specific algorithm proposed by [9, 10]. The absorption contrast images were also reconstructed for the first two distances of acquisition. The total volume studied contained six matrix cracks at the highest loading level (92 N). In fact, fig.6 shows the effects of the crack on both reconstruction type, absorption and holotomography. On this slice, several zones within the minicomposite are affected by the cracking. The crack effect is, in a first visual observation, more pronounced on absorption contrast images but there is also more artefacts in healthy zones due to the crack. Finally note that the contrast between fibres and matrix is not better in holotomographic reconstructions than in absorption reconstruction. In fact, the beam energy was not optimized for holotomography with a quartz tube around the sample.

Fig. 6: Reconstruction of a transverse slice in absorption (first two distances) and holotomographic mode within a crack

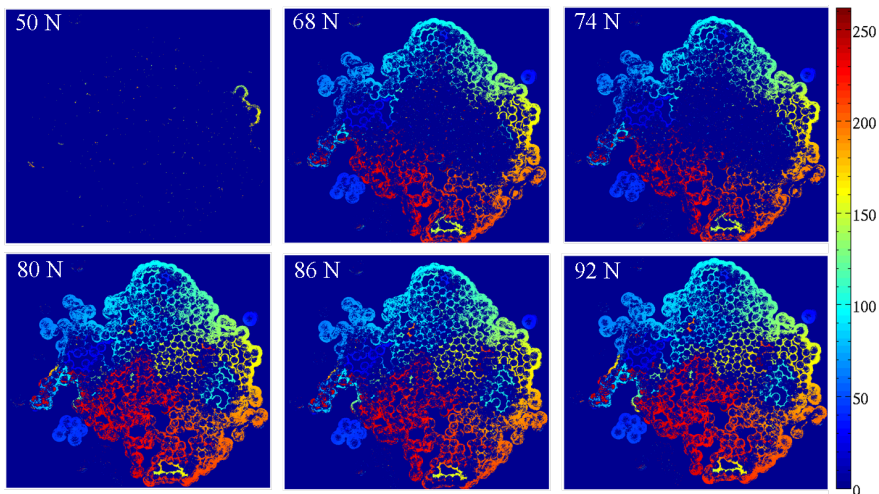
The procedure was computed for each loading level. Fig.8 presents the crack projection onto the transverse plan. It clearly shows three propagation states at 50, 68 and 80 N. The initiation of the crack is observed at 50 N. From 50 N to 68 N, the crack propagates on the minicomposite periphery, following a spiral shape. Then from 74 N to 80 N, the crack goes to the center of the minicomposite. Moreover, there is no evolution between 68 and 74 N. That reveals a discontinuous propagation. These results contradict the classical 1D modelling of minicomposite [5, 11], which assumes that the matrix cracks suddenly cross the whole section.

Fig. 8: Propagation of a crack over a tensile load (the color scale corresponds to the average height in pixels where the crack is detected)

Second, a 3D microtomographic observation of a minicomposite under tensile load was performed using the X-ray synchrotron source provided by the ESRF. Images of a short tow segment have been reconstructed, using absorption and holotomographic modes, at six loading states and reveal some cracks. A specific procedure was applied on the three types of reconstructions to extract a crack of the minicomposite. Unlike what is often assumed, the matrix crack slowly propagates within the bundle of fibres, at first on the peripheral zone, and then through the center of the section. Further analysis also are under development to study the density of fibre failures.
