## Experimental characterisation of damage in SiC/SiC minicomposites

Camille Chateau, L. Gélébart, Michel Bornert, Jérôme Crépin, Daniel Caldemaison, Elodie Boller, C. Sauder, M. Langer, Wolfgang Ludwig

**Abstract.** SiC/SiC composites are studied for their potential use in the next generation of nuclear reactors. A multiscale approach is under development to construct a predictive modelling of their complex damageable mechanical behaviour due to their heterogeneous microstructure. This paper focuses on the damage characterisation of the composite at the scale of the tow at room temperature, both in terms of its spatial distribution and its chronology. Such observations are necessary to validate a multiscale damage modelling at the microscopic scale. The nonlinear behaviour is related to the accumulation of damages such as matrix cracking, fibre/matrix debonding and finally fibre breaking. Therefore, in-situ tensile tests were carried out on SiC/SiC minicomposites using scanning electron microscopy. Specific procedures could be used to get statistical data on the crack evolution. The first results especially show that the growth of the crack openings over the global strain is rel

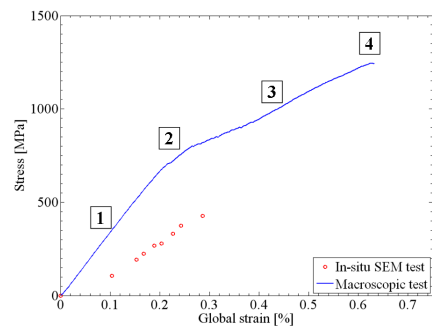
(b) Macroscopic tensile behaviour of a minicomposite (obtained with a macroscopic and the in-situ devices)

Fig. 1: Experimental device and material behaviour

Like the woven composite, minicomposites have an elastic damageable behaviour. Their macroscopic behaviour follows successive typical steps [8] (see fig.1b). The first one is the elastic domain of the minicomposite behaviour : no crack occurs. The non-linear second domain is associated with the matrix cracking until its saturation ( $\approx 0.3\%$ ). A second linear region thanks to the elastic deformation of fibres then appears after saturation. The final step is characterised by a slight nonlinearity associated with fibre breaking just before the ultimate failure (close to  $\approx 0.7\%$ ). If this qualitative description is usually accepted, the purpose of this experimental study is now to quantify the evolution of damage mechanisms as a function of the load.

The strain-stress curve corresponding to the studied minicomposite batch, given in fig.1b, has been obtained with the macroscopic device presented in [8]. The average crack spacing distance, measured after failure, is equal to 193  $\mu\text{m}$ .

For now, as shown on fig.1b, the macroscopic behaviour of the minicomposite, obtained with the in-situ tensile test machine is not satisfying and reveals a premature failure. The way to improve this test is under investigation. Nevertheless, these tests allowed us to develop specific procedures to study the matrix cracking evolution over the minicomposite global strain.

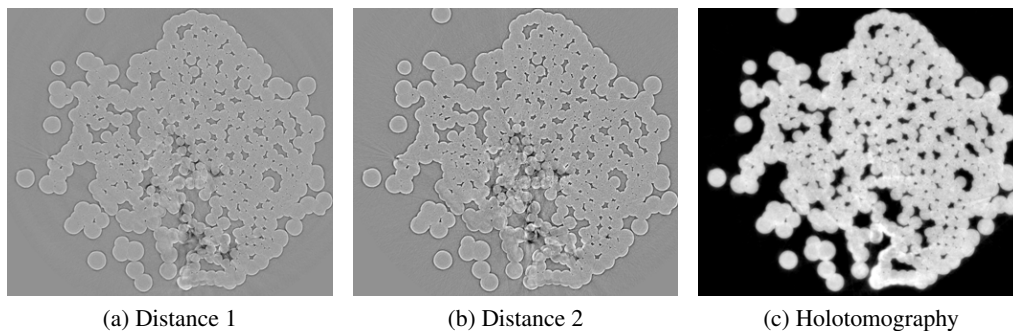
Fig. 6: Reconstruction of a transverse slice in absorption (first two distances) and holotomographic mode within a crack

The holotomographic images were reconstructed for all loadings using the specific algorithm proposed by [9, 10]. The absorption contrast images were also reconstructed for the first two distances of acquisition. The total volume studied contained six matrix cracks at the highest loading level (92 N). In fact, fig.6 shows the effects of the crack on both reconstruction type, absorption and holotomography. On this slice, several zones within the minicomposite are affected by the cracking. The crack effect is, in a first visual observation, more pronounced on absorption contrast images but there is also more artefacts in healthy zones due to the crack. Finally note that the contrast between fibres and matrix is not better in holotomographic reconstructions than in absorption reconstruction. In fact, the beam energy was not optimized for holotomography with a quartz tube around the sample.

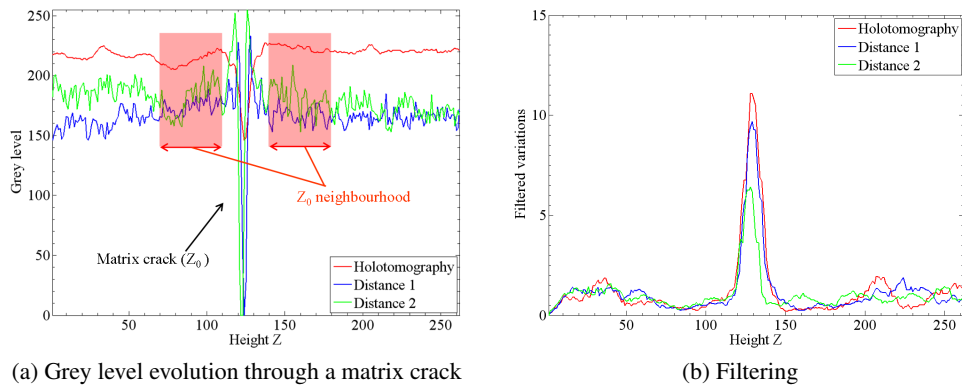
Fig. 7: Crack detection in the Z direction (the height is in pixels)

The detection procedure is based on the processing of the grey level evolution in the Z direction. An example of a such an evolution (for (X,Y) located in a matrix crack) is given in fig.7a. The crack is responsible for an important variation of the grey levels on a relatively short length. The aim of the automatic procedure is to spot this fluctuation, in reducing the detection of artefacts such as evolutions of the microstructure (matrix/pore interface) in the fibre direction. The variation detection is based on the study of the ratio of the derivative to the average derivative on a neighbourhood (see fig.7a). An example of this filtering is presented in fig.7b. A crack is detected when the three reconstructions global maxima match. Otherwise, the material is considered healthy.
