Tribological study of a press-fit assembling process

Laurent Boissonnet, Benjamin Duffau, Pierre Montmitonnet

Laurent Boissonnet, Benjamin Duffau, Pierre Montmitonnet. Tribological study of a press-fit assembling process. ICTMP 2010, Jun 2010, Nice, France. 10 p. <hal-00527847>

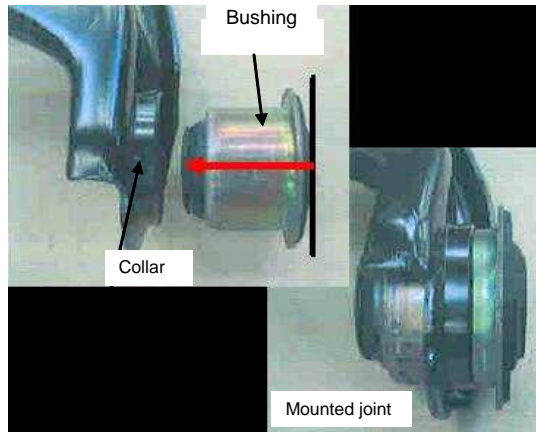
Figure 1: Press-fit pieces

The press-fit process is used to assemble pieces in several automotive sub-systems [1]. In the system studied, a cylindrical bushing (consisting in an external steel envelope connected to a central axis by a rubber layer) is press-fitted into a deep-drawn collar, made of a steel strip covered by a ca. 30 μm epoxy layer deposited by cataphoresis (Figure 1). The bushing envelope is covered by an electrodeposited zinc-nickel layer. The assembled joint must resist mechanical loadings all along the service life of the vehicle. It is therefore necessary to ensure a minimal level of joint mechanical resistance (disassembling force), which depends on force distributions to be undergone by the joint during its life. To be able to assess the quality of each joint, the purpose of the work is to establish reliable relations between this disassembling, joint resistance force and the press-fitting force which is systematically measured on the joint production line.

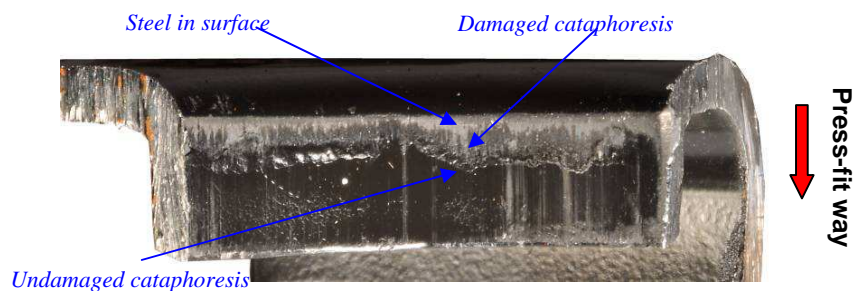
Figure 2: Cutting of a “collar way” press-fitted lower arm – cataphoresis aspect

There are two ways of assembling a deep-drawn collar and a bushing : using the same direction for press-fitting (“collar way”) as for deep-drawing, or using opposite directions (“counter-collar way”). They lead to different contact conditions, as will be shown.

Have a look at the “collar way” case. Figure 2 shows the range of damage undergone by epoxy during press-fitting and it gives information on the contact distribution between the two parts. Figure 3 shows SEM observation of the polymer coating, from the collar entry to its exit (i.e. along the press-fit way). At the top (figure 3a), epoxy is pushed down from the collar entry, forming an “epoxy roll” downstream (figure 3b,c). In some cases like in Figure 2, the epoxy layer is completely shaved off and the resultant surface is a patchwork of steel and phosphate layer (adhesion primer before cataphoresis) (Figure 3-a).

Regardless of interference, the main result of simulation is that contact between the bushing and the collar does not occur uniformly on the whole nominal contact surface, but tends to be limited to short areas on the entry and exit sides, due to the elastic and plastic mechanical response of the collar and bushing to press-fitting forces. It is all the more concentrated at the entry as interference is high. This is consistent with optical observation of Figure 2.

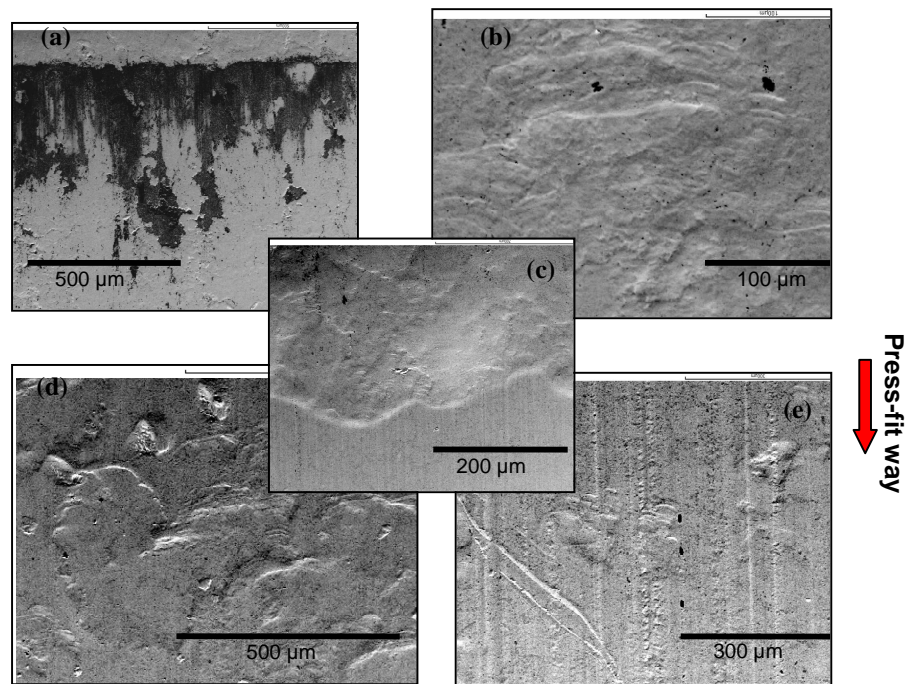
Figure 3 : SEM observation of rubbed polymer coating ; backscattered electron analysis, topographic mode – (a) : steel and phosphate show at surface of collar entry (complete wear of epoxy) – (b) : surface damage in the pushed-back epoxy area (before the “roll”) – (c) : “epoxy roll” (transition between sheared and rubbed epoxy coating areas) – (d) : after the roll: epoxy damage by wrenching of particles – (e) : after the roll: epoxy light superficial damage mainly by scratching

- epoxy particle wrenching is seen mainly in the pushed area (Figure 3-b) where the contact conditions are most severe.

- In Figure 3-d and to a lesser extent in Figure 3-b, there are steps in the profile, in the direction of press-fitting. Referring to the wave model of Challen and Oxley [3], this may be explained by local waves formed during sliding that degenerate into adhesive rolls (due to microscopic friction), which may eventually be detached by a crack at their basis. This mechanism is found mainly after the macroscopic “roll”, but also in the pushed area.

- for lower friction conditions, i.e. locally after the epoxy roll, superficial scratches are noticed (Figure 3-e).

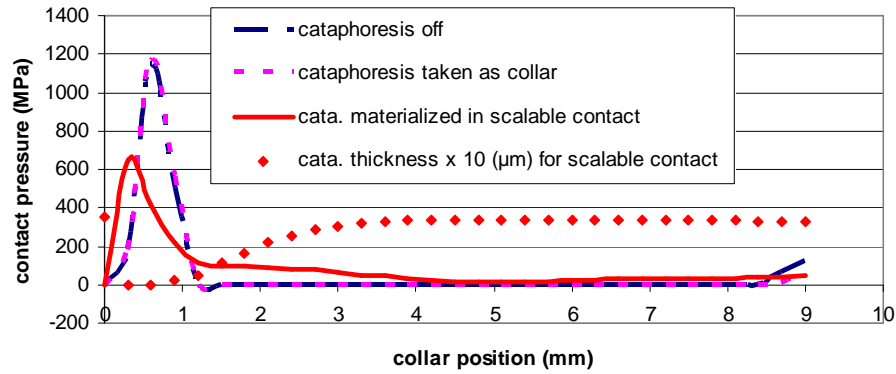
Figure 4 : press-fitting axisymmetric FEM simulation – contact pressure distribution along collar (position 0 = collar entry) at the end of press-fitting

Finite element simulations are carried out in a case of press-fitting with high interference, the same as for Figure 2, using a constant coefficient of friction (COF) $\mu = 0.3$. Contact pressure distribution is plotted in Figure 4. Apart from the “scalable contact” simulation, two other simulations are reported, with extreme cases of interference: considering the epoxy coating is off, and considering the coating as made out of the steel of the collar. For both cases, contact distribution is similar and is concentrated at collar entry with a high contact pressure. A secondary contact area is found at the other end of the joint, due to the plastic deformation of bushing external envelope. Press-fitting forces are 20.73 kN and 21.08 kN. Thus for this high interference case the 30 μm the additional interference fit effect due to cataphoresis do not change anything to efforts.

For the “scalable contact” simulation, both the contact pressure distribution and the remaining coating thickness are plotted along the collar in figure 4. It is obvious that contact pressure is more widely spread ; the coating is completely removed at the collar

entry (which is relevant, considering Figure 2). The press-fitting force is 25.09 kN, still with a constant $\mu = 0.3$. A constant COF is not necessarily realistic, considering the elimination of the coating at entry, but the goal is to uncouple tribological effects. Therefore the coating does not play just as an additional interference fit. Thanks to its elasticity, it tends to spread the contact and increase the integral contact pressure (hence, the disassembling force), all the more as interference is high.

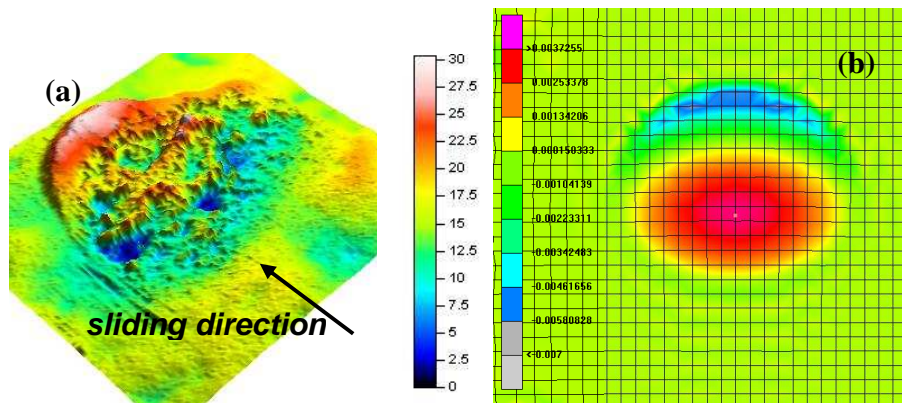
Figure 5 : Sliding of an epoxy-coated. cylinder on a bushing, $F_n=150 \text{ N}$ (a) 3D roughness mapping of sliding track (b) : FEM simulation of the test, normal displacement of the coating surface.

A tribological test has been designed to study, under conditions close to press-fitting, both mechanical behavior of the epoxy coating and tribological behaviour. The former is dealt with here, the latter is detailed in section 3.2. It consists in a steel cylinder of diameter 14 mm covered by a $30\text{ }\mu\text{m}$ epoxy layer sliding linearly on a bushing: cylinder and bushing axes are perpendicular and sliding is along the bushing axis. This is a case of maintained contact for the polymer coating ; hence, even if this is point contact with high pressure at the beginning, the non-confined polymer flows, the contact area increases and contact pressure is quickly decreasing. The goal here is to analyse epoxy shear deformation, and not the consequences of surface damage. Therefore sliding tests were performed on a short sliding length ($0,5\text{ mm}$) to examine incipient shear, with a normal force of 150 N at a speed of $0,1\text{ mm/s}$. The apparent COF is measured anyway, at the end of the test it has reached a stable value of 0.32. A "roll" (bulge) is formed, with maximum height $15\text{ }\mu\text{m}$; the area after deformation is about $1,1 \times 0,7\text{ mm}^2$. This gives an average contact pressure of 250 MPa, which is moderate and an average frictional stress of 80 MPa. Figure 5-a shows the mark on the polymer coating, showing large-scale, through-thickness shear, superficial tearing and the induced roughness; no sign of delamination has been found. This suggests that perfect adhesion may be assumed for moderate contact pressure, and that internal shear and high rate of polymer wear are responsible for the disappearance of the coating, rather than a weak interface.

As the contact pressure is quite similar to nano-indentation tests, the elastic-plastic properties determined in section 3.1.1 have been selected to perform a numerical simulation of the test using Abaqus® Explicit. Epoxy and the underlying steel are supposed perfectly adherent and are both meshed, whereas the bushing is considered rigid. Moreover the Coulomb COF is set to 0,35 and the friction stress is limited to 80 MPa (corresponding to a limitation by a friction factor of $\mu=0,9$). The simulated contact area is increasing only over the first 50 μm sliding, with polymer distortion. It can therefore be considered that contact pressure is moderate (250 MPa) over the whole test. The result at the end of the simulation is shown in Figure 5-b : the shape of the contact surface is correct, but its area of $0,65 \times 0,8 \text{ mm}^2$ and the bulge height of 6 μm are lower than experimental values. One hypothesis is that the yield stress may be lower than 150 MPa in this case, which raises the question of a possible hydrostatic pressure dependence (pressure is higher in indentation, overestimating the yield stress). This should be checked in future investigations.

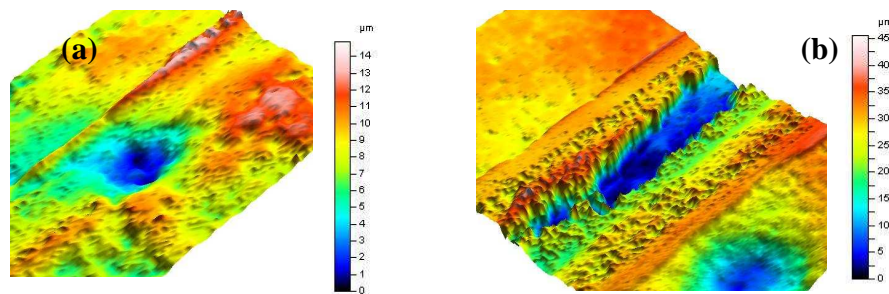
Figure 6 : Sliding of a Zn-Ni-coated ball on an epoxy-coated steel plate; 3D roughness mapping of the groove for $F_n=250 \text{ N}$ (a) after one run – (b) : after two runs.

Two successive runs on the same track were carried out under a normal force of 500 N. The 3D roughness mapping is reported in Figure 6. The first run leads to a small ploughed groove (lateral bulge, no coating removal): the groove width is $2a=0,6 \text{ mm}$, the bulge height is between 2 and 8 μm , and the measured apparent COF is 0,16.

To clarify the contact conditions in this test, numerical simulation has been carried out. The results show that substrate displacement in the normal direction is only 2 μm and the contact can be supposed on a whole disc (contact area $\pi \cdot a^2$ and contact length in the sliding direction 2.a) with an average contact pressure reaching 2000 MPa. The mapping of the groove after the second run shows local coating wrenching at the bottom. There is still epoxy at the surface, which means that fracture happened within the coating, near the phosphate primer ; between 5 and 10 μm of epoxy remain, based on the groove depth. An estimate of the frictional dissipated energy per unit area for one run is $w_f = \mu_{app} \cdot \bar{p} \cdot 2a \approx 200 \text{ mJ} / \text{mm}^2$.

For the second run, the apparent COF increases to 0.3 , so the energy necessary to generate fracture in the coating seems to be comprised between 200 and 600 mJ/mm^2 .

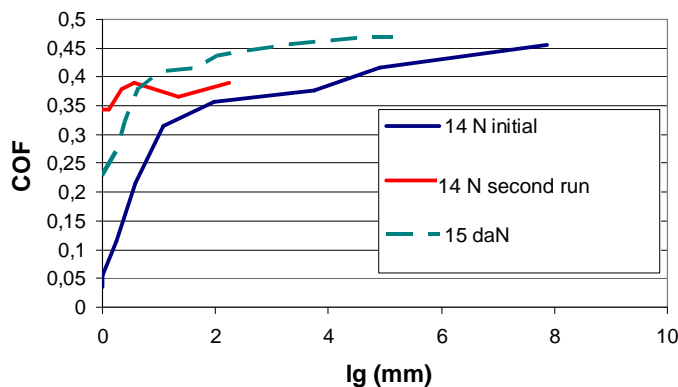
Figure 7: Apparent coefficient of friction vs sliding length – epoxy-coated cylinder on bushing layout.

Figure 7 shows a large evolution of the measured apparent (macroscopic) COF as a function of sliding length for $F_n=150$ N (dashed curve). This is similar to the previous section, where the apparent COF was shown to increase from 0.16 at the first run to 0.3 for the second. This is due to the epoxy coating being sheared and damaged by the frictional energy, so that the contact area increases and the pressure decreases; since under high pressure, the contact is in the limiting shear stress regime, the apparent COF decreases.

Therefore, a small normal force of 14 N is chosen, so that no plastic distortion of the coating occurs. In this simple case, the contact properties can be estimated through an elastic foundation hypothesis: area $0,21 \times 0,62$ mm² and maximum contact pressure 271 MPa at the beginning, without considering wear. Indeed, with sliding, the epoxy film is removed from the cylinder by abrasive wear and the contact area increases.

There is still an increase of the COF with sliding length : from below 0,1 to 0,45 after 8 mm of sliding. Considering that this is linked to the frictional dissipated energy, it is important to realize that in this case, the coating is sheared only in its topmost layer, not in the whole thickness. The reason of such an increase could be strain hardening of the polymer, or maybe roughness increase (remember that in this configuration, the same coating area is in contact throughout with a constantly renewed bushing surface).

For confirmation, we performed a second run, with as far as possible the same rubbed epoxy surface sliding on the same part of the bushing. The result is a COF of 0,35 at the beginning of the test. This is smaller than the final 0,45 of the first run, which would be expected if friction depends only on a single state variable, frictional energy; the difference can be explained by a slightly different contact area. Nevertheless, the increase during the first mm of sliding is very small compared to the first run, which is reminiscent of the quasi-stable COF of the end of the first test. In a first approximation, it confirms the link established between friction and surface energy dissipation.
