# TRIBOLOGICAL STUDY OF A PRESS-FIT ASSEMBLING PROCESS

A particular case of press-fitting of two metal parts is studied, with high fit interference inducing high contact pressures and plastic deformation of the bushing and collar. Furthermore, the female piece is polymer-coated by cataphoresis, and the coating evolution by damage and wear during sliding promotes significant changes of friction with sliding length. These particular frictional properties impact the structural mechanics behaviour of the system during assembling.

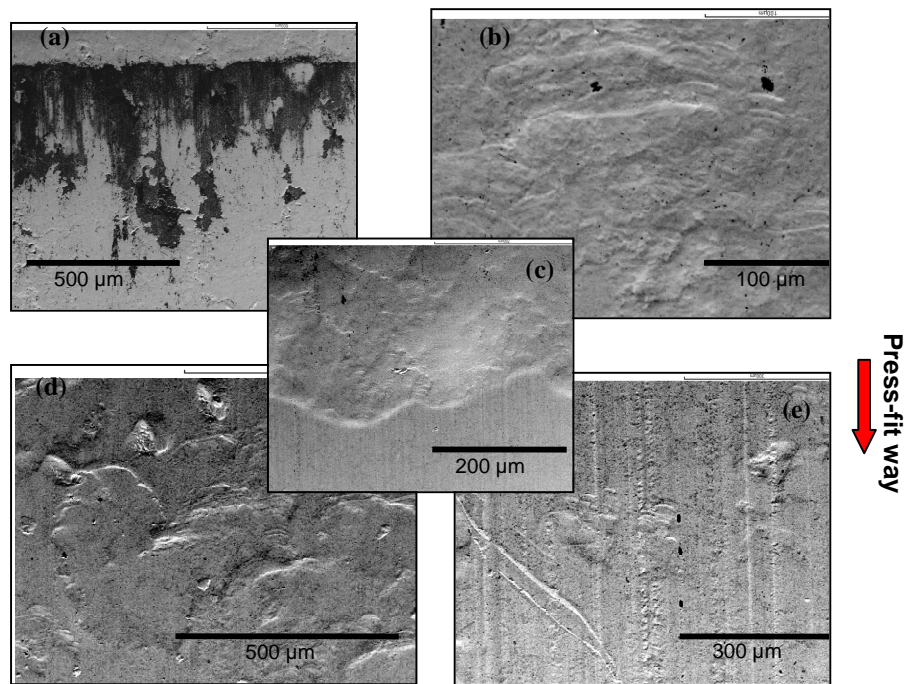
Have a look at the “collar way” case. Figure 2 shows the range of damage undergone by epoxy during press-fitting and it gives information on the contact distribution between the two parts. Figure 3 shows SEM observation of the polymer coating, from the collar entry to its exit (i.e. along the press-fit way). At the top (figure 3a), epoxy is pushed down from the collar entry, forming an “epoxy roll” downstream (figure 3b,c). In some cases like in Figure 2, the epoxy layer is completely shaved off and the resultant surface is a patchwork of steel and phosphate layer (adhesion primer before cataphoresis) (Figure 3-a).

Figure 3 : SEM observation of rubbed polymer coating ; backscattered electron analysis, topographic mode – (a) :steel and phosphate show at surface of collar entry (complete wear of epoxy) – (b) : surface damage in the pushed-back epoxy area (before the “roll”) – (c) : “epoxy roll” (transition between sheared and rubbed epoxy coating areas) – (d) : after the roll: epoxy damage by wrenching of particles – (e) : after the roll: epoxy light superficial damage mainly by scratching

- epoxy particle wrenching is seen mainly in the pushed area (Figure 3-b) where the contact conditions are most severe.

- In Figure 3-d and to a lesser extent in Figure 3-b, there are steps in the profile, in the direction of press-fitting. Referring to the wave model of Challen and Oxley [3], this may be explained by local waves formed during sliding that degenerate into adhesive rolls (due to microscopic friction), which may eventually be detached by a crack at their basis. This mechanism is found mainly after the macroscopic “roll”, but also in the pushed area.

- for lower friction conditions, i.e. locally after the epoxy roll, superficial scratches are noticed (Figure 3-e).

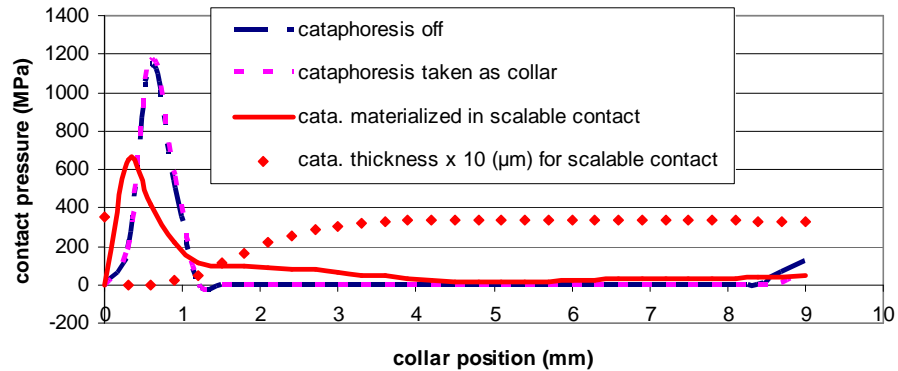
Finite element simulations are carried out in a case of press-fitting with high interference, the same as for Figure 2, using a constant coefficient of friction (COF)  $\mu = 0.3$ . Contact pressure distribution is plotted in Figure 4. Apart from the “scalable contact” simulation, two other simulations are reported, with extreme cases of interference: considering the epoxy coating is off, and considering the coating as made out of the steel of the collar. For both cases, contact distribution is similar and is concentrated at collar entry with a high contact pressure. A secondary contact area is found at the other end of the joint, due to the plastic deformation of bushing external envelope. Press-fitting forces are 20.73 kN and 21.08 kN. Thus for this high interference case the 30  $\mu\text{m}$  the additional interference fit effect due to cataphoresis do not change anything to efforts.

For the “scalable contact” simulation, both the contact pressure distribution and the remaining coating thickness are plotted along the collar in figure 4. It is obvious that contact pressure is more widely spread ; the coating is completely removed at the collar

Figure 4 : press-fitting axisymmetric FEM simulation – contact pressure distribution along collar (position 0 = collar entry) at the end of press-fitting

Regardless of interference, the main result of simulation is that contact between the bushing and the collar does not occur uniformly on the whole nominal contact surface, but tends to be limited to short areas on the entry and exit sides, due to the elastic and plastic mechanical response of the collar and bushing to press-fitting forces. It is all the more concentrated at the entry as interference is high. This is consistent with optical observation of Figure 2.

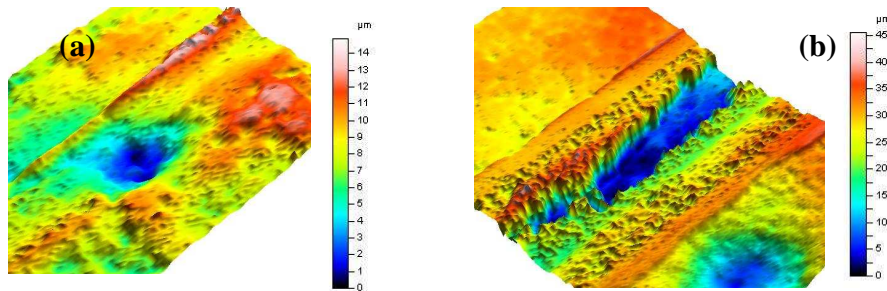
Two successive runs on the same track were carried out under a normal force of 500 N. The 3D roughness mapping is reported in Figure 6. The first run leads to a small ploughed groove (lateral bulge, no coating removal): the groove width is  $2a=0,6 \text{ mm}$ , the bulge height is between 2 and 8  $\mu\text{m}$ , and the measured apparent COF is 0,16.

Figure 6 : Sliding of a Zn-Ni-coated ball on an epoxy-coated steel plate; 3D roughness mapping of the groove for  $F_n=250 \text{ N}$  (a) after one run – (b) : after two runs.

To clarify the contact conditions in this test, numerical simulation has been carried out. The results show that substrate displacement in the normal direction is only 2  $\mu\text{m}$  and the contact can be supposed on a whole disc (contact area  $\pi \cdot a^2$  and contact length in the sliding direction 2.a) with an average contact pressure reaching 2000 MPa. The mapping of the groove after the second run shows local coating wrenching at the bottom. There is still epoxy at the surface, which means that fracture happened within the coating, near the phosphate primer ; between 5 and 10  $\mu\text{m}$  of epoxy remain, based on the groove depth. An estimate of the frictional dissipated energy per unit area for one run is  $w_f = \mu_{app} \cdot \bar{p} \cdot 2a \approx 200 \text{ mJ} / \text{mm}^2$ .

For the second run, the apparent COF increases to 0.3 , so the energy necessary to generate fracture in the coating seems to be comprised between 200 and 600  $\text{mJ}/\text{mm}^2$ .

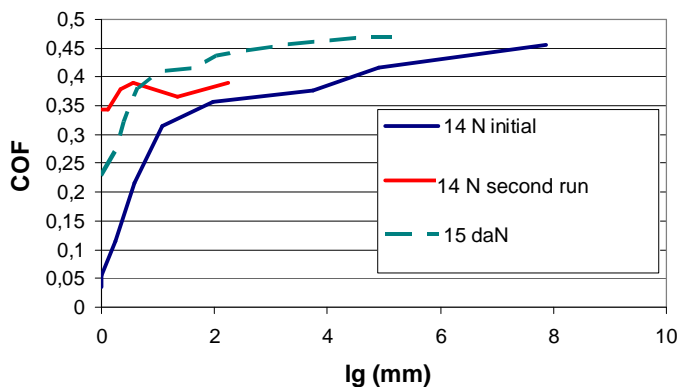
Figure 7 shows a large evolution of the measured apparent (macroscopic) COF as a function of sliding length for  $F_n=150$  N (dashed curve). This is similar to the previous section, where the apparent COF was shown to increase from 0.16 at the first run to 0.3 for the second. This is due to the epoxy coating being sheared and damaged by the frictional energy, so that the contact area increases and the pressure decreases; since under high pressure, the contact is in the limiting shear stress regime, the apparent COF decreases.

Figure 7: Apparent coefficient of friction vs sliding length – epoxy-coated cylinder on bushing layout.

There is still an increase of the COF with sliding length : from below 0,1 to 0,45 after 8 mm of sliding. Considering that this is linked to the frictional dissipated energy, it is important to realize that in this case, the coating is sheared only in its topmost layer, not in the whole thickness. The reason of such an increase could be strain hardening of the polymer, or maybe roughness increase (remember that in this configuration, the same coating area is in contact throughout with a constantly renewed bushing surface).

For confirmation, we performed a second run, with as far as possible the same rubbed epoxy surface sliding on the same part of the bushing. The result is a COF of 0,35 at the beginning of the test. This is smaller than the final 0,45 of the first run, which would be expected if friction depends only on a single state variable, frictional energy; the difference can be explained by a slightly different contact area. Nevertheless, the increase during the first mm of sliding is very small compared to the first run, which is reminiscent of the quasi-stable COF of the end of the first test. In a first approximation, it confirms the link established between friction and surface energy dissipation.
