# HIGH TEMPERATURE CREEP PROPERTIES AND MICROSTRUCTURAL EXAMINATIONS OF P92 WELDS

The present study deals with the creep properties of welded joints made of P92 steels. The purpose is to determine the weakest zone at 550°C under various load levels (160-240 MPa) and to investigate the evolution of the microstructure during creep.

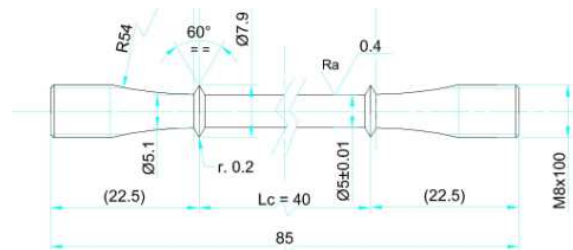
Smooth cross-weld specimens were extracted from the weldment, along the longitudinal axis of the pipe. Their geometry is presented in figure 1.

Figure 1: Scheme of creep specimen geometry.

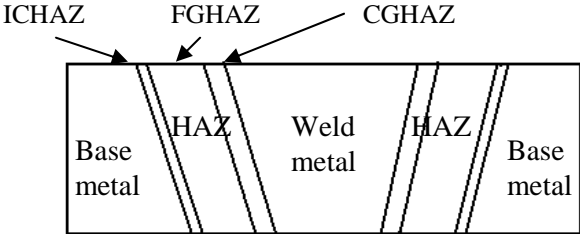
The various zones in the welded joint are schematically represented in Figure 2.

Figure 2: Scheme of the welded joint.

The welded joint is composed of a range of different microstructures which constitute the base metal, the welded joint and the heat affected zone (HAZ). The microstructure is related to the thermal history experienced during the welding.

The area close to the weld metal shows coarse parent austenite grains and is called the coarse-grained zone (CGHAZ). Then, next to the CGHAZ, the HAZ presents an area with very fine parent austenite grains (FGHAZ). A last zone, located between the base metal and the FGHAZ, presents a particular microstructure, made of martensite laths and prior austenite grains denoted the intercritical zone (ICHAZ).

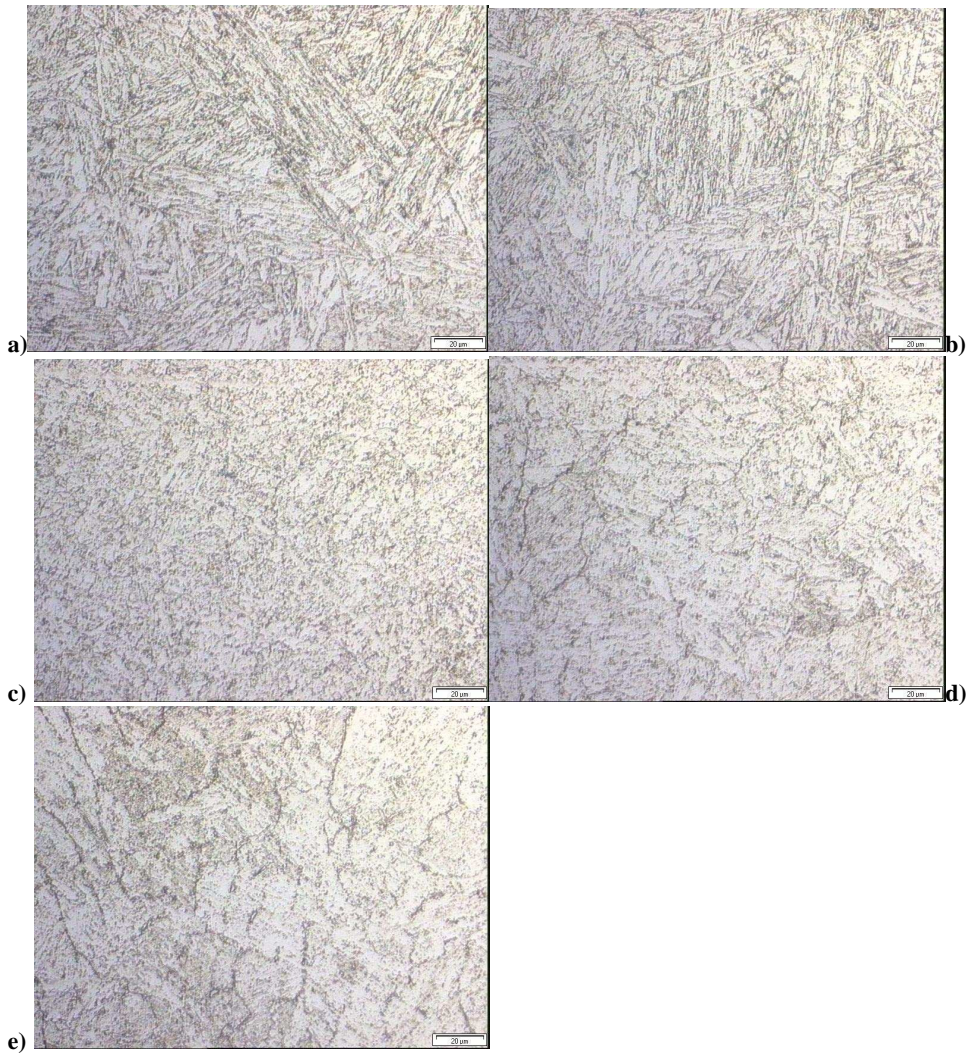
**Figure 4: Optical observations of the different areas of the welded joint: a) the base metal, b) the intercritical area, c) the FGHAZ, d) the CGHAZ and e) the weld metal.**

A microhardness profile performed at mid-thickness is symbolized by the dash-dot line in Figure 3. The combination of microhardness profiles and observations of the welded joint allows highlighting the location and the width of the different areas of the HAZ (Figure 4).

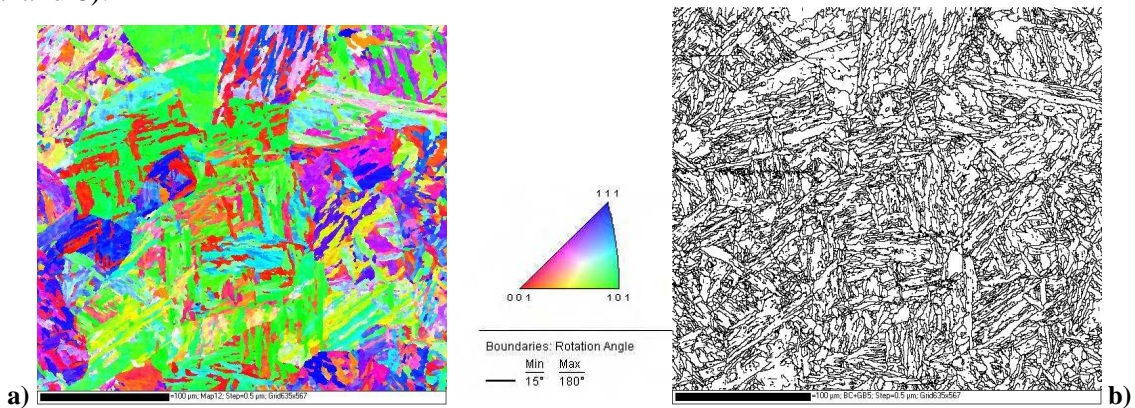
**Figure 5: EBSD orientation map a) and boundary map (misorientation  $>5^\circ$ ) b) of the base metal.**

The microstructure of the base metal is a usual martensitic microstructure made of laths, arranged in blocks and packets (Figures 5 and 6) [4, 5].

The average size of a block is about  $4 \mu\text{m}$  (Detection criterion: misorientation  $> 5^\circ$ ). Giroux [6] estimated the subgrain size of the same base metal to be  $0.37 \mu\text{m}$ . He estimated the average dislocation density of the material at about  $2.10^{14} \text{ m}^{-2}$ .

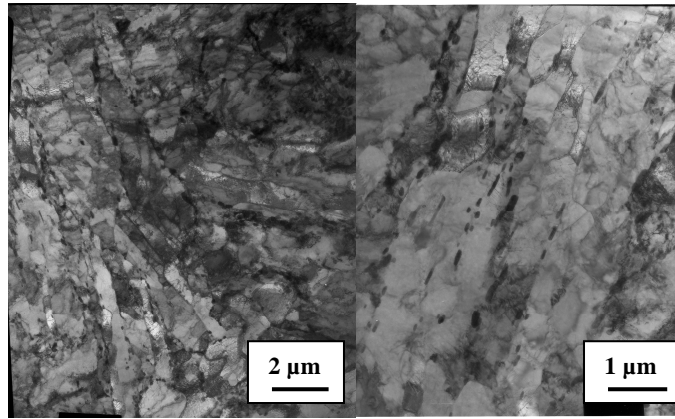
**Figure 6: Bright Field TEM observations of the Base metal.**

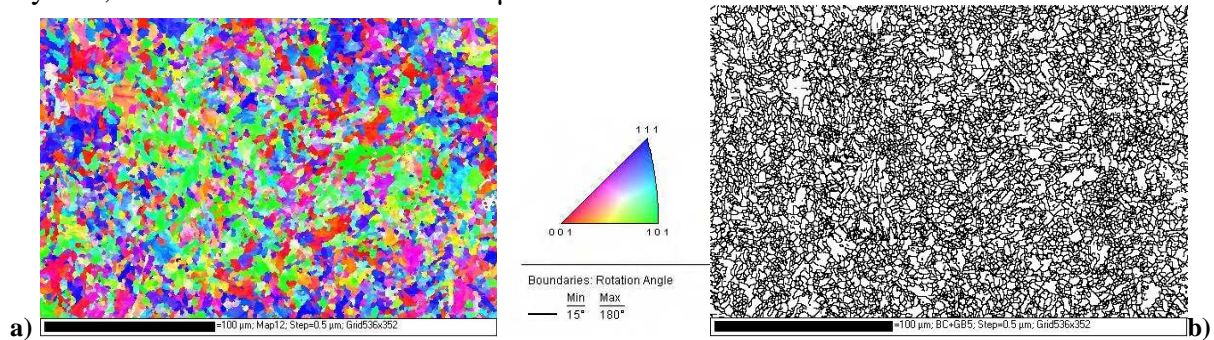
The fine-grained zone (FGHAZ) (figure 7) presents a microstructure with very fine crystals, which mean size is about 2.9  $\mu\text{m}$ .

**Figure 7: EBSD orientations map a) and boundary map (misorientation  $>5^\circ$ ) b) of the fine-grained zone.**

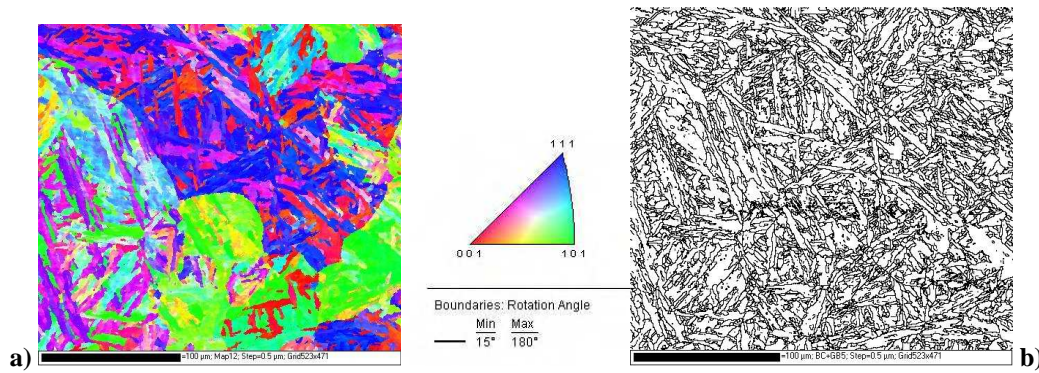
**Figure 8: EBSD orientations map a) and boundary map (misorientation  $>5^\circ$ ) b) of the softened zone.**

EBSD observations of the softened zone show that the microstructure is very similar to that of the base metal at the investigated scale (figure 8). This suggests that the lower hardness might be due to a difference of subgrain or lath size or to a different precipitation state.

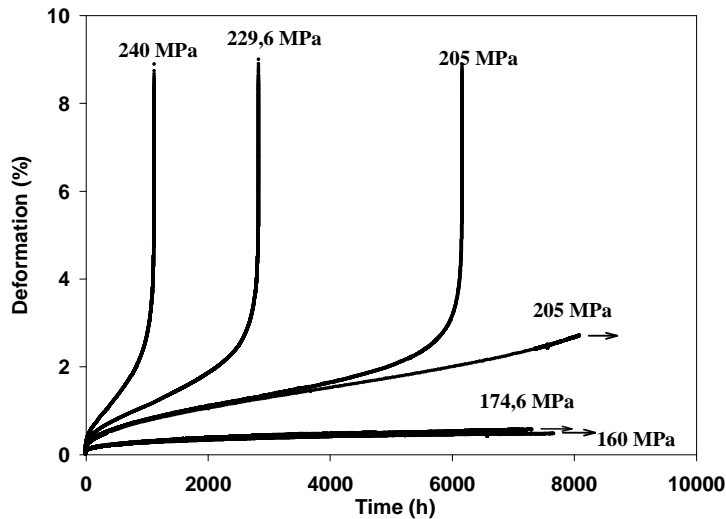
Creep tests results are summarized in Table 2 and Figure 9. Specimens subjected to applied stresses of 229.6 MPa and 240 MPa both broke in the HAZ, very close to the base metal, namely, in the ICHAZ. The specimen crept at 205 MPa has not been observed yet.

Figure 9: Creep curves at 550°C.

The fracture elongation is rather high (several percents). The three typical creep stages are clearly visible in Figure 9. The values of strain at the end of the first two stages are indicated in Table 3. The two creep curves at 205 MPa are superimposed for the first two creep stages but differ in the third stage. However, the ratio between both lifetimes will probably not exceed 2 or 3 as the third stage already started for the ongoing test.

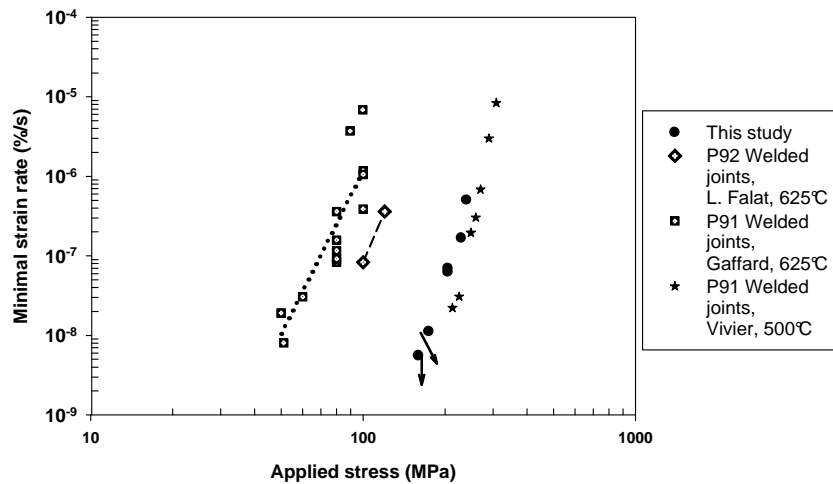
Figure 10: Minimal strain rate versus applied stress for welded joints [3, 6 and 7].

The minimum creep rates of the crept samples can be modelled by a typical Norton power-law curve defined by equation 1:

Where  $\dot{\varepsilon}$  is the minimum creep rate,  $\sigma$  the applied stress,  $A$  and  $n$  are parameters depending on material and temperature. For this study, the model gives  $n=11.57$ . This relatively high value suggests that the creep deformation mechanism is controlled by dislocations motion, possibly together with an effect of internal stresses. This result can be compared with the values found at 500°C by Vivier [1] and at 625°C by Gaffard [7] for welded joints of P91 (Figure 10).

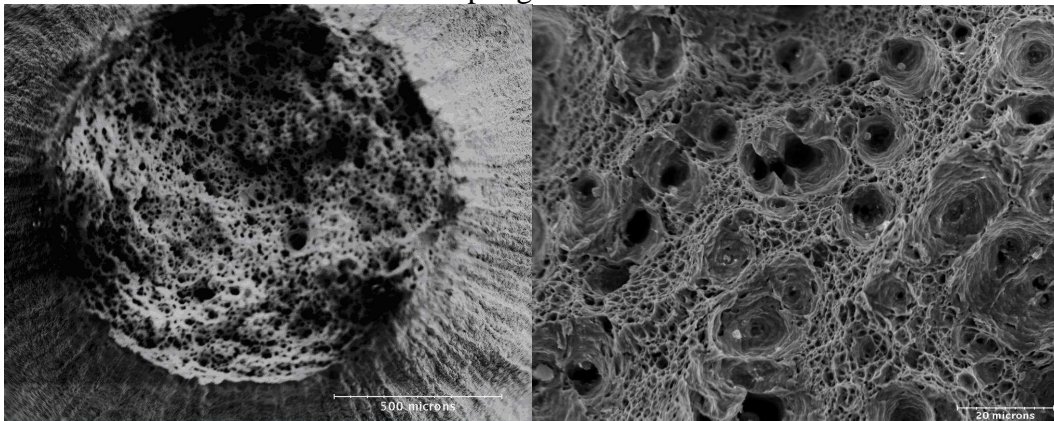
Fracture surfaces of broken samples present a circular shape. The fracture mode is transgranular ductile. The fracture surfaces in figure 13 exhibit many dimples, which is typical of a ductile fracture in the dislocation creep regime.

Figure 13: Fracture surface of the crept sample after 2837h (229.6 MPa, 550°C).

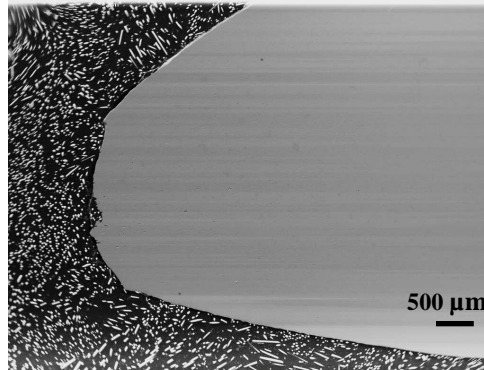
The samples (figure 14) display a pronounced reduction of area at the fracture surface, which highlights significant plastic deformation before fracture.

*Figure 14: Necking area of a crept sample (240 MPa, 550°C).*

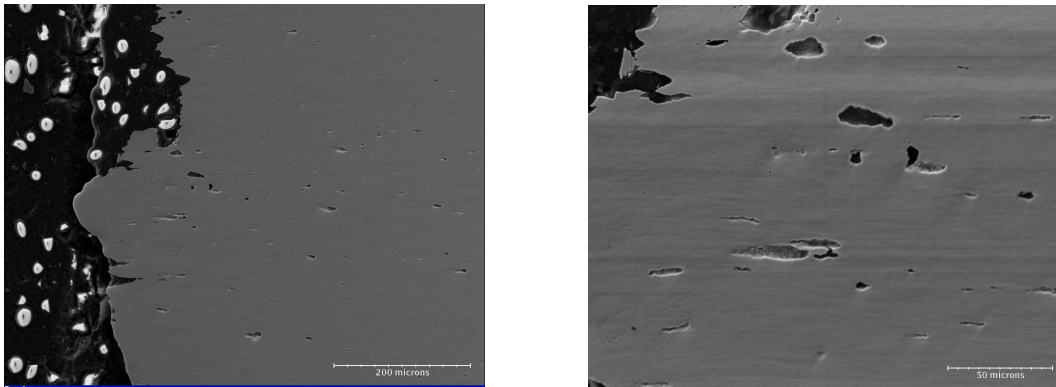
A lot of cavities and short cracks can be observed in the necking area of the broken specimen (Figure 15). Cavities are elongated along the loading direction.

*Figure15: SEM observations of damage in the necking area of crept sample (240 MPa, 550°C, cross-section).*

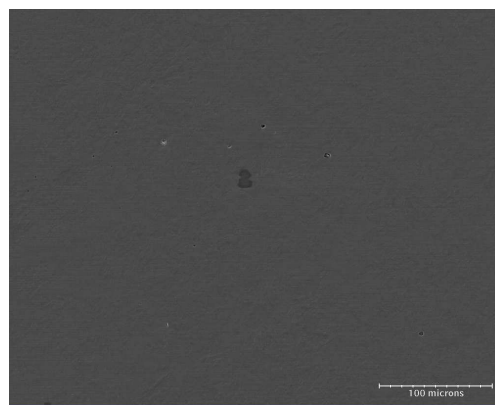
*Figure 16: SEM observations of the cross-section of the crept specimen far from the necking area (240 MPa, 550°C).*

Far from the necking area (figure 16), much lower cavities are concentrated in the necking zone. Therefore, the damage mechanism does not seem to be controlled by vacancy diffusion at 550°C in the tested conditions. This assumption is in agreement with the significant reduction of area and the Norton parameters.

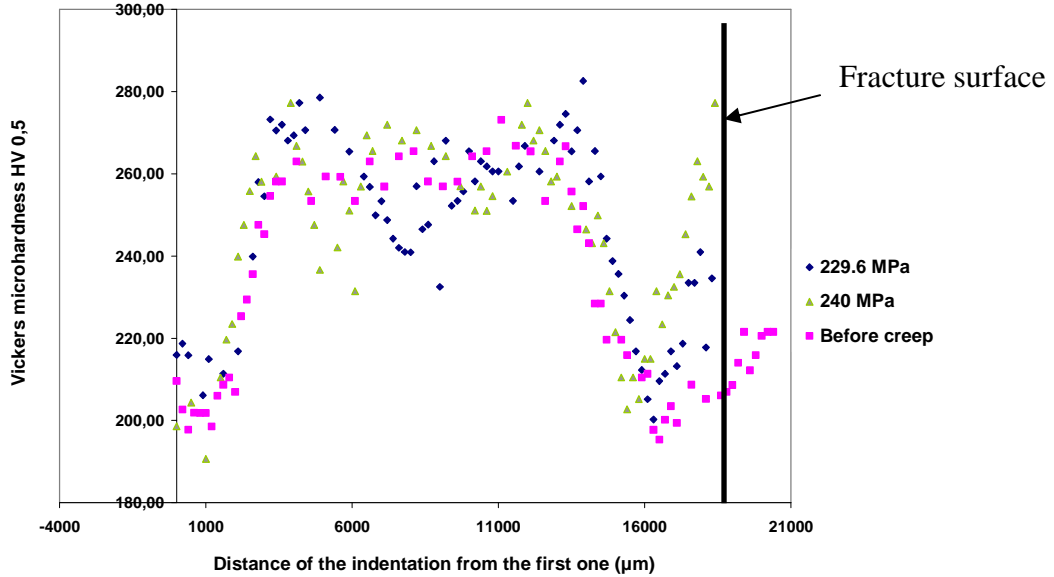
Microhardness profiles were measured on longitudinal cross sections of two creep fractured samples (figure 17), showing a significant increase in hardness in the necking area. This fact is linked to the strain hardening occurring during deformation. Moreover, in the weld metal, hardness values are more scattered than before creep.

Figure 17: Cross-weld microhardness profiles of two crept specimens

The microhardness profiles allowed determining the location of fracture in two specimens. Fracture occurred in the intercritical area for both samples. Table 5 presents the fracture location of samples having experienced creep tests under different conditions.
