HIGH TEMPERATURE CREEP PROPERTIES AND MICROSTRUCTURAL EXAMINATIONS OF P92 WELDS

The present study deals with the creep properties of welded joints made of P92 steels. The purpose is to determine the weakest zone at 550°C under various load levels (160-240 MPa) and to investigate the evolution of the microstructure during creep.

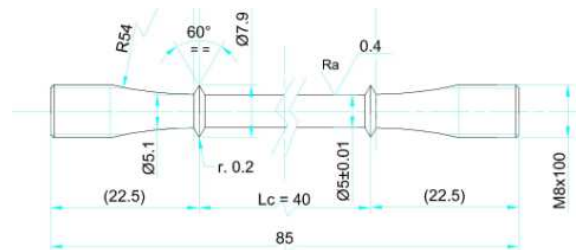
Figure 1: Scheme of creep specimen geometry.

Smooth cross-weld specimens were extracted from the weldment, along the longitudinal axis of the pipe. Their geometry is presented in figure 1.

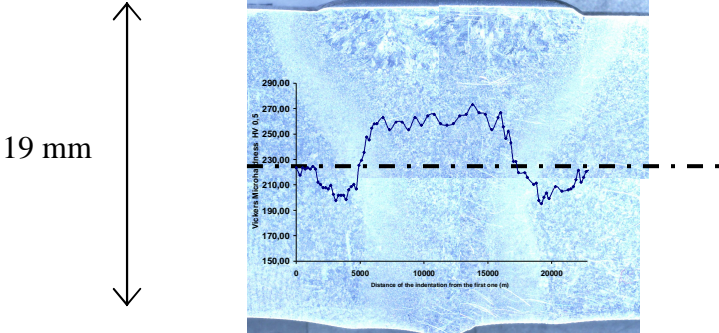
A microhardness profile performed at mid-thickness is symbolized by the dash-dot line in Figure 3. The combination of microhardness profiles and observations of the welded joint allows highlighting the location and the width of the different areas of the HAZ (Figure 4).

Figure3: Cross-weld microhardness profile combined with observations of the welded joint.

The weld metal is the harder part of the joint (the average value is 265 HV). The hardness in the HAZ is varying. A softened zone (200 HV) is observed in the HAZ next to the base metal. It probably corresponds to the ICHAZ. Then, the hardness strongly increases in the HAZ towards the weld metal. The area which is harder than the other zones and located close to the weld metal corresponds to the CGHAZ.

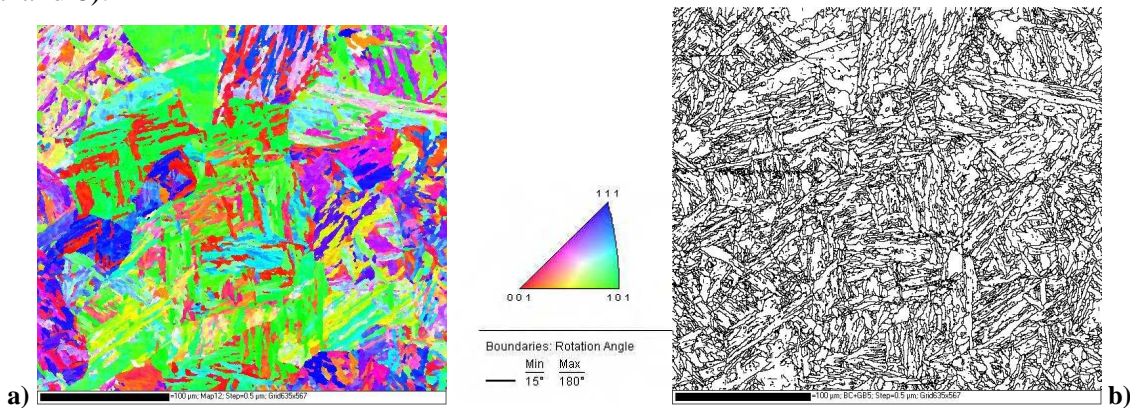
Figure 5: EBSD orientation map a) and boundary map (misorientation $>5^\circ$) b) of the base metal.

The microstructure of the base metal is a usual martensitic microstructure made of laths, arranged in blocks and packets (Figures 5 and 6) [4, 5].

The average size of a block is about $4 \mu\text{m}$ (Detection criterion: misorientation $> 5^\circ$). Giroux [6] estimated the subgrain size of the same base metal to be $0.37 \mu\text{m}$. He estimated the average dislocation density of the material at about 2.10^{14} m^{-2} .

EBSD maps display the microstructure of different zones of the welded joint (figures 5, 7 and 8).

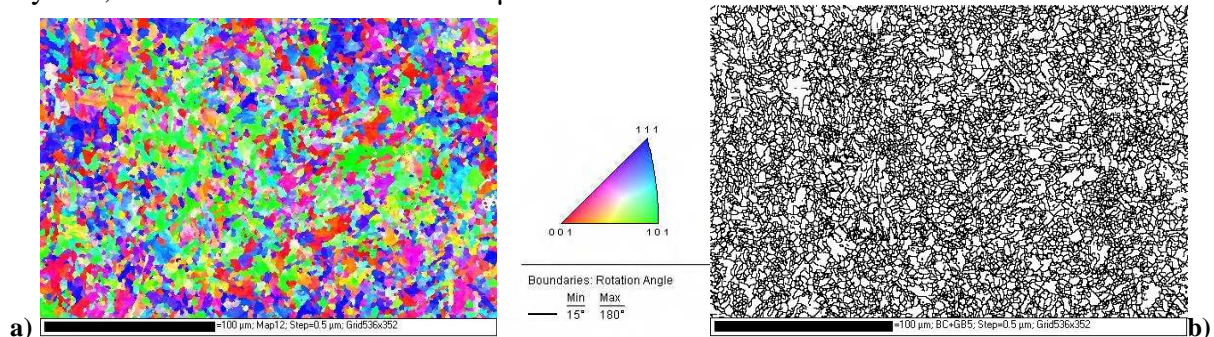
The fine-grained zone (FGHAZ) (figure 7) presents a microstructure with very fine crystals, which mean size is about 2.9 μm .

Figure 7: EBSD orientations map a) and boundary map (misorientation $>5^\circ$) b) of the fine-grained zone.

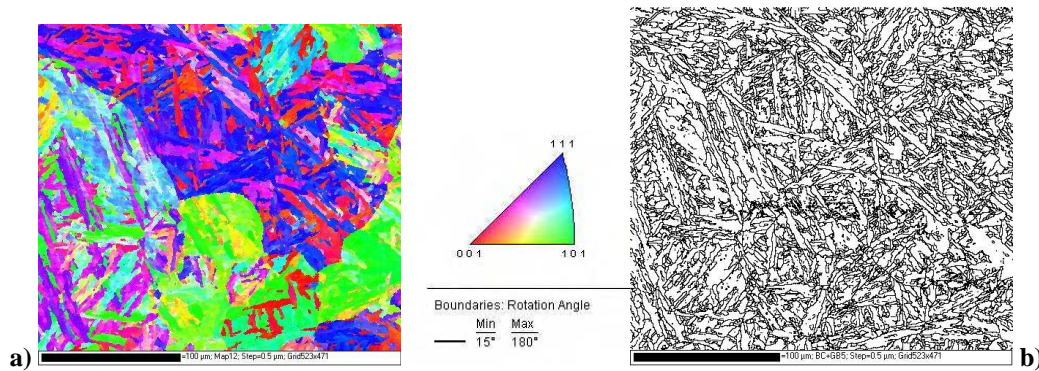
Figure 8: EBSD orientations map a) and boundary map (misorientation $>5^\circ$) b) of the softened zone.

EBSD observations of the softened zone show that the microstructure is very similar to that of the base metal at the investigated scale (figure 8). This suggests that the lower hardness might be due to a difference of subgrain or lath size or to a different precipitation state.

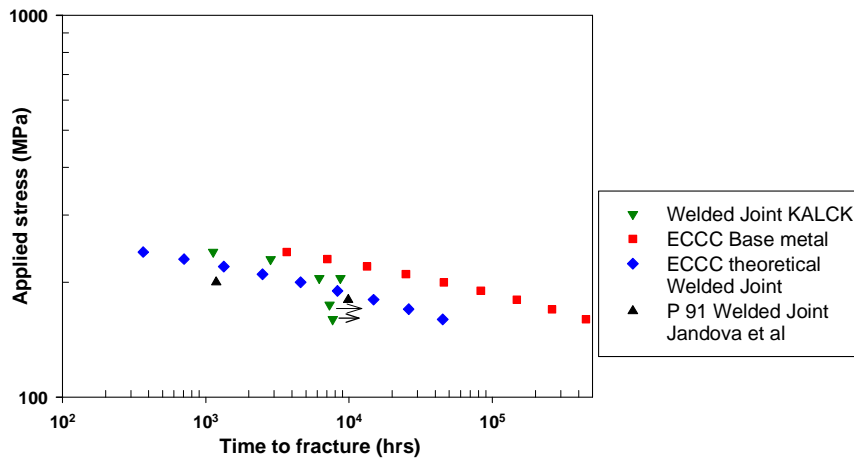
Figure 11: Applied stress versus time to fracture, at 550°C [1, 8].

In Figure 11, ECCC “theoretical” values correspond to times to fracture of welded joint calculated from ECCC base metal values and reduced by a factor of 10 compared to time to fracture of base material [8].

As expected, the creep strength of the welded joint is lower than the creep resistance of the base metal. The ratio between the values of the base metal and the actual welded joint is about 3.3 i.e. three times lower than that expected from “theoretical” ECCC values.

Besides, we can see that the diminution of P92 properties due to the welding is less significant than for P91. The difference between the Monkman-Grant properties (figure 12) of the welds compared to the base metal is much more pronounced for P91 than P92. This is consistent with the 3.3 ratio observed on the lifetime in figure 11.

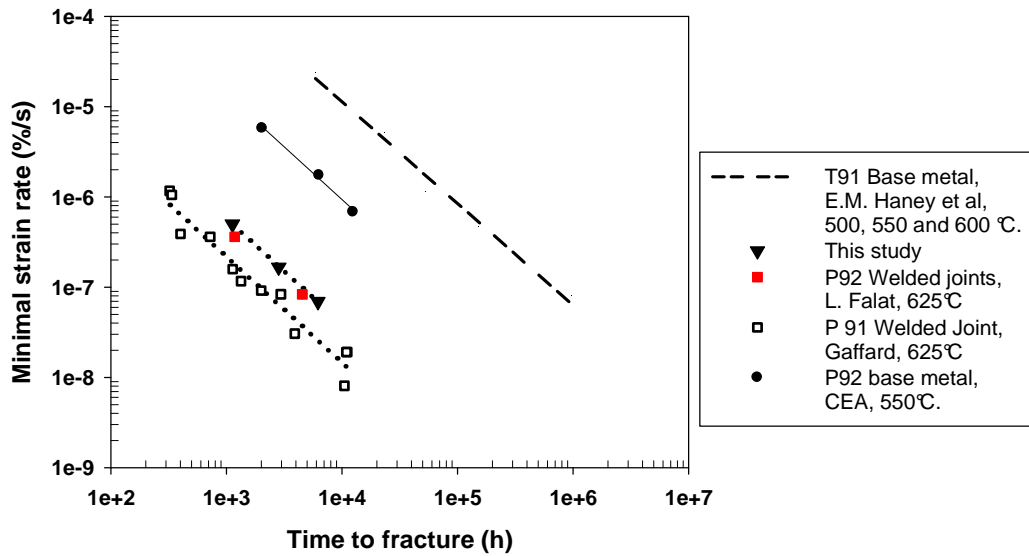
Figure 12: Monkman-Grant curve for crept specimens [8, 9 and 10].

The dashed line in Figure 12 corresponds to a linear approximation of a set of data about T91 at temperatures ranging from 500 to 625°C, studied by E.M. Haney et al [10]. Data about P92 welded joints coming both from this study and from L. Falat experiments [4] are spread homogeneously along the same line.

Moreover, creep lifetime is larger for P92 welded joints than for P91 welded joints [9] at the same temperature. The Monkman-Grant constant (Figure 12) is also higher than that of P91.

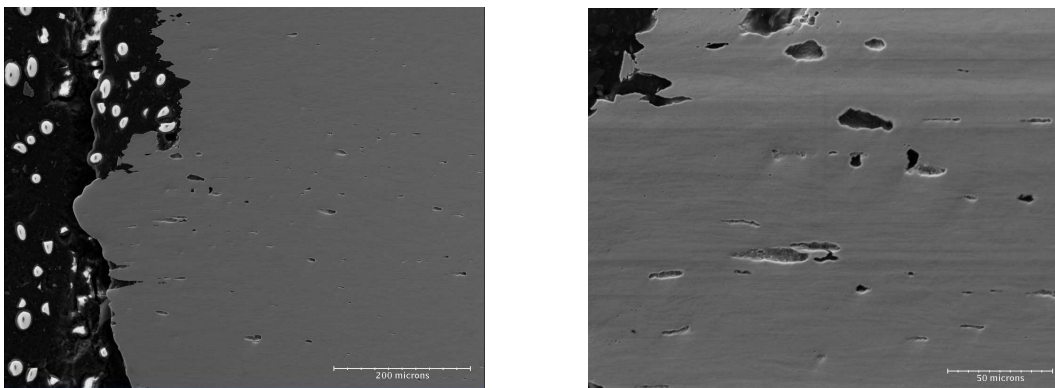
A lot of cavities and short cracks can be observed in the necking area of the broken specimen (Figure 15). Cavities are elongated along the loading direction.

Figure15: SEM observations of damage in the necking area of crept sample (240 MPa, 550°C, cross-section).

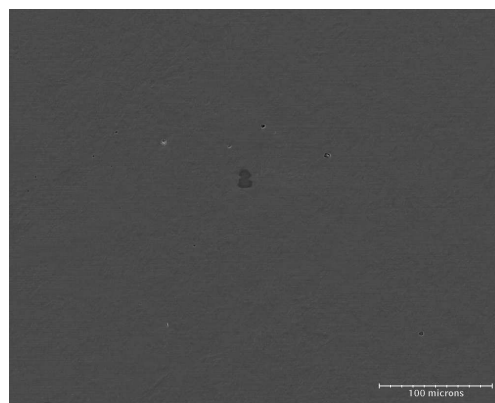
Figure 16: SEM observations of the cross-section of the crept specimen far from the necking area (240 MPa, 550°C).

Far from the necking area (figure 16), much lower cavities are concentrated in the necking zone. Therefore, the damage mechanism does not seem to be controlled by vacancy diffusion at 550°C in the tested conditions. This assumption is in agreement with the significant reduction of area and the Norton parameters.

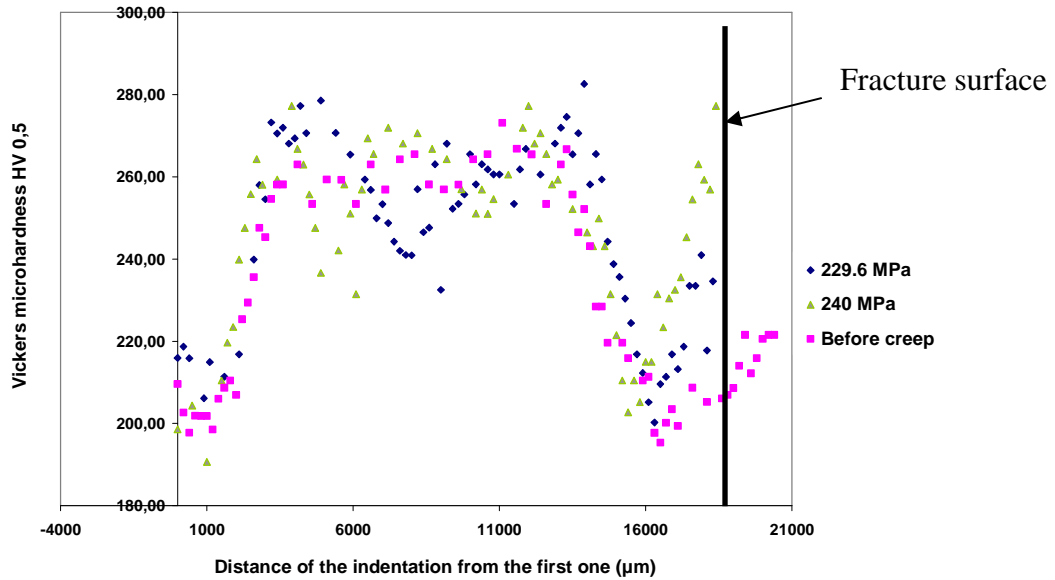
Microhardness profiles were measured on longitudinal cross sections of two creep fractured samples (figure 17), showing a significant increase in hardness in the necking area. This fact is linked to the strain hardening occurring during deformation. Moreover, in the weld metal, hardness values are more scattered than before creep.

Figure 17: Cross-weld microhardness profiles of two crept specimens

The microhardness profiles allowed determining the location of fracture in two specimens. Fracture occurred in the intercritical area for both samples. Table 5 presents the fracture location of samples having experienced creep tests under different conditions.
