International Conference on the Technology of Plasticity, ICTP 2017, 17-22 September 2017,
Cambridge, United Kingdom

Analysis and modeling of the failure behavior of carbonitrided parts

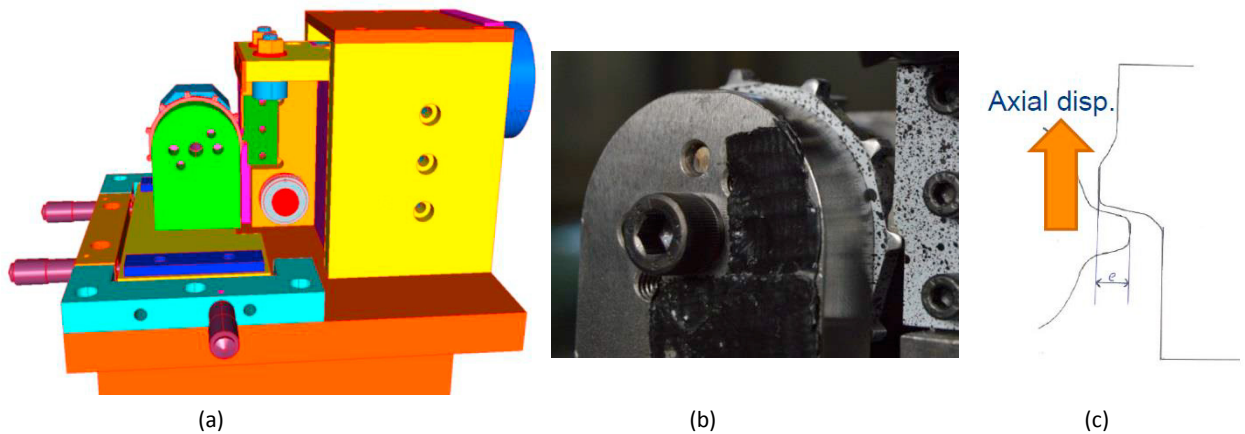
The test-bench was designed so as to analyze precisely failure mechanisms occurring during the shear loading of a carbonitrided pinion tooth. Fig. 2.a shows a schematic view of the test bench, where the pinion (in red) moves up and the pinion tooth is sheared by the tool (dark green) which is fixed. In order to get the exact local displacements, digital image correlation (DIC) is used on both the tool and the pinion (See Fig. 2.b). Finally, the test-bench is also designed to enable the analysis of various engagement depths e (defined in Fig. 2.c) on failure modes.

Fig. 2. (a) Schematic view of the semi-industrial test-bench; (b) close-up view of the loaded tooth; (c) definition of engagement depth e .

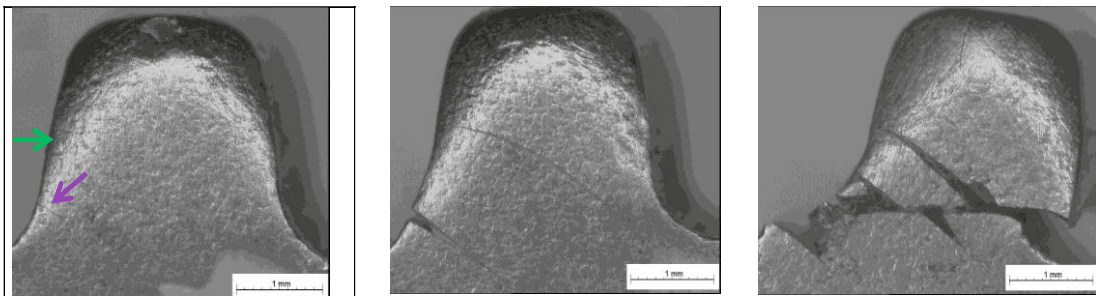
Regarding failure mechanism (see Fig. 3.), the initial crack (purple arrow) appears below the contact surface with the tool indicated by a green arrow in Fig. 3. The CN layer is brittle and multiple superficial cracks initiate and propagate in the CN layer perpendicularly to the maximum principal stress. In the depth, these cracks usually stop in the transition area. Final failure is due to a main shear crack in the core material.

Fig. 3. Failure mechanisms observed on a carbonitrided pinion tooth.

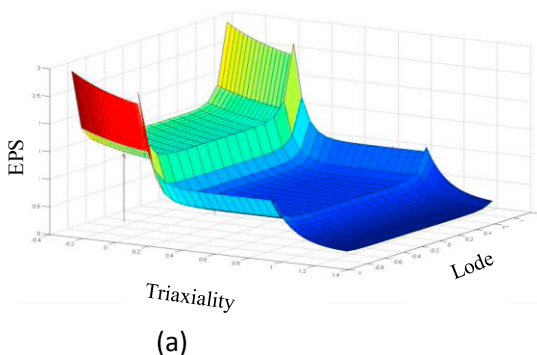
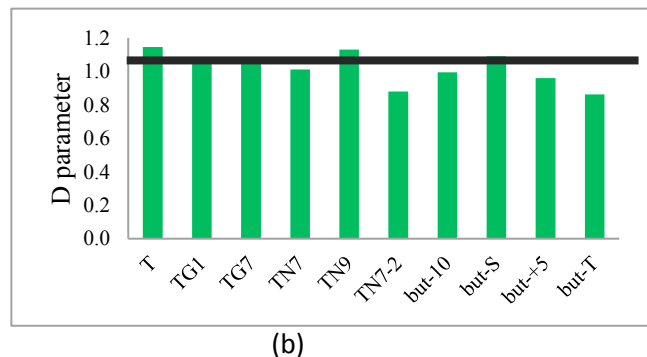
Fig. 4. (a) representation of the fitted failure surface (in the space of Lode parameter, triaxiality, and strain to fracture) of the new exponential failure criterion; (b) prediction of damage for the 10 experimental tests.

The resulting function (Fig. 4.a) representing strain to fracture as a function of stress triaxiality ratio and Lode parameter differs from the functions usually seen in the literature. Fig. 4.b shows the prediction of the failure criteria for the 10 calibration tests. Green columns correspond to the damage value given by the criterion when the experimental displacement to fracture is reached. This value should therefore be as close as possible to 1 to predict failure correctly. The average discrepancy for this criterion is 8% whereas the discrepancy for the Bai & Wierzbicki criterion and the Lou & Huh criterion are respectively 24% and 21%.

Several fracture criteria from the literature were tested, among which were the Bai & Wierzbicki criterion [4] and the Lou & Huh criterion [5]. None of them succeeded in representing correctly strain to failure for all 10 mechanical tests. An adapted criterion has therefore been proposed as an outcome of this extensive mechanical testing campaign. For this particular quenched steel, it suggests a quasi-independence on the Lode parameter except for very high values ($\bar{\theta} = 0.8 - 1.0$) where the strain to fracture strongly increases. Stress triaxiality influence is represented by three branches of exponentials:

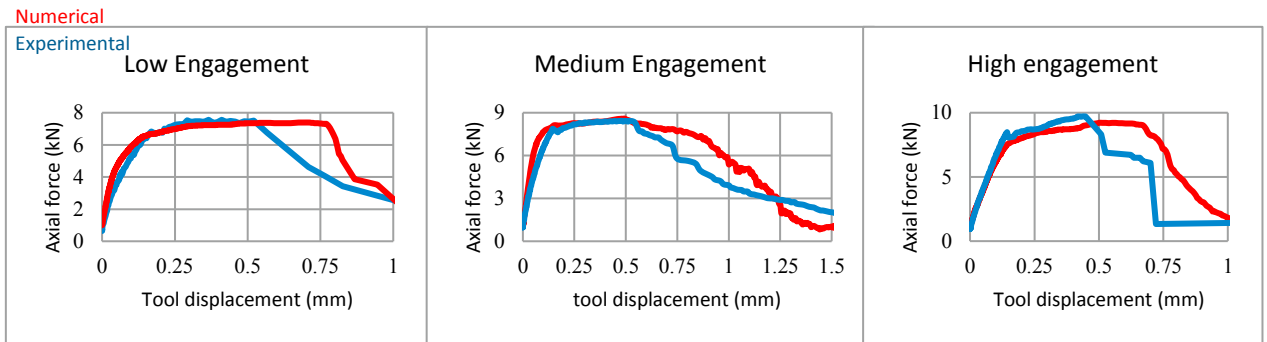
Simulations presented here were carried out on pinions made out of the core material only. These pinions exhibit ductile failure. Fig.5 shows the load-displacement comparison between experimental tests and numerical simulations for three different engagement depths. The maximum load reached is in very good agreement whereas the displacement to failure is slightly overestimated. However, the analysis after experimental failure must be taken with care since boundary conditions adopted for numerical simulations come from DIC measurements, which are not reliable beyond the onset of fracture if fracture did not already occurred numerically. Fig.6 shows the tooth failure for the medium engagement and its comparison with experimental observations. The shear-based failure mechanism is well predicted, and it can be concluded that the new proposed failure criterion is well-suited for the modelling of pinions made out of core material only.

Fig. 5. Comparison of experimental and numerical load-displacement curves for 3 different engagement depths and for the core material only
