## Analysis and modeling of the failure behavior of carbonitrided parts

International Conference on the Technology of Plasticity, ICTP 2017, 17-22 September 2017,  
Cambridge, United Kingdom

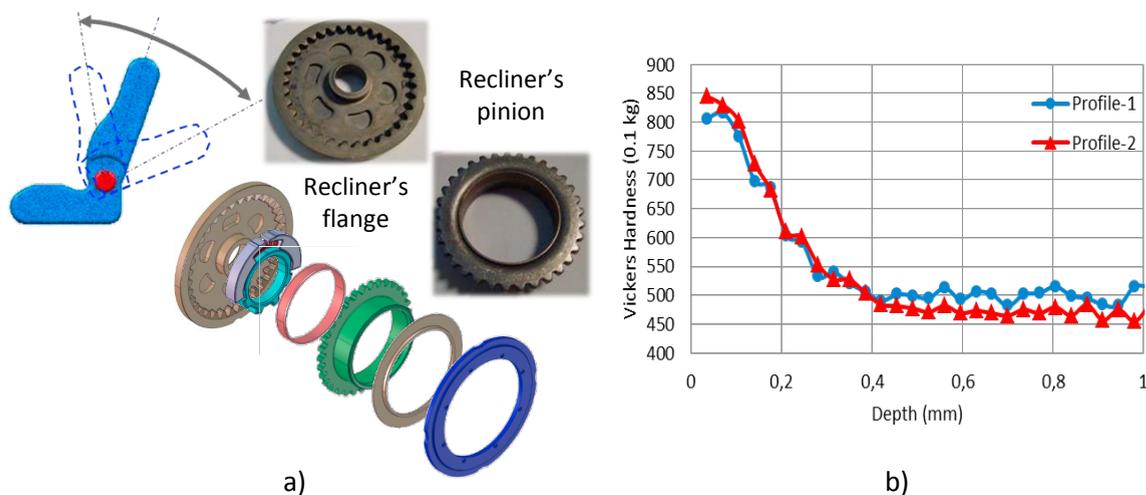
Fig. 1. (a) Seat recliner; (b) hardness profile after carbonitriding.

In the automotive industry, carbonitriding is a common thermochemical treatment for improving steel components' surface hardness. The study focuses on carbonitrided pinions made out of 20MnB5 steel, inserted in a "recliner", a safety mechanism controlling the inclination of the back of automotive seats (see Fig. 1.a). Carbonitriding consists in enriching in Carbon and Nitrogen a superficial layer of steel components by heating them in the austenitic range in an atmosphere enriched in the aforementioned elements. Then the parts are quenched to trigger martensitic transformation. The treated steel is thus a gradient property material, with a continuous transition (Fig. 1.b) between a 200  $\mu\text{m}$  deep very hard external layer (high %C martensite, 850 Hv) and a more ductile core material (bainite and/or low %C martensite, 450 Hv). This is an interesting feature for power transmission parts such as gears. These recliners may be severely loaded during crash analyses and it is essential to predict failure correctly. However, these gradient properties make the prediction of failure particularly complex.

To understand these failure mechanisms, an analysis of the failure behavior of the teeth of the pinions of seat recliners in an industrial test has been conducted. This analysis confirms the dual failure behavior in a shear mode: brittle in the external carbonitrided layer and ductile in the core material, with a transition area around 250  $\mu\text{m}$  depth [1].

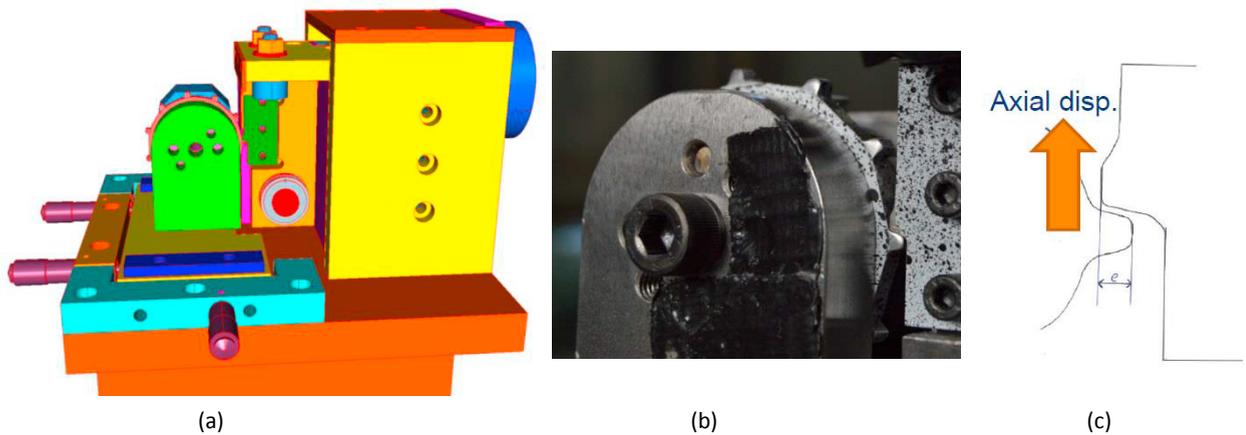
Fig. 2. (a) Schematic view of the semi-industrial test-bench; (b) close-up view of the loaded tooth; (c) definition of engagement depth  $e$ .

The test-bench was designed so as to analyze precisely failure mechanisms occurring during the shear loading of a carbonitrided pinion tooth. Fig. 2.a shows a schematic view of the test bench, where the pinion (in red) moves up and the pinion tooth is sheared by the tool (dark green) which is fixed. In order to get the exact local displacements, digital image correlation (DIC) is used on both the tool and the pinion (See Fig. 2.b). Finally, the test-bench is also designed to enable the analysis of various engagement depths  $e$  (defined in Fig. 2.c) on failure modes.

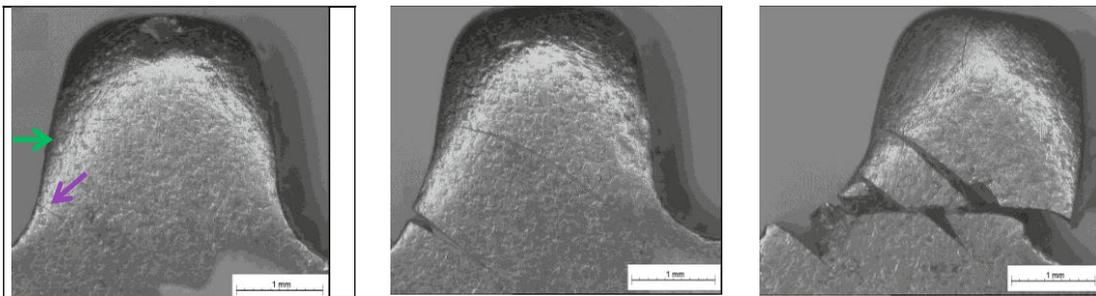
Fig. 3. Failure mechanisms observed on a carbonitrided pinion tooth.

Regarding failure mechanism (see Fig. 3.), the initial crack (purple arrow) appears below the contact surface with the tool indicated by a green arrow in Fig. 3. The CN layer is brittle and multiple superficial cracks initiate and propagate in the CN layer perpendicularly to the maximum principal stress. In the depth, these cracks usually stop in the transition area. Final failure is due to a main shear crack in the core material.

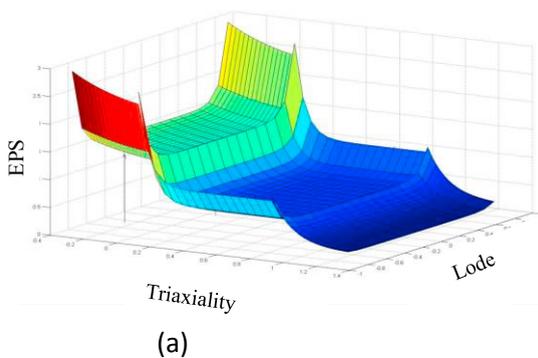
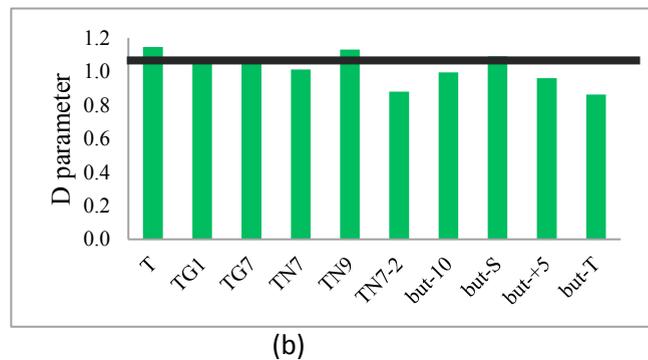
Fig. 4. (a) representation of the fitted failure surface (in the space of Lode parameter, triaxiality, and strain to fracture) of the new exponential failure criterion; (b) prediction of damage for the 10 experimental tests.

The resulting function (Fig. 4.a) representing strain to fracture as a function of stress triaxiality ratio and Lode parameter differs from the functions usually seen in the literature. Fig. 4.b shows the prediction of the failure criteria for the 10 calibration tests. Green columns correspond to the damage value given by the criterion when the experimental displacement to fracture is reached. This value should therefore be as close as possible to 1 to predict failure correctly. The average discrepancy for this criterion is 8% whereas the discrepancy for the Bai & Wierzbicki criterion and the Lou & Huh criterion are respectively 24% and 21%.

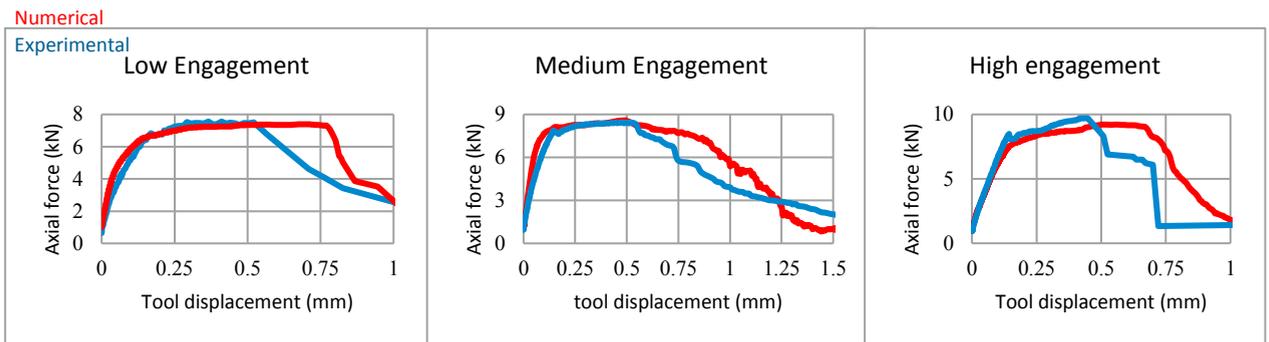
Fig. 5. Comparison of experimental and numerical load-displacement curves for 3 different engagement depths and for the core material only

Simulations presented here were carried out on pinions made out of the core material only. These pinions exhibit ductile failure. Fig.5 shows the load-displacement comparison between experimental tests and numerical simulations for three different engagement depths. The maximum load reached is in very good agreement whereas the displacement to failure is slightly overestimated. However, the analysis after experimental failure must be taken with care since boundary conditions adopted for numerical simulations come from DIC measurements, which are not reliable beyond the onset of fracture if fracture did not already occurred numerically. Fig.6 shows the tooth failure for the medium engagement and its comparison with experimental observations. The shear-based failure mechanism is well predicted, and it can be concluded that the new proposed failure criterion is well-suited for the modelling of pinions made out of core material only.

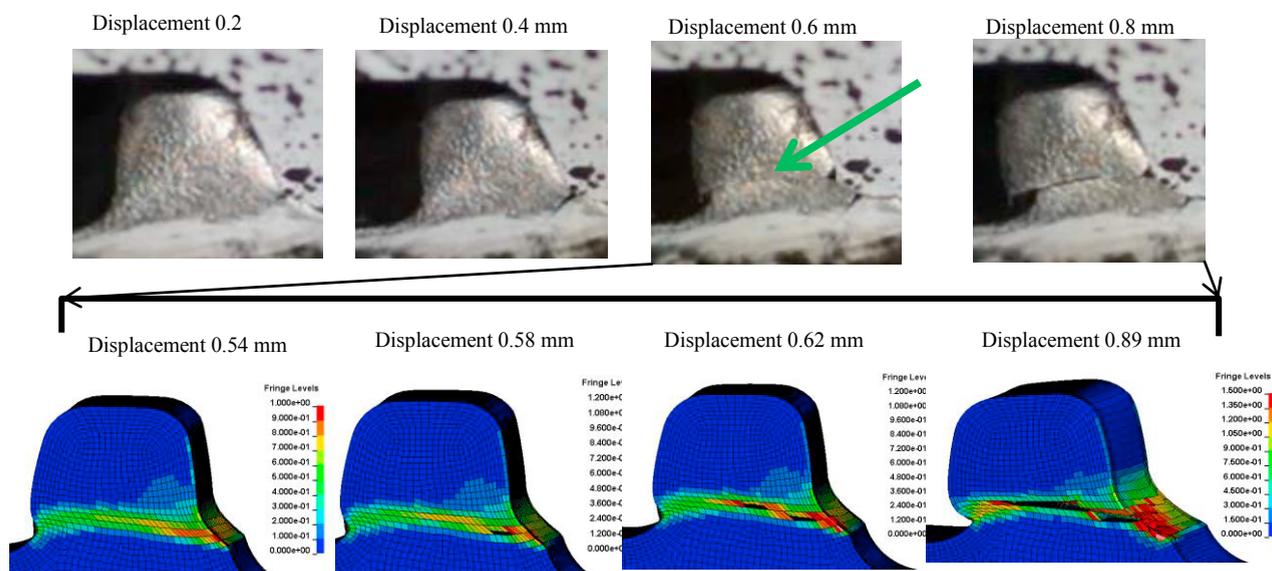
Fig. 6. Shear failure of the tooth made out of core material only for the medium engagement depth

In this work, the failure mechanisms of carbonitrided pinions made out of 20MnB5 steel was studied. A test bench was designed so as to analyze these failure mechanisms in terms of load-displacement curves together with local observations of failure on the pinion's tooth. Due to the small influence of the carbonitrided layer in terms of maximum load and toughness of carbonitrided tooth, it was decided to concentrate here on the core material only. The identification of material behavior and of failure criteria parameters was based on 10 experimental tests with significant variation of stress triaxiality ratio and Lode parameter. As failure criteria from the literature were unable to predict correctly failure for the 10 tests, it was decided to define a new failure criteria with a quasi-independence on the Lode parameter except for very high values ( $\bar{\theta} = 0.8 - 1.0$ ) where the strain to fracture strongly increases. Simulations were carried out with LS-Dyna and for three different engagement depths. The overall results are in good agreement with the experimental ones both in terms of load-displacement curves and failure pattern.
