International Conference on the Technology of Plasticity, ICTP 2017, 17-22 September 2017,
Cambridge, United Kingdom

Analysis and modeling of the failure behavior of carbonitrided parts

This work aims at a better understanding and modeling of the failure of carbonitrided pinions made out of 20MnB5 steel. Carbonitriding is a thermochemical treatment inducing high surface hardness while preserving significant core ductility. This results in graded microstructure and properties which makes the prediction of failure particularly complex: brittle external layer, ductile core material. A test bench was specifically designed to load one tooth of the studied pinions with a lateral force until complete failure. In situ observations were performed and the load-displacement curve recorded, showing a variety of behaviors as a function of the teeth engagement depth. The presence of the carbonitrided layer induces only a slight force and toughness increase. The main failure mechanism comes from shear failure of the ductile core material which will therefore be studied in this paper. Experimental tests with various stress states were conducted to measure plastic properties as well as to calibra

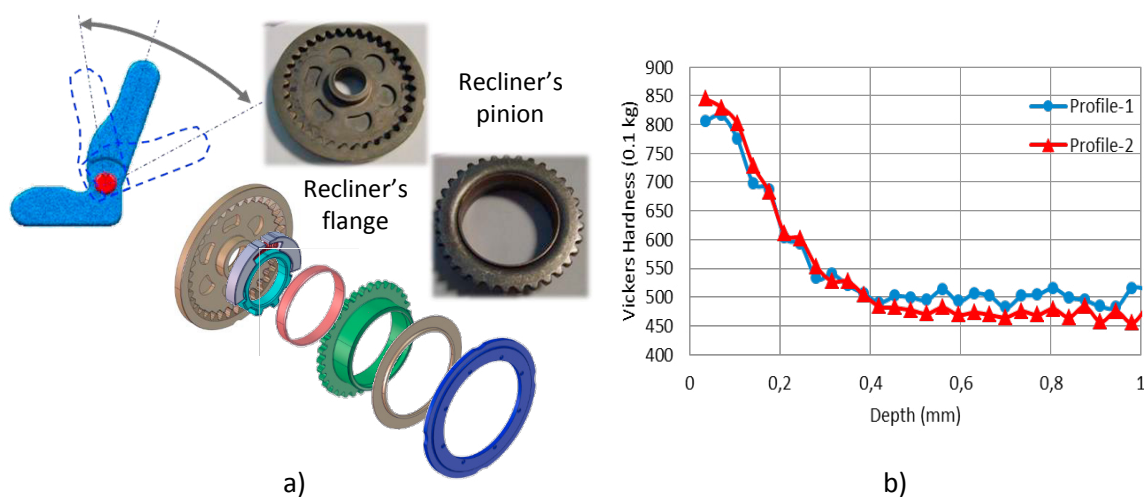
Fig. 1. (a) Seat recliner; (b) hardness profile after carbonitriding.

In the automotive industry, carbonitriding is a common thermochemical treatment for improving steel components' surface hardness. The study focuses on carbonitrided pinions made out of 20MnB5 steel, inserted in a "recliner", a safety mechanism controlling the inclination of the back of automotive seats (see Fig. 1.a). Carbonitriding consists in enriching in Carbon and Nitrogen a superficial layer of steel components by heating them in the austenitic range in an atmosphere enriched in the aforementioned elements. Then the parts are quenched to trigger martensitic transformation. The treated steel is thus a gradient property material, with a continuous transition (Fig. 1.b) between a 200 μm deep very hard external layer (high %C martensite, 850 Hv) and a more ductile core material (bainite and/or low %C martensite, 450 Hv). This is an interesting feature for power transmission parts such as gears. These recliners may be severely loaded during crash analyses and it is essential to predict failure correctly. However, these gradient properties make the prediction of failure particularly complex.

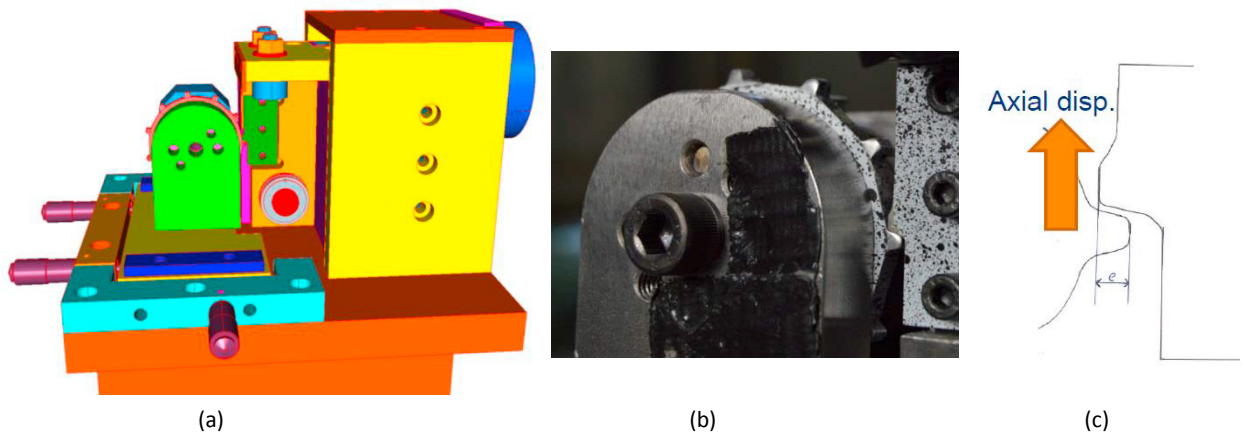
The test-bench was designed so as to analyze precisely failure mechanisms occurring during the shear loading of a carbonitrided pinion tooth. Fig. 2.a shows a schematic view of the test bench, where the pinion (in red) moves up and the pinion tooth is sheared by the tool (dark green) which is fixed. In order to get the exact local displacements, digital image correlation (DIC) is used on both the tool and the pinion (See Fig. 2.b). Finally, the test-bench is also designed to enable the analysis of various engagement depths e (defined in Fig. 2.c) on failure modes.

Fig. 2. (a) Schematic view of the semi-industrial test-bench; (b) close-up view of the loaded tooth; (c) definition of engagement depth e .

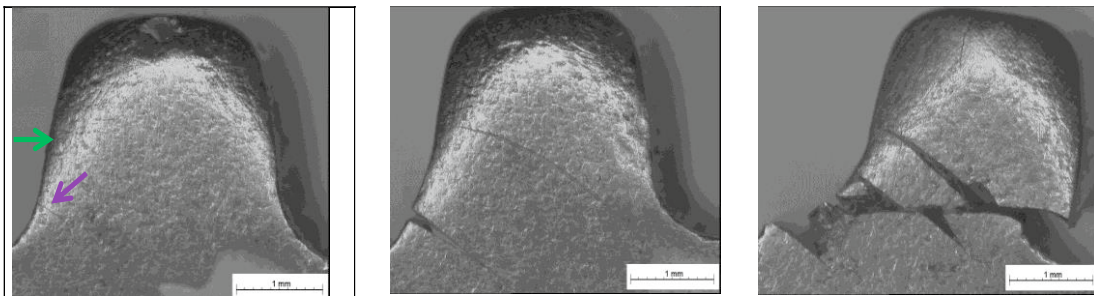
Regarding failure mechanism (see Fig. 3.), the initial crack (purple arrow) appears below the contact surface with the tool indicated by a green arrow in Fig. 3. The CN layer is brittle and multiple superficial cracks initiate and propagate in the CN layer perpendicularly to the maximum principal stress. In the depth, these cracks usually stop in the transition area. Final failure is due to a main shear crack in the core material.

Fig. 3. Failure mechanisms observed on a carbonitrided pinion tooth.

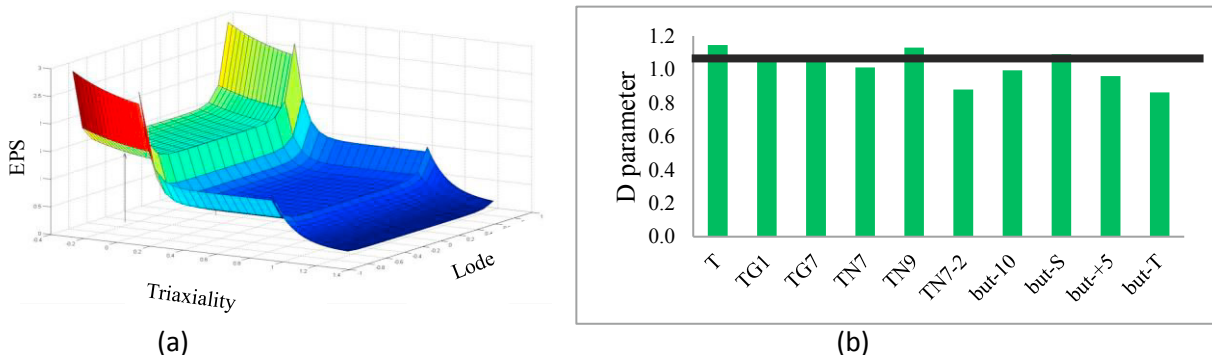
Fig. 4. (a) representation of the fitted failure surface (in the space of Lode parameter, triaxiality, and strain to fracture) of the new exponential failure criterion; (b) prediction of damage for the 10 experimental tests.

The resulting function (Fig. 4.a) representing strain to fracture as a function of stress triaxiality ratio and Lode parameter differs from the functions usually seen in the literature. Fig. 4.b shows the prediction of the failure criteria for the 10 calibration tests. Green columns correspond to the damage value given by the criterion when the experimental displacement to fracture is reached. This value should therefore be as close as possible to 1 to predict failure correctly. The average discrepancy for this criterion is 8% whereas the discrepancy for the Bai & Wierzbicki criterion and the Lou & Huh criterion are respectively 24% and 21%.

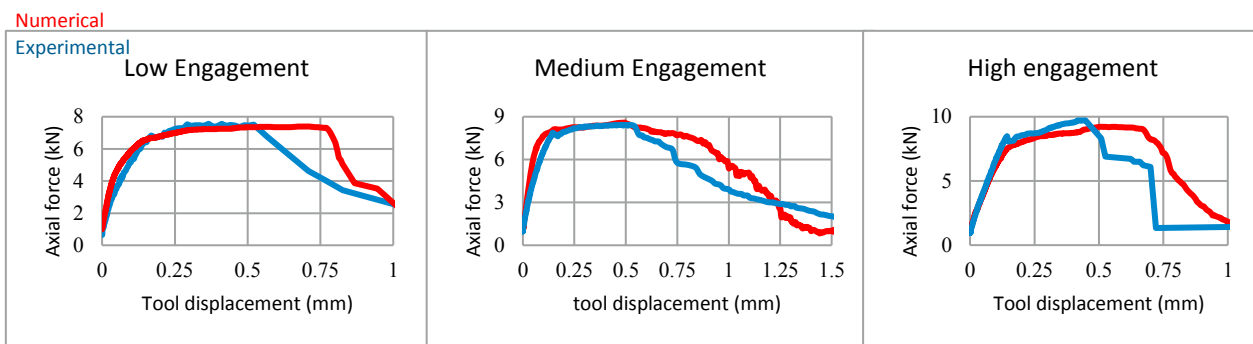
Simulations presented here were carried out on pinions made out of the core material only. These pinions exhibit ductile failure. Fig.5 shows the load-displacement comparison between experimental tests and numerical simulations for three different engagement depths. The maximum load reached is in very good agreement whereas the displacement to failure is slightly overestimated. However, the analysis after experimental failure must be taken with care since boundary conditions adopted for numerical simulations come from DIC measurements, which are not reliable beyond the onset of fracture if fracture did not already occurred numerically. Fig.6 shows the tooth failure for the medium engagement and its comparison with experimental observations. The shear-based failure mechanism is well predicted, and it can be concluded that the new proposed failure criterion is well-suited for the modelling of pinions made out of core material only.

Fig. 5. Comparison of experimental and numerical load-displacement curves for 3 different engagement depths and for the core material only

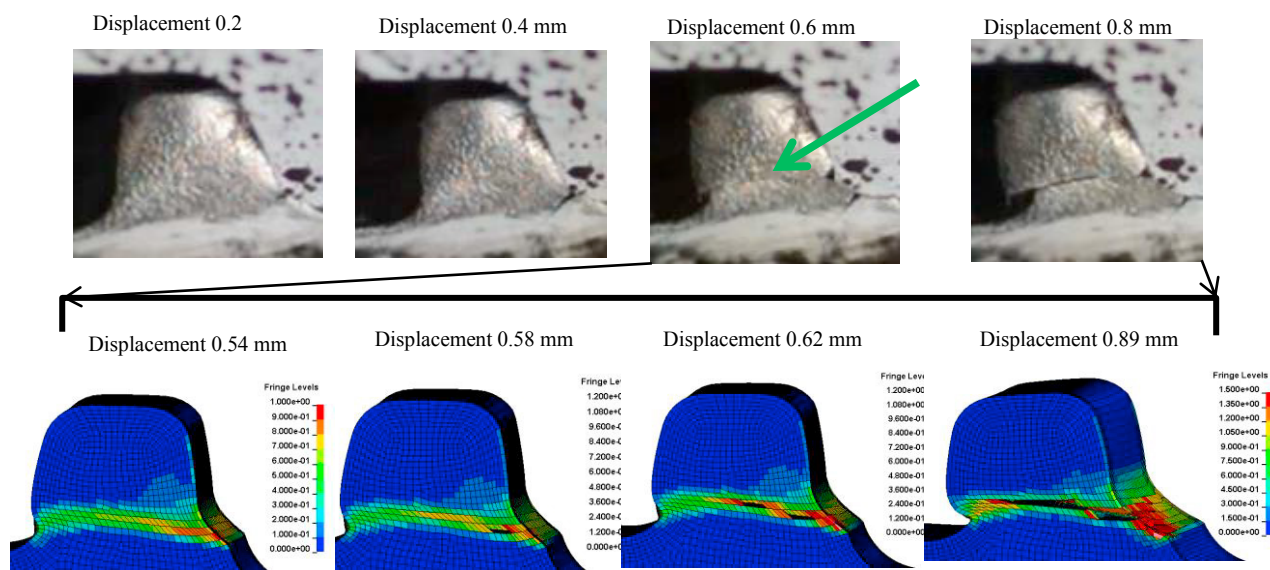
Fig. 6. Shear failure of the tooth made out of core material only for the medium engagement depth

In this work, the failure mechanisms of carbonitrided pinions made out of 20MnB5 steel was studied. A test bench was designed so as to analyze these failure mechanisms in terms of load-displacement curves together with local observations of failure on the pinion's tooth. Due to the small influence of the carbonitrided layer in terms of maximum load and toughness of carbonitrided tooth, it was decided to concentrate here on the core material only. The identification of material behavior and of failure criteria parameters was based on 10 experimental tests with significant variation of stress triaxiality ratio and Lode parameter. As failure criteria from the literature were unable to predict correctly failure for the 10 tests, it was decided to define a new failure criteria with a quasi-independence on the Lode parameter except for very high values ($\bar{\theta} = 0.8 - 1.0$) where the strain to fracture strongly increases. Simulations were carried out with LS-Dyna and for three different engagement depths. The overall results are in good agreement with the experimental ones both in terms of load-displacement curves and failure pattern.
