Ilan Raphael, Nicolas Saintier, Lucien Laiarinandrasana, Gilles Robert. Investigation of the fatigue behavior of notched reinforced thermoplastics. 12th International Fatigue Congress (FATIGUE 2018), May 2018, Poitiers, France. 10.1051/mateconf/201816507010 . hal-01805190

Investigation of the fatigue behavior of notched reinforced thermoplastics

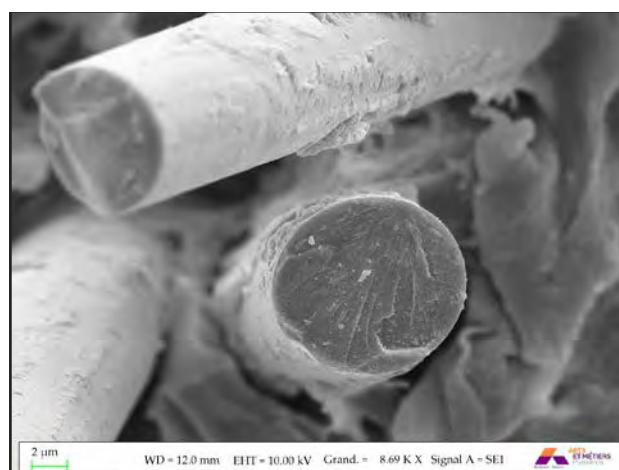
Fig. 3. Failure induced by a crossing with a neighboring fiber.

Earlier works have shown that fibers tend to break at the crossing with another fiber. This crossing of fibers induces a confinement of the matrix in between and a stress concentration in the adjacent fibers, thus triggering the failure (fig.3).

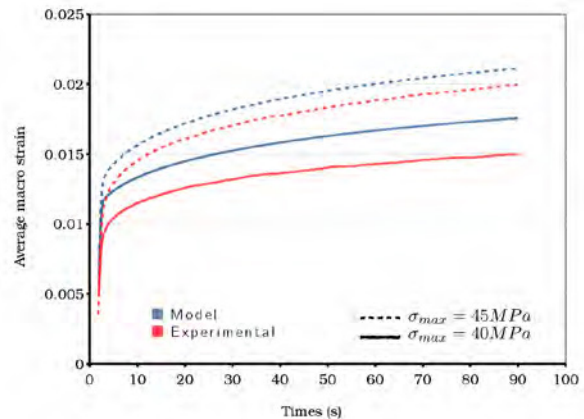
Fig. 11. Average axial strain for a U2 notched PA66 specimen.

First cyclic tests were performed at 0.5Hz and R=0.1. Axial strain is averaged on each cycle to be plotted and compared to the experimental data (fig.11 and fig.12).

It can be noted that the average axial strain differs from the experimental data, especially at lower stress levels. However, in all cases, the strain rate is accurately determined as the slopes of the experimental and model curves are alike.

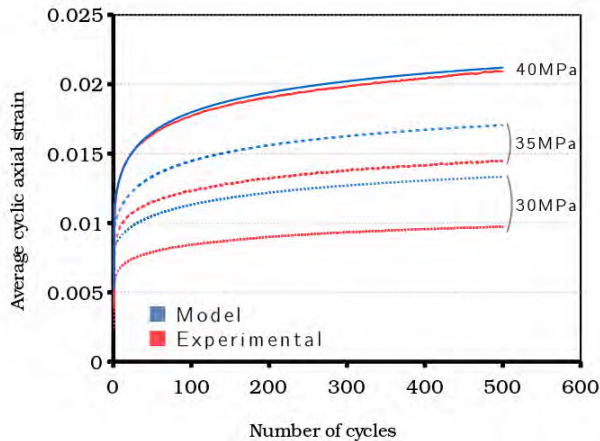
Fig. 12. Average axial strain for a U0.5 notched PA66 specimen.

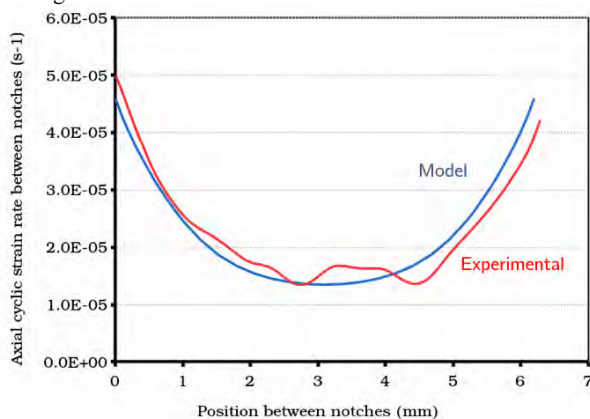
Fig. 14. Axial cyclic strain rate between the notches for a U2 notched PA66 specimen.

The computed NOD can also be compared to the experimental data (fig.13), as well as the cyclic strain rate between notches at half the fatigue life of the specimen (fig.14), giving a good agreement between the model and the experimental results.
