# Development of Environmental Barrier Coatings on Ceramic Matric Composites assisted by LASAT (Laser Shock Adhesion Test)

Guillaume Cottin, Vincent Guipont, Vincent Maurel, Emine Bakan, Robert Vassen, et al.. Development of Environmental Barrier Coatings on Ceramic Matric Composites assisted by LASAT (Laser Shock Adhesion Test). HT-CMC, Sep 2019, Bordeaux, France. hal-02185840

# Development of EBC on CMC assisted by LASAT (Laser Shock Adhesion Test)

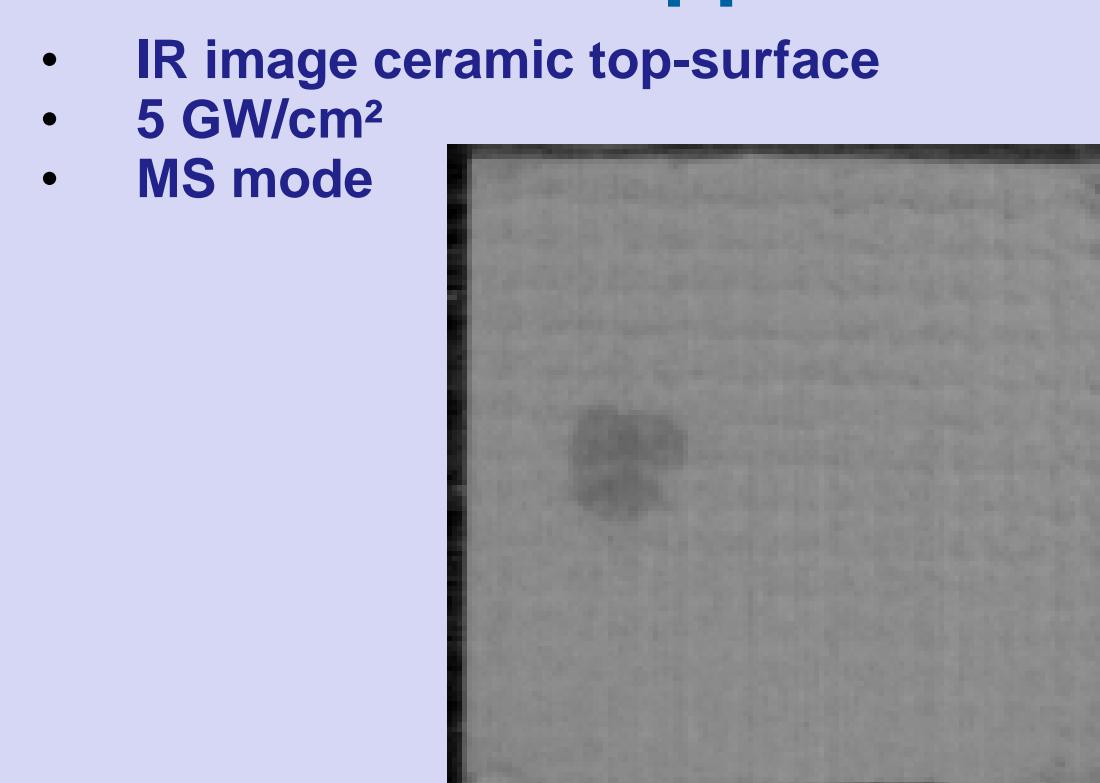
### 1. LASAT can be applied to CMC/EBC

- LASAT can be applied to CMC/EBC systems involving SiC/SiC -Si-Yb<sub>2</sub>Si<sub>2</sub>O<sub>7</sub>
- HV-APS 25x25 mm<sup>2</sup> sample exhibited a conventional behaviour upon LASAT → LAST 2D curves can be envisaged
- IR imaging can be advantageously envisaged for a non destructive assessment of the interfacial damage
- MS or CS modes can be envisaged, the use of a protective layer is preferred
- The weakest and lowest toughness interfacial zone seems to be located within the Si layer after deposition
- The presence of large pores within CMC may have attenuated the propagating shockwave in case of the APS sample

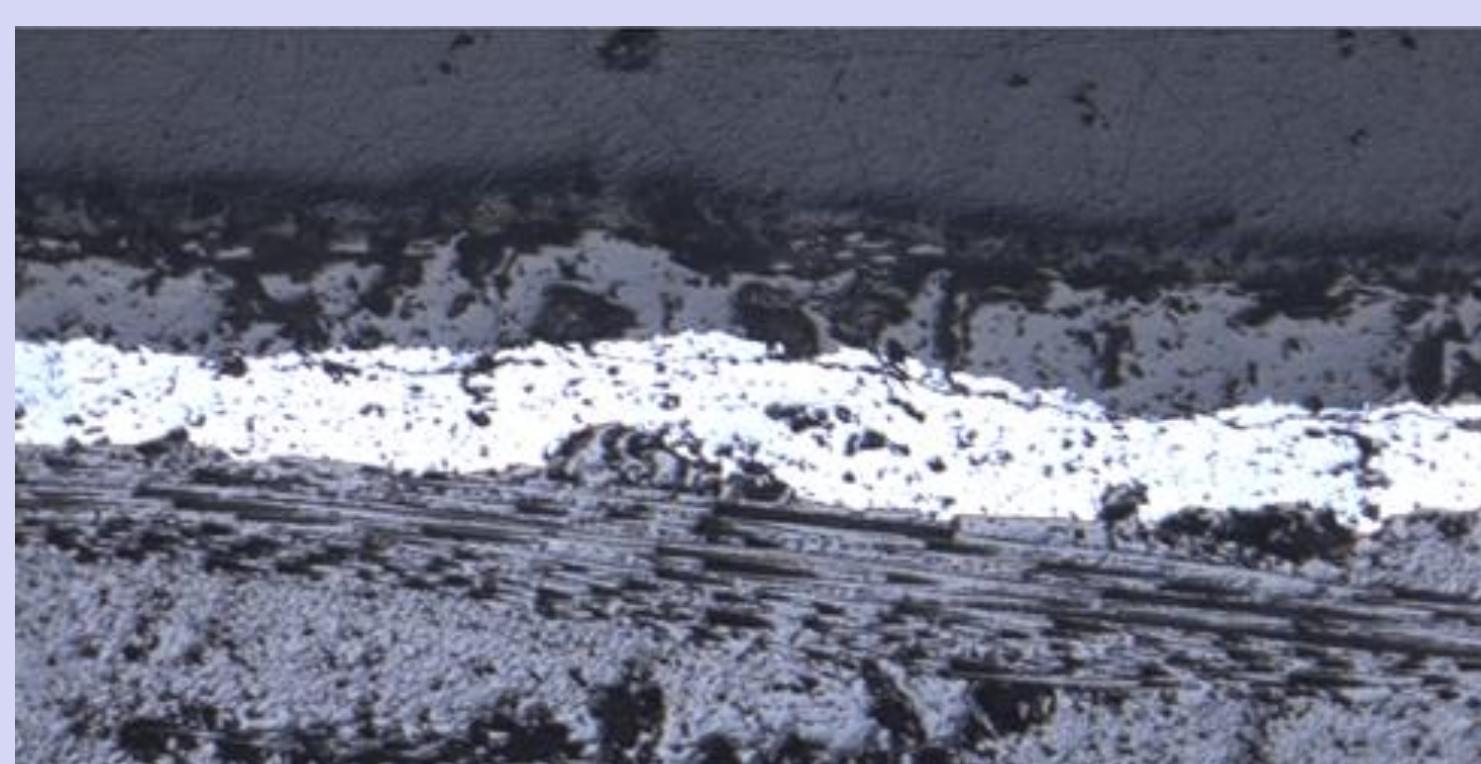
### 2. Laser-induced crack is located within the Si layer (HV-APS sample)

- Crack size is decreasing with laser energy
- Crack located Si Si near  $\text{Yb}_2\text{Si}_2\text{O}_7$  coating
- LASAT with CS mode is applicable

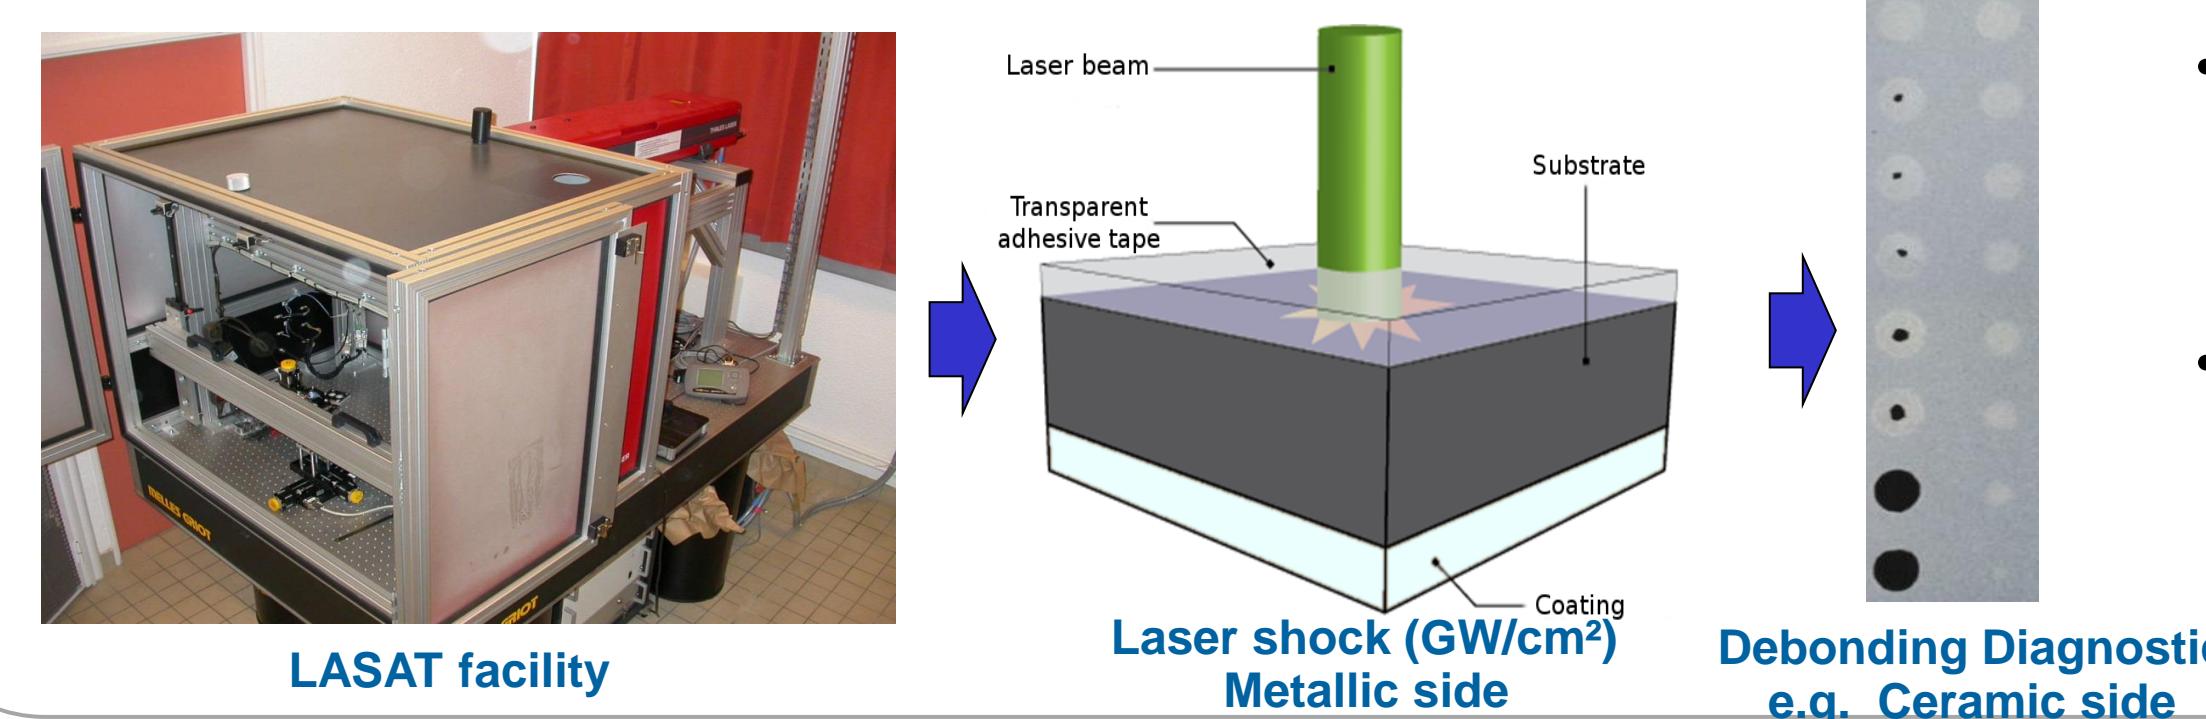
### LASAT: Laser Shock Adhesion Test

#### Saga –Thales Laser :

- maximum energy: 2J
- pulse duration: 5.2 ns
- wavelength: 532 nm

#### Two settings parameters are:

- Irradiated area diameter,  $\varnothing_{\text{laser}}$
- Laser energy, J

– laser fluency (power density),  $0,1 \rightarrow 10 \text{ GW/cm}^2$

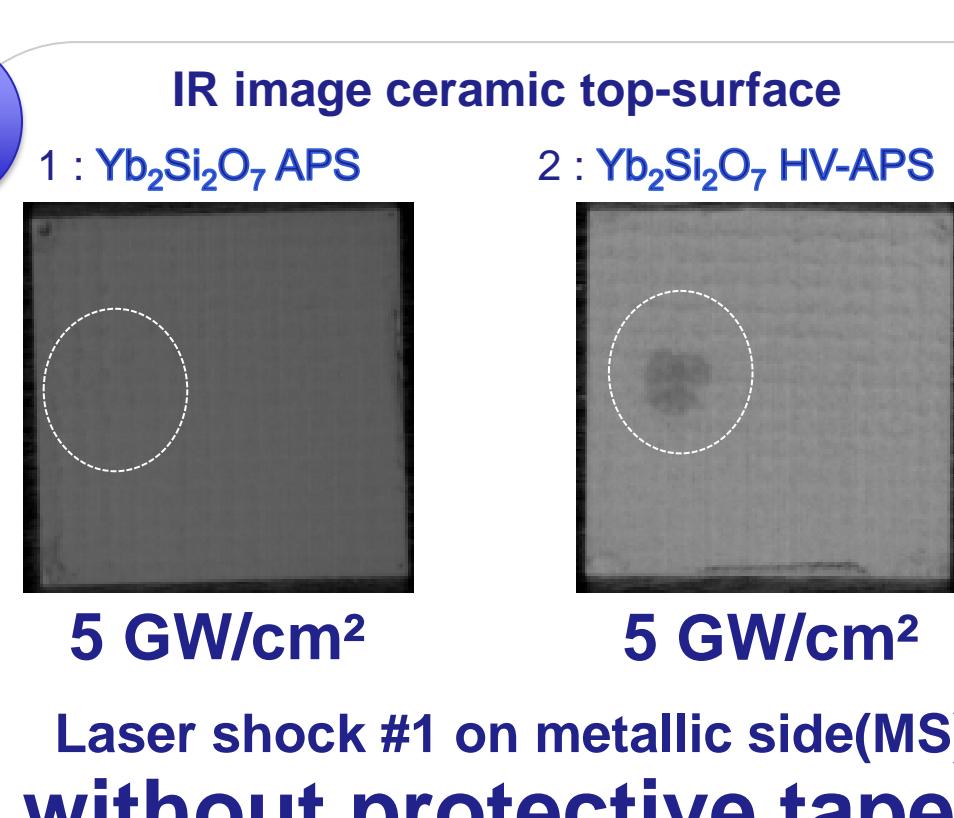
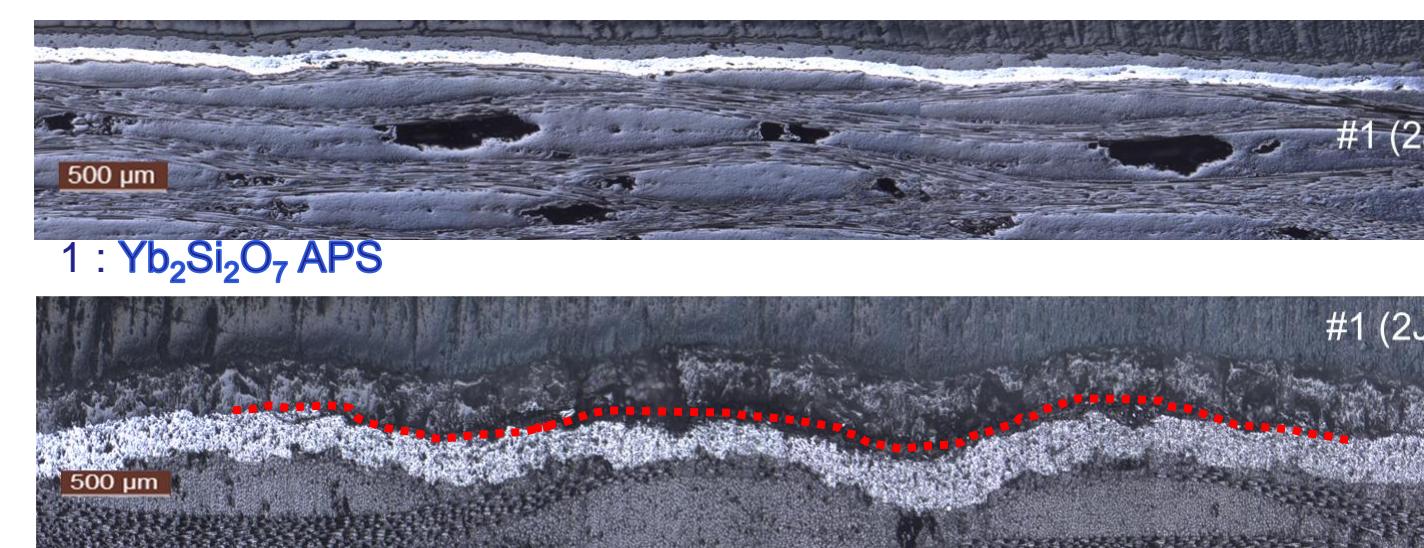
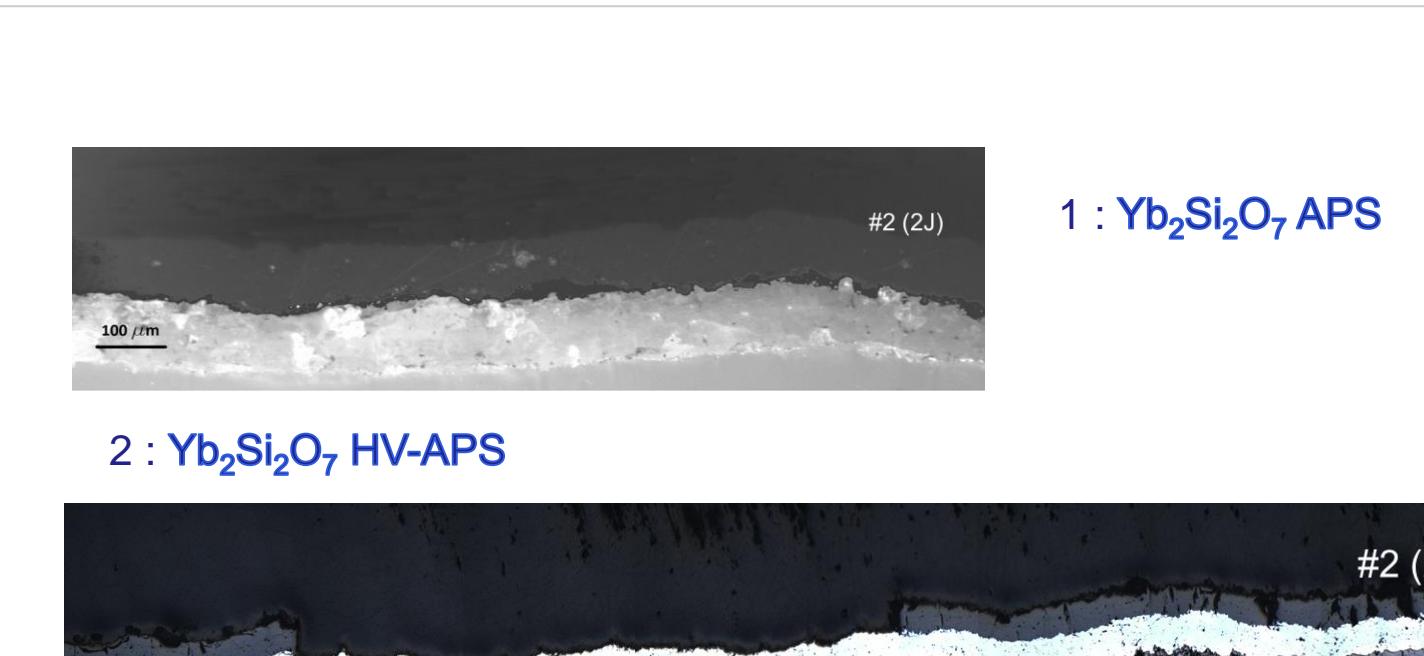
1

Laser shock #1 on metallic side(MS)  
without protective tape

#1 (2J)

#2 (2J)

- Debonding occurred only for HV-APS sample
- IR imaging is applicable, not optical imaging
- Pores are evidenced within CMC substrate

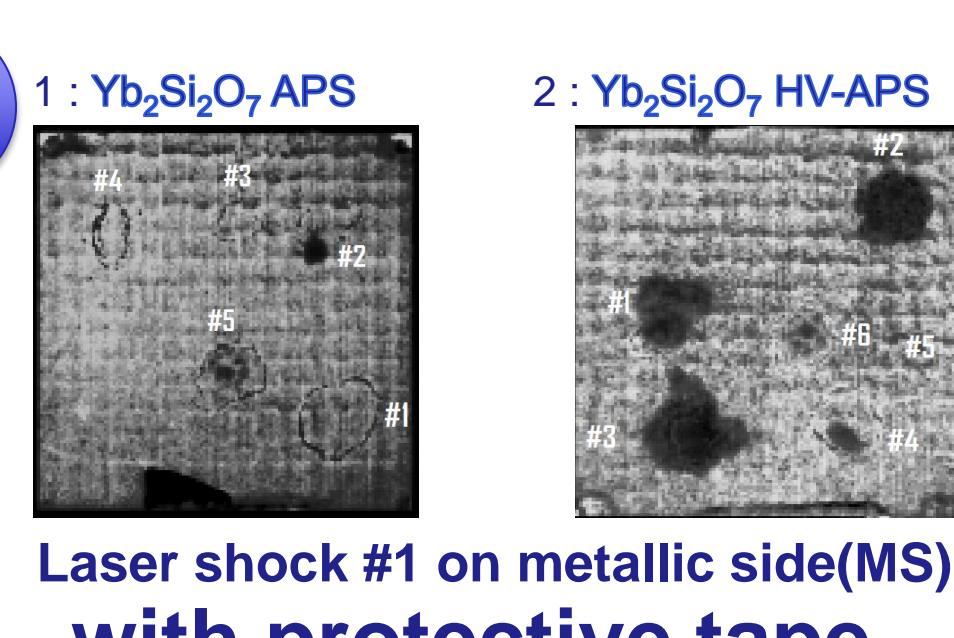
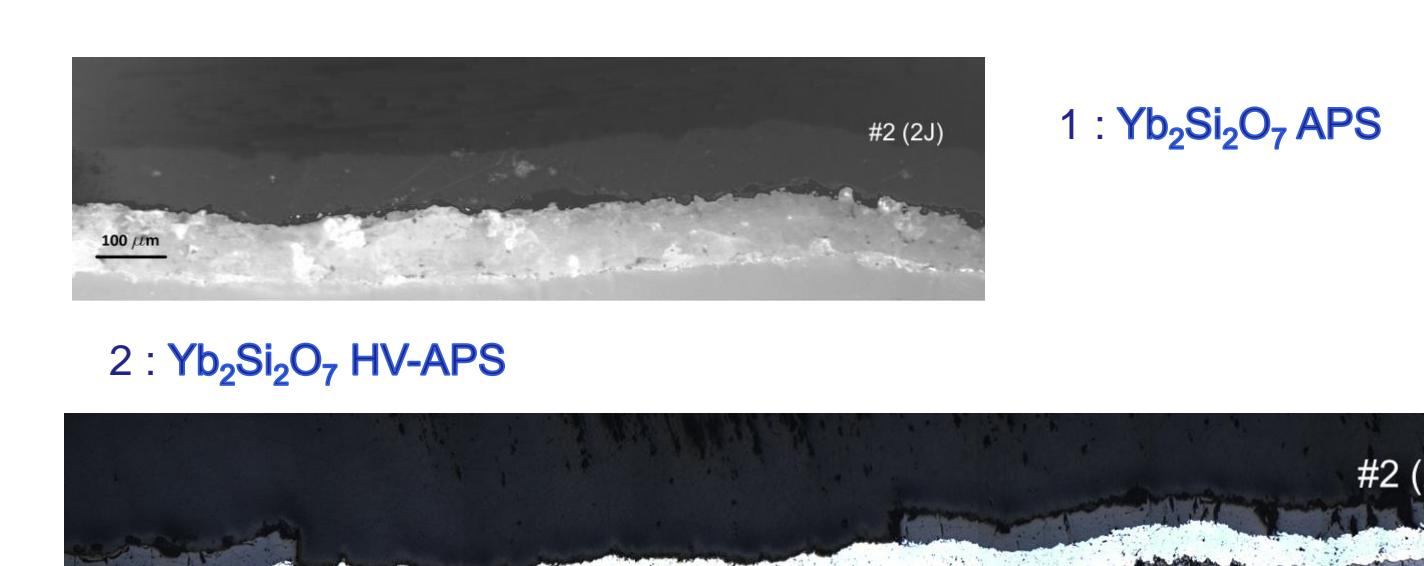
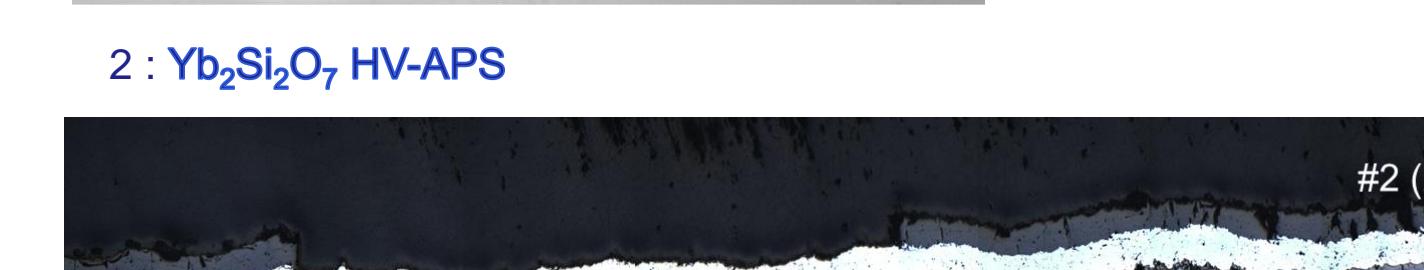
Laser shock #1 on metallic side(MS)  
with protective tape  
IR image ceramic top-surface

#1 (2J)

#2 (2J)

- Small crack in case of 1 :  $\text{Yb}_2\text{Si}_2\text{O}_7$  APS
- Spallation in case of 2 :  $\text{Yb}_2\text{Si}_2\text{O}_7$  HV-APS
- IR imaging is applicable for small crack
- Protective layer and water increase laser-induced input pressure

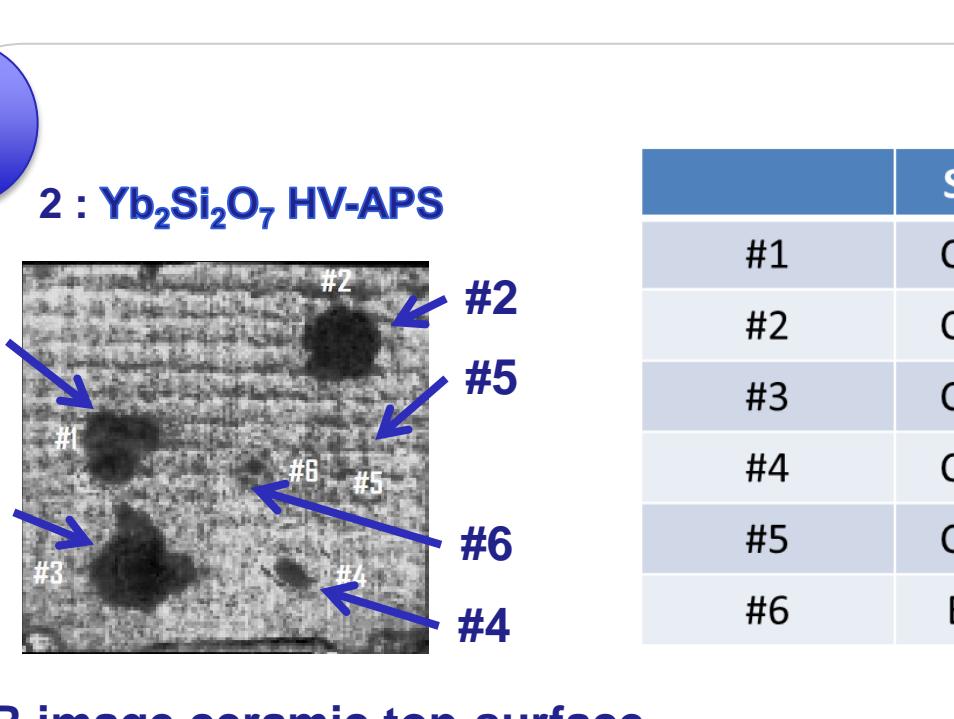
3

IR image ceramic top-surface

Side	$\text{GW/cm}^2$	Damage	Laser shock conditions
#1	CMC	5,1	Crack 5 mm	Without protective tape + transparent tape
#2	CMC	4,8	spallation	With protective tape + water
#3	CMC	3,7	spallation	With protective tape + water
#4	CMC	2,5	Crack 1.2 mm	With protective tape + water
#5	CMC	1,9	Crack 0.8 mm	With protective tape + water
#6	EBC	4,9	Crack 0.5 mm	With protective tape + water
