## Development of Environmental Barrier Coatings on Ceramic Matrix Composites assisted by LASAT (Laser Shock Adhesion Test)

Guillaume Cottin, Vincent Guipont, Vincent Maurel, Emine Bakan, Robert Vassen, Dieter Koch

# Development of EBC on CMC assisted by LASAT (Laser Shock Adhesion Test)

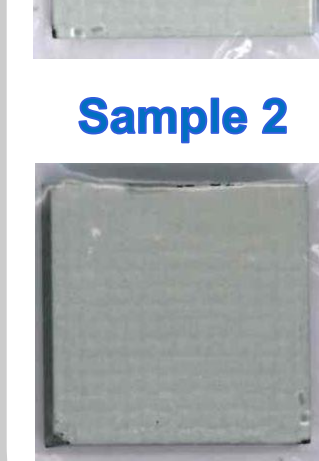
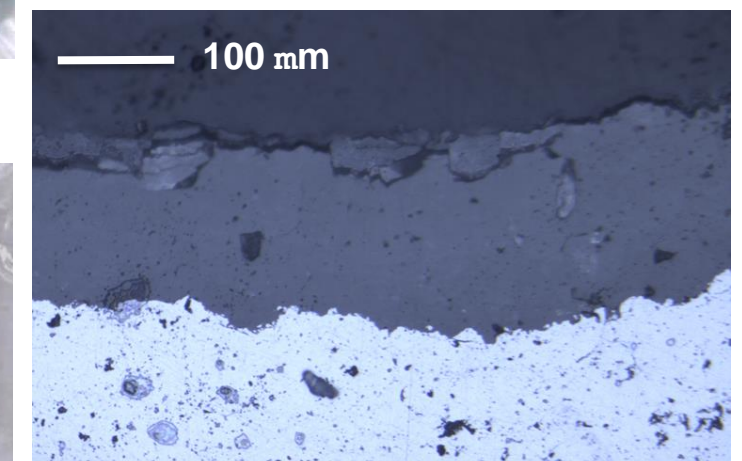
Sample	Dimensions	SiC/SiC	Si	Yb <sub>2</sub> Si <sub>2</sub> O <sub>7</sub>	Plasma
Sample 1	#1 25x25 mm <sup>2</sup>	3.4 mm	115 μm	109 μm	APS
	#2 25x25 mm <sup>2</sup>	3.4 mm	92 μm	123 μm	HV-APS

Sample #1 : Yb<sub>2</sub>Si<sub>2</sub>O<sub>7</sub> APS

Sample #2 : Yb<sub>2</sub>Si<sub>2</sub>O<sub>7</sub> HV-APS

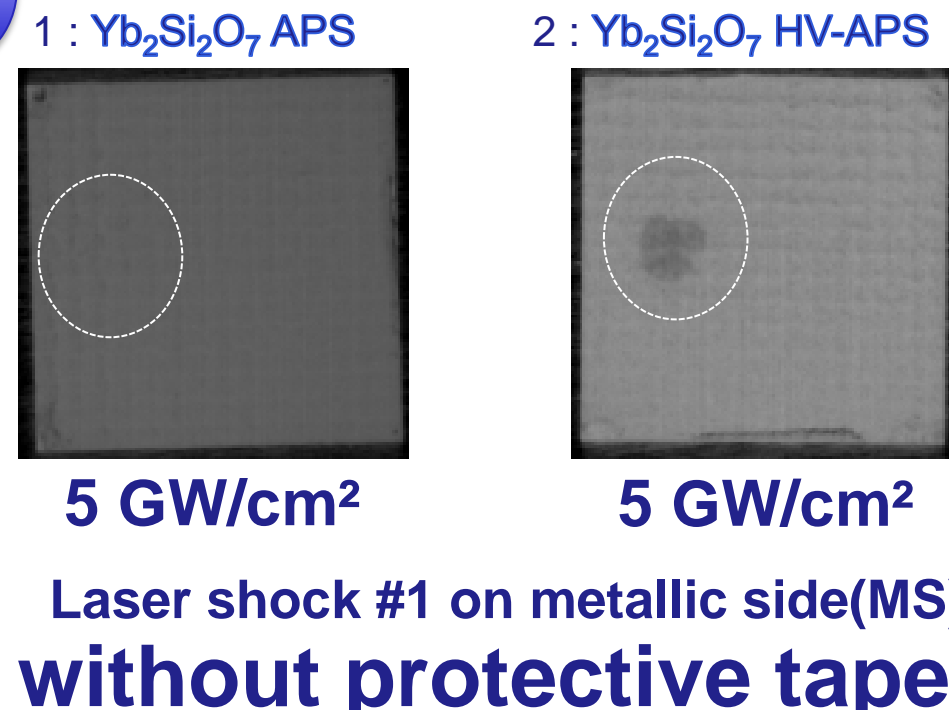
### 1 IR image ceramic top-surface

- Debonding occurred only for HV-APS sample
- IR imaging is applicable, not optical imaging
- Pores are evidenced within CMC substrate

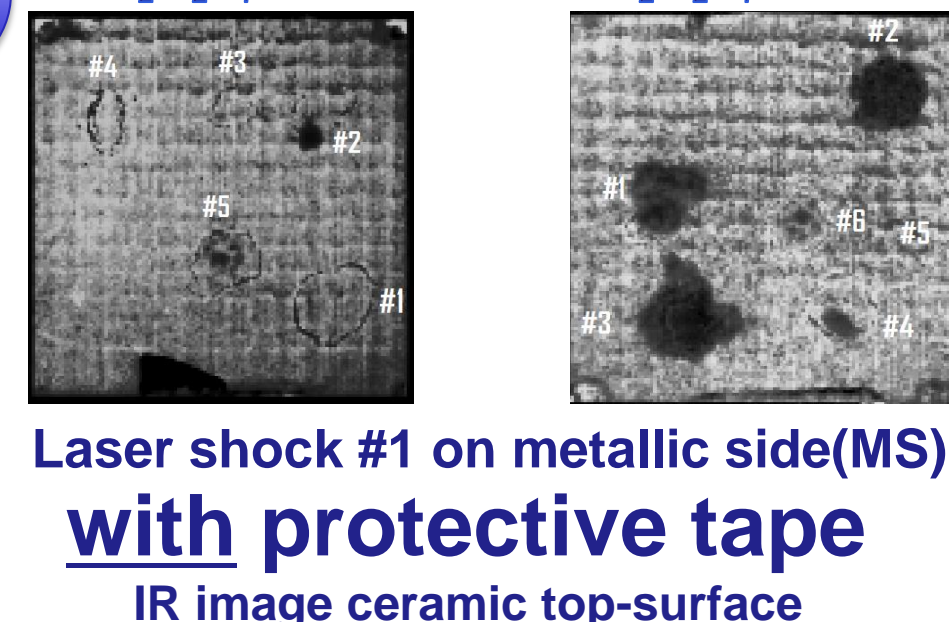
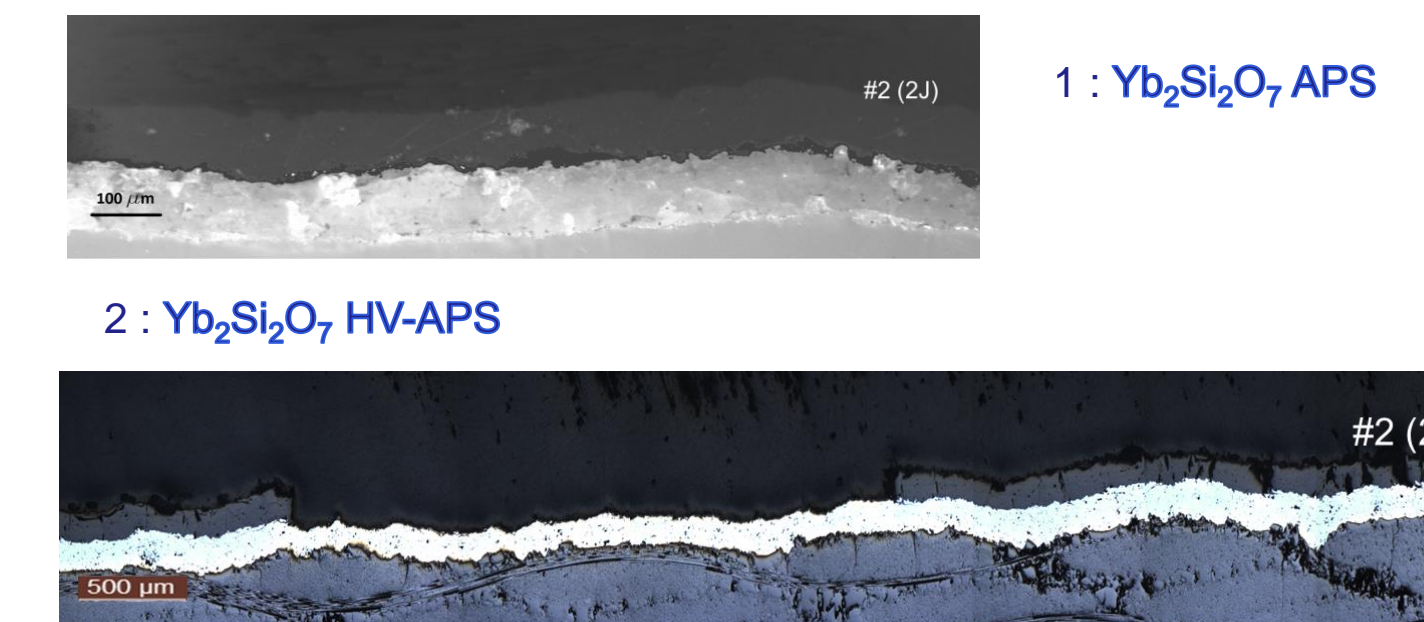
### 2 IR image ceramic top-surface

- Small crack in case of 1 : Yb<sub>2</sub>Si<sub>2</sub>O<sub>7</sub> APS
- Spallation in case of 2 : Yb<sub>2</sub>Si<sub>2</sub>O<sub>7</sub> HV-APS
- IR imaging is applicable for small crack
- Protective layer and water increase laser-induced input pressure

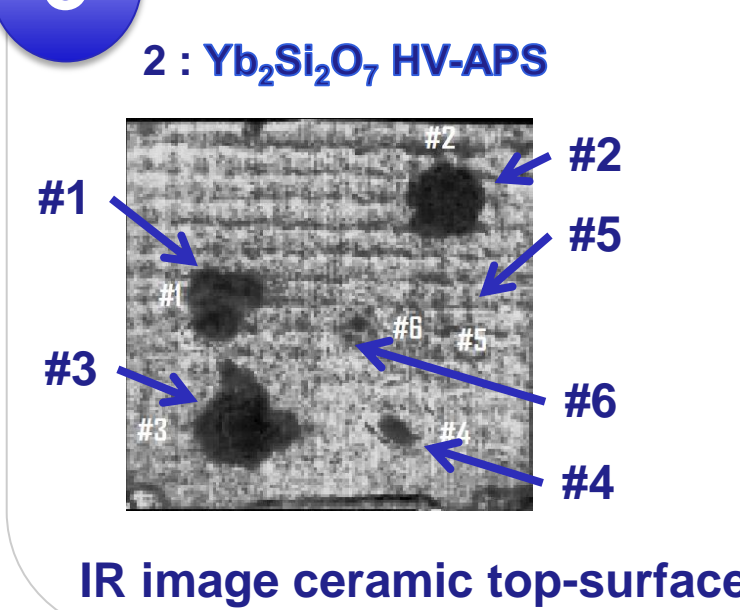
### 3 IR image ceramic top-surface

Side	GW/cm <sup>2</sup>	Damage	Laser shock conditions
#1	CMC	5,1	Crack 5 mm	Without protective tape + transparent tape
#2	CMC	4,8	spallation	With protective tape + water
#3	CMC	3,7	spallation	With protective tape + water
#4	CMC	2,5	Crack 1.2 mm	With protective tape + water
#5	CMC	1,9	Crack 0.8 mm	With protective tape + water
#6	EBC	4,9	Crack 0.5 mm	With protective tape + water

- Crack size is decreasing with laser energy
- Crack located Si/Si near Yb<sub>2</sub>Si<sub>2</sub>O<sub>7</sub> coating
- LASAT with CS mode is applicable

### 3. LASAT on ceramic side is applicable
