## Development of Environmental Barrier Coatings on Ceramic Matrix Composites assisted by LASAT (Laser Shock Adhesion Test)

Guillaume Cottin, Vincent Guipont, Vincent Maurel, Emine Bakan, Robert Vassen, et al.. Development of Environmental Barrier Coatings on Ceramic Matrix Composites assisted by LASAT (Laser Shock Adhesion Test). HT-CMC, Sep 2019, Bordeaux, France. hal-02185840

# Development of EBC on CMC assisted by LASAT (Laser Shock Adhesion Test)

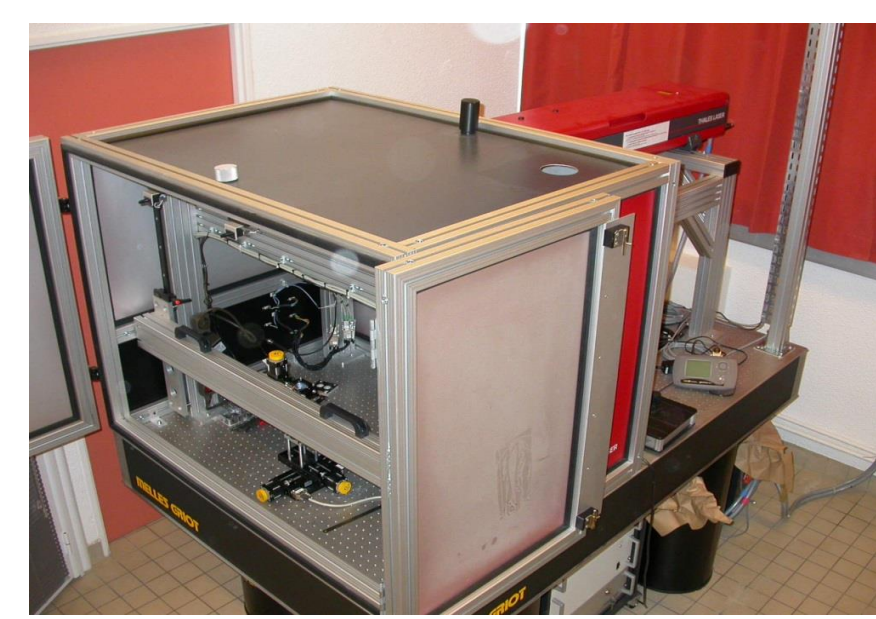
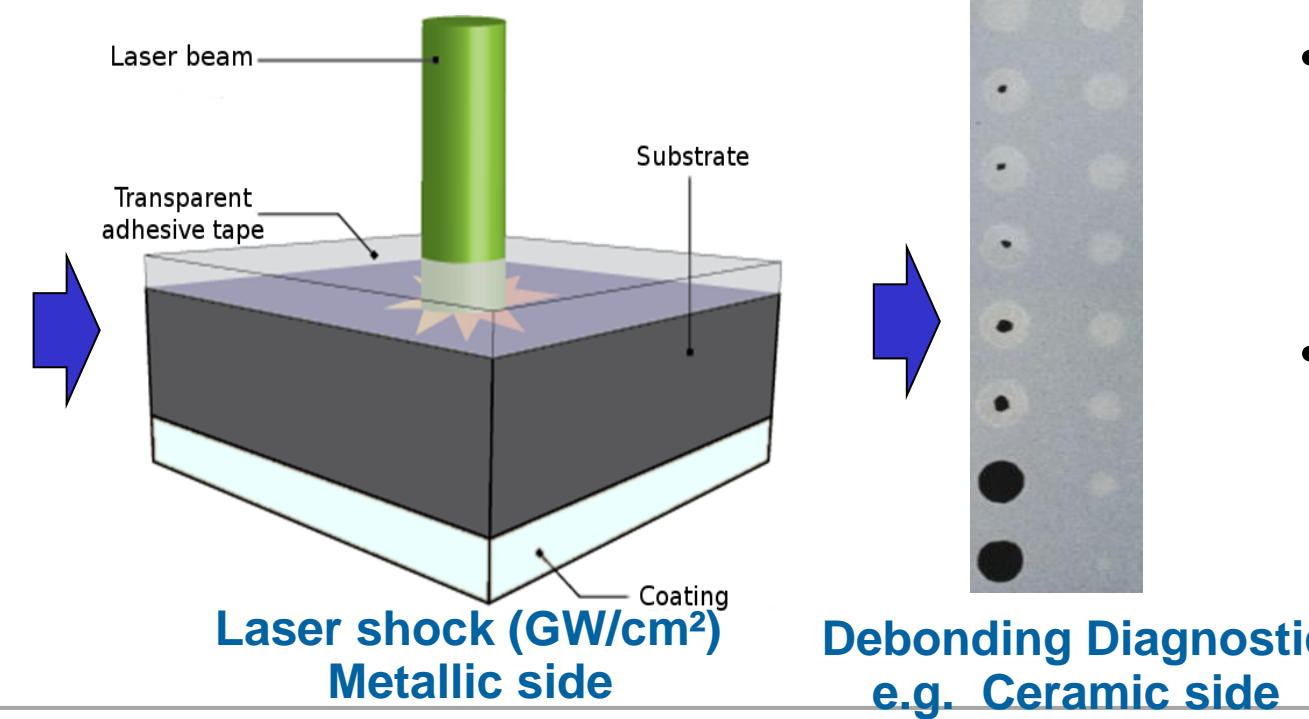
LASAT facility

#### • Saga –Thales Laser :

- maximum energy: 2J
- pulse duration: 5.2 ns
- wavelength: 532 nm

#### • Two settings parameters are:

- Irradiated area diameter,  $\phi_{laser}$
- Laser energy, J
- laser fluency (power density), 0,1 → 10GW/cm<sup>2</sup>

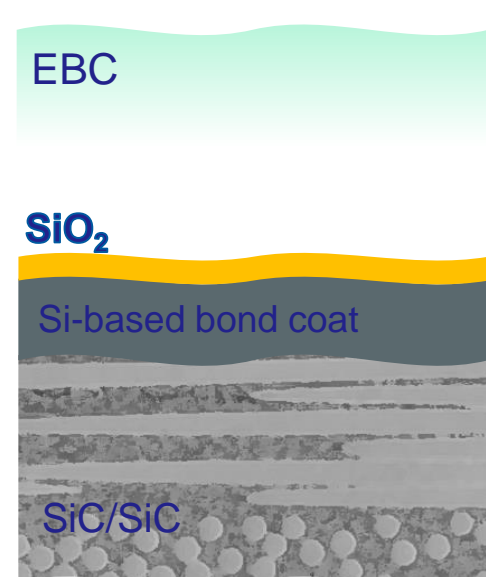
Development of Plasma Spray Multilayered Environmental Barrier Coatings on CMCs

LASAT applied to EBC?  
→ Assessment of interface strength of CMC/EBC

- Dense layers
- Minimal CTE mismatch with CMC
- High water vapor resistance oxides e.g. Yb<sub>2</sub>Si<sub>2</sub>O<sub>7</sub> for SiC/SiC

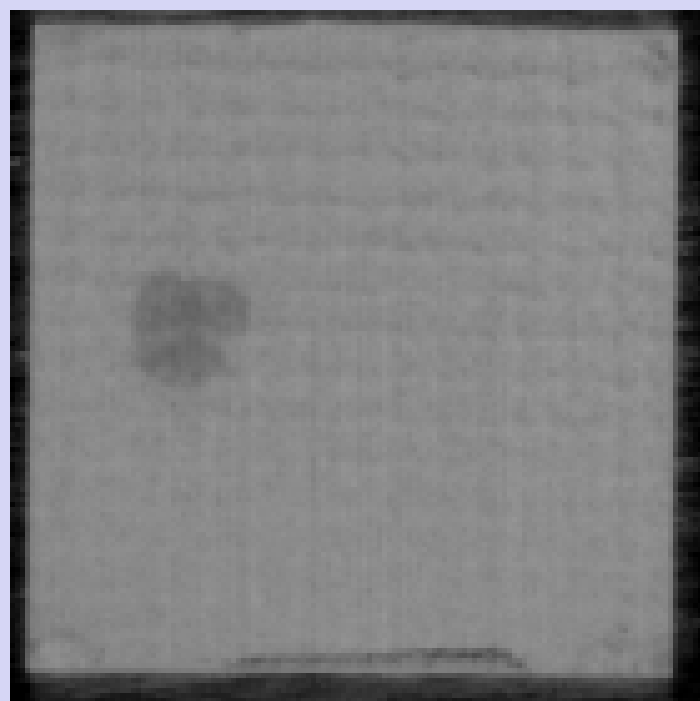
### 1. LASAT can be applied to CMC/EBC

- IR image ceramic top-surface
- 5 GW/cm<sup>2</sup>
- MS mode

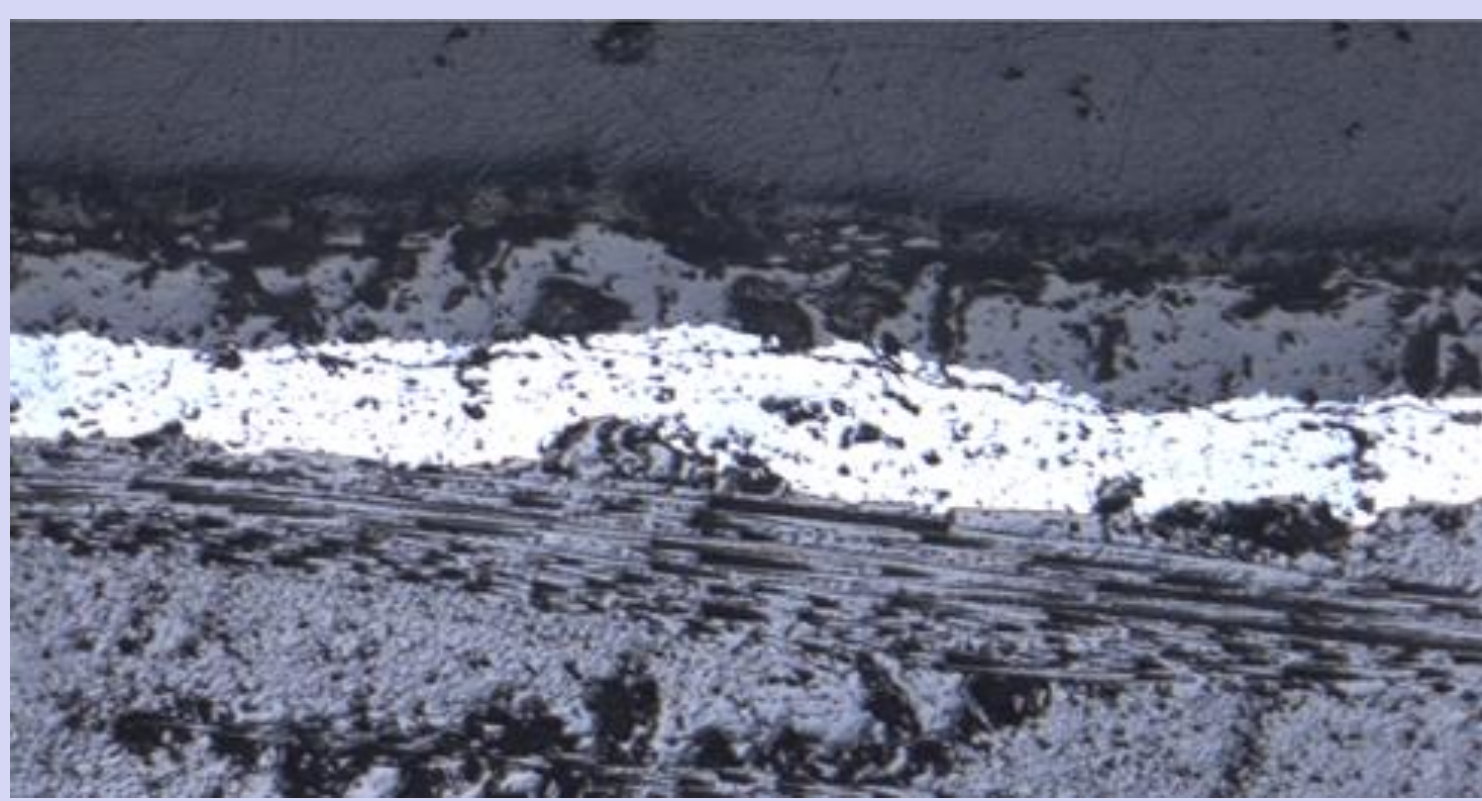
### 2. Laser-induced crack is located within the Si layer (HV-APS sample)

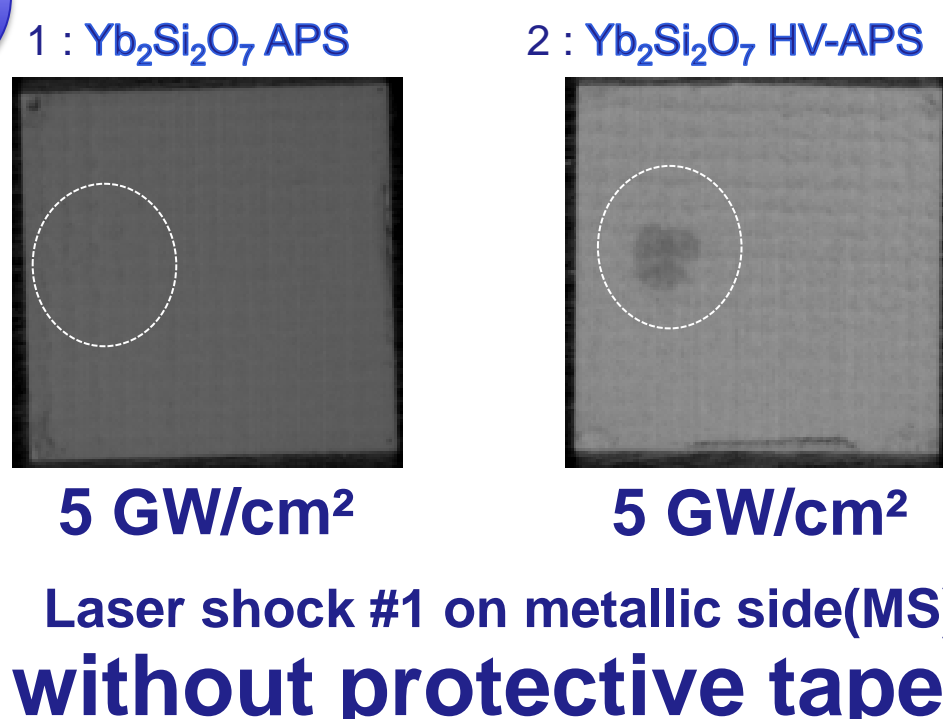
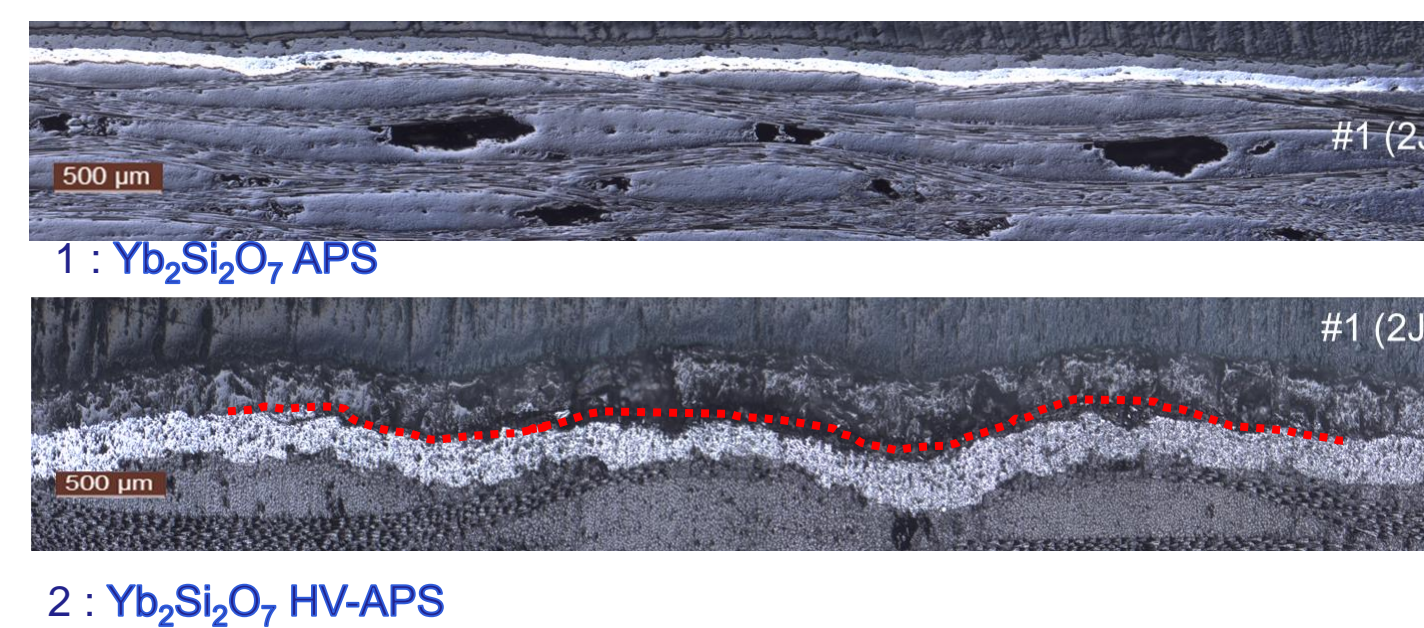
### 1 IR image ceramic top-surface

Laser shock #1 on metallic side (MS) without protective tape

- Debonding occurred only for HV-APS sample
- IR imaging is applicable, not optical imaging
- Pores are evidenced within CMC substrate

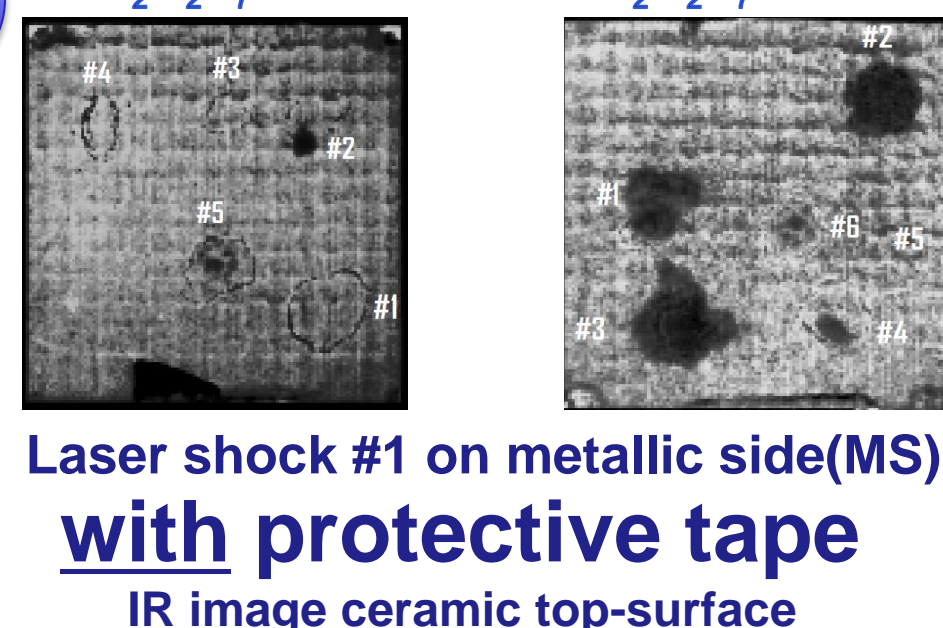
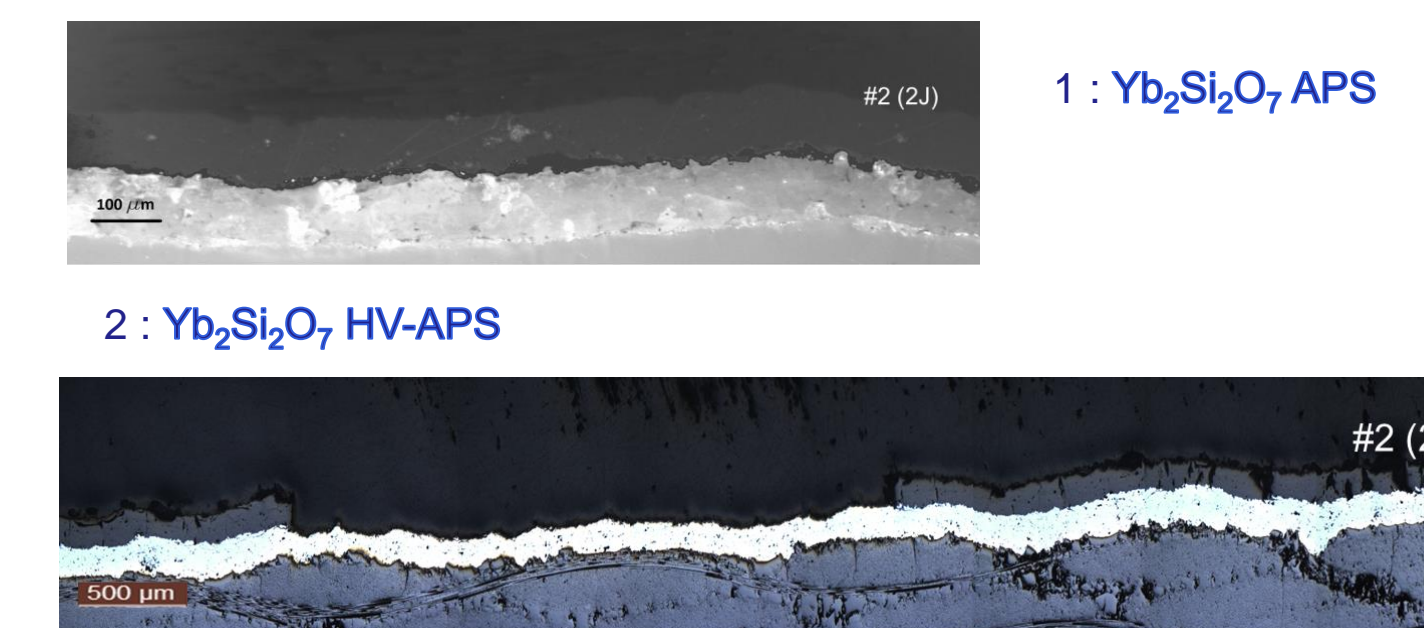
### 2 Yb<sub>2</sub>Si<sub>2</sub>O<sub>7</sub> APS and HV-APS

Laser shock #1 on metallic side (MS) with protective tape  
IR image ceramic top-surface

- Small crack in case of 1 : Yb<sub>2</sub>Si<sub>2</sub>O<sub>7</sub> APS
- Spallation in case of 2 : Yb<sub>2</sub>Si<sub>2</sub>O<sub>7</sub> HV-APS
- IR imaging is applicable for small crack
- Protective layer and water increase laser-induced input pressure

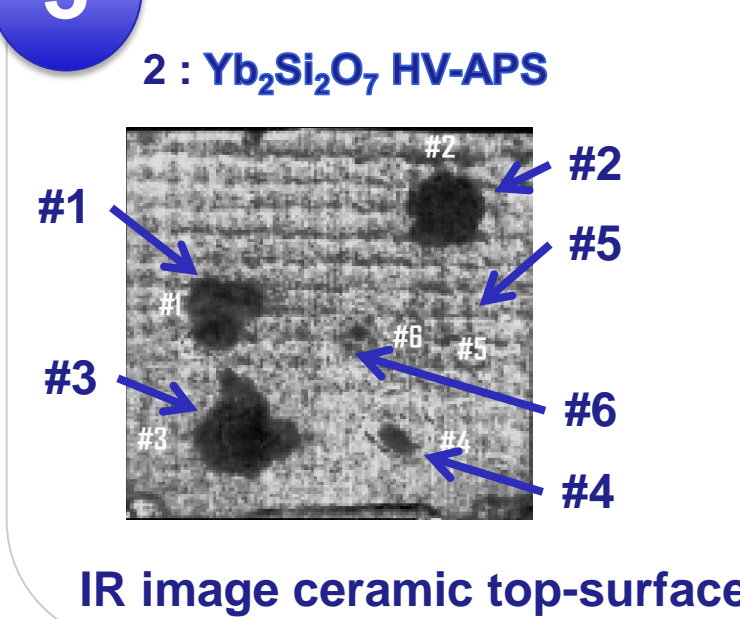
### 3 Yb<sub>2</sub>Si<sub>2</sub>O<sub>7</sub> HV-APS

IR image ceramic top-surface

Side	GW/cm <sup>2</sup>	Damage	Laser shock conditions
#1	CMC	5,1	Crack 5 mm	Without protective tape + transparent tape
#2	CMC	4,8	spallation	With protective tape + water
#3	CMC	3,7	spallation	With protective tape + water
#4	CMC	2,5	Crack 1.2 mm	With protective tape + water
#5	CMC	1,9	Crack 0.8 mm	With protective tape + water
#6	EBC	4,9	Crack 0.5 mm	With protective tape + water

- Crack size is decreasing with laser energy
- Crack located Si/Si near Yb<sub>2</sub>Si<sub>2</sub>O<sub>7</sub> coating
- LASAT with CS mode is applicable
