Geology, Engineering & Humanities: 3 sciences behind the Malpasset dam failure (France, Dec. 2, 1959)

P. Duffaut, Justin Larouzée

(Abbreviated title: “3 sciences behind the Malpasset dam failure”)

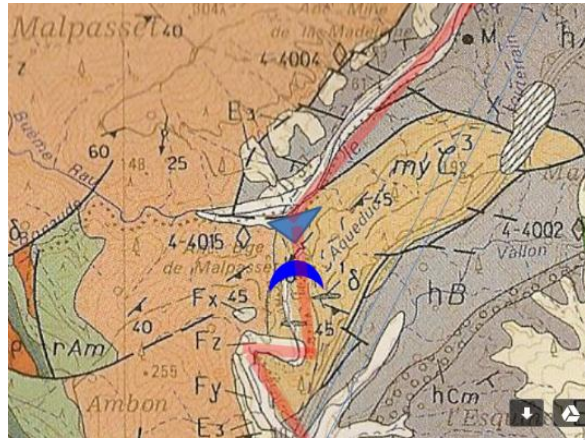
Fig. 2. From Geological map of France, sheet Cannes : position of two dam projects, either gravity dam at the gorge entrance, or arch dam close downstream (the river, colored in red, flows North-South) (gneiss brown, sediments grey)

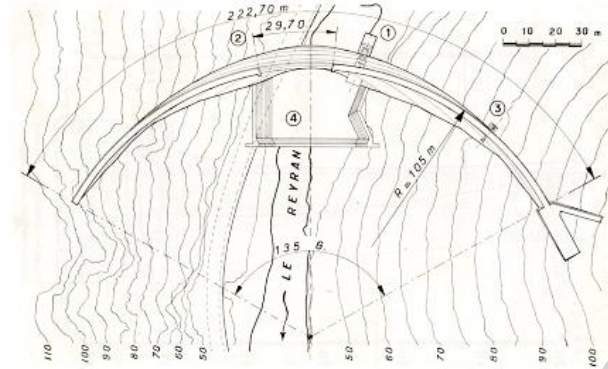
Fig. 3. *Layout of the arch dam; its right end abuts on a thrust block protected against water by a wing wall*

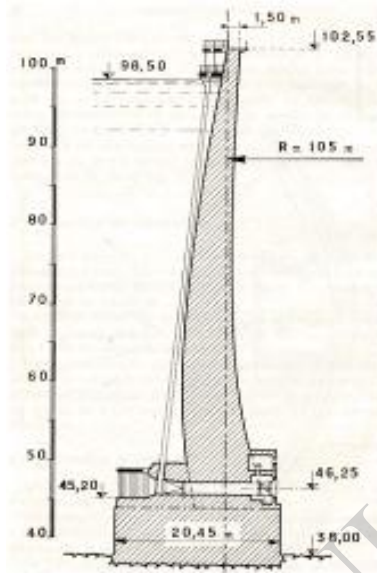
Fig. 4. Vertical section of the dam along cantilever IJ; the foundation block is thicker to encase the conduit of the bottom valve and its control cabinet downstream (at right)

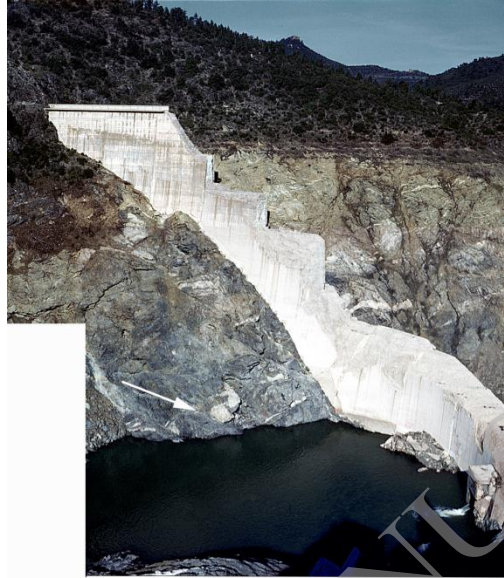
Today, only a part of the dam remains standing on the right bank, up to half of the cantilever JK, as a giant stairs, cut along vertical construction joints and horizontal concrete layers (Fig. 6) conversely, on the left bank only one half of the thrust block remains and a deep excavation was open in the rock at the foot of what had been the dam foundation (Fig. 6)⁵.

Fig. 6. *Remains of the dam on right valley side and valley bottom; the rock appears crisscrossed with white pegmatite dykes; the arrow shows the main fault; the river flow passes through the outlet valve (two assembled photos, J. Duffaut, Dec.20, 1959)*

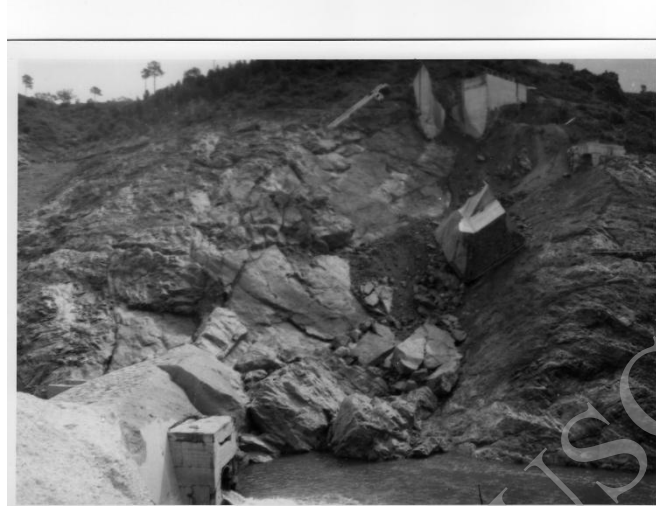
Fig. 7. The "dihedron", a deep excavation cut inside left valley side at the foot of the dam. The concrete block inside has fallen from the thrust block after the flow (photo P. Duffaut, May 1960)

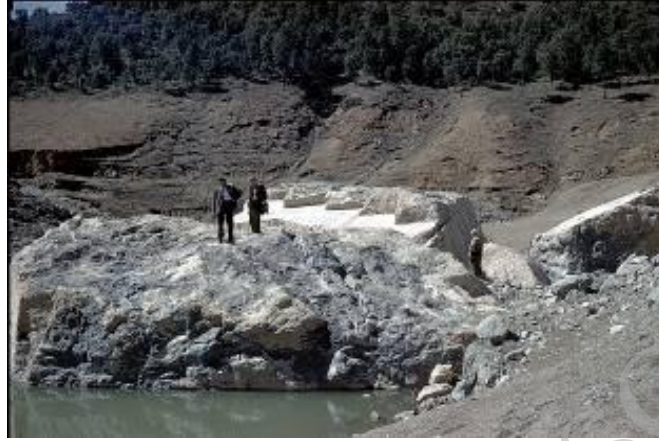
The experts led by Goguel also asked for a geodetic check of the position of the dam's remains. Geodetic measurements confirmed the movement first developed from the crevice (Fig. 9). The whole concrete arch had rotated as one piece around the fixed right end of the dam, with displacements up to 60 cm, without any apparent disturbance inside the rock foundation. An exception was that the thrust block had moved about 2 metres, two times more than that explained by the rotation.

Fig. 9. *The two main concrete blocks, 600 m downstream of the dam: on the one overturned, the foundation rock keeps adherent to concrete (photo J. Duffaut, 20 Dec. 1959)*

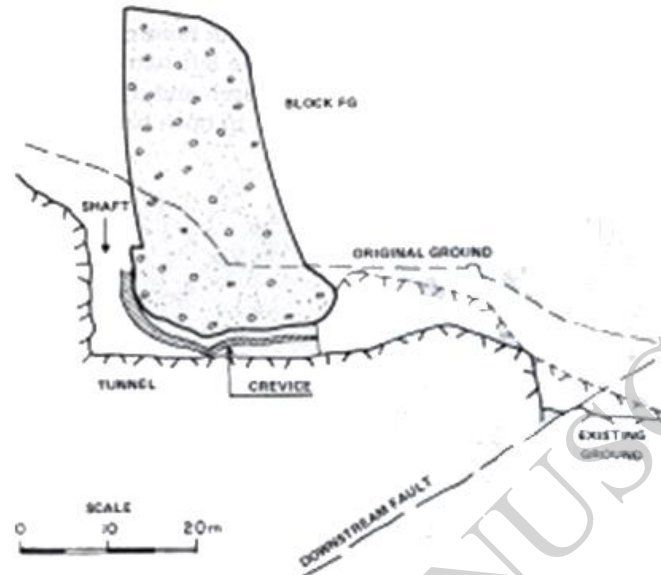
Thanks to a very dry spring in 1962, the water ponds around the dam base dried, giving access to the very foot of the shell; it was possible to bore a small gallery under cantilever FG (Fig. 11). Indeed a water flow below the dam had been suspected from bubbles on the day after the failure and a debris sill formed below the water level by a large discharge during the

Fig. 11. Cross section of the base of cantilever FG showing the investigations performed in late spring 1960 and the crevice discovered; the downstream fault appears also below the dam (from Mary, 1968, the length scale is faulty).

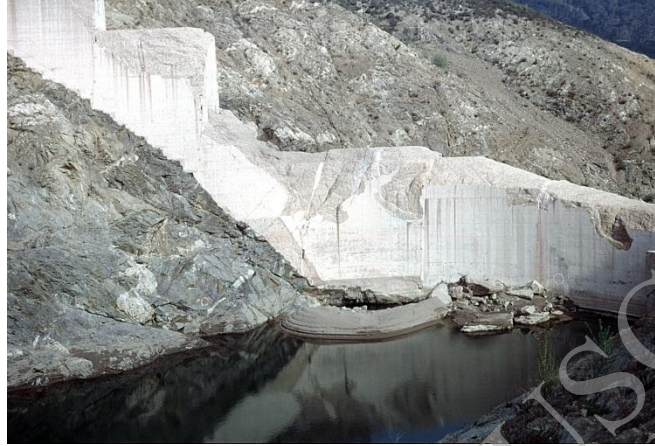
Fig. 12. *The debris sill built under water by the flow below cantilever FG (photo P. Duffaut, May 1960).*

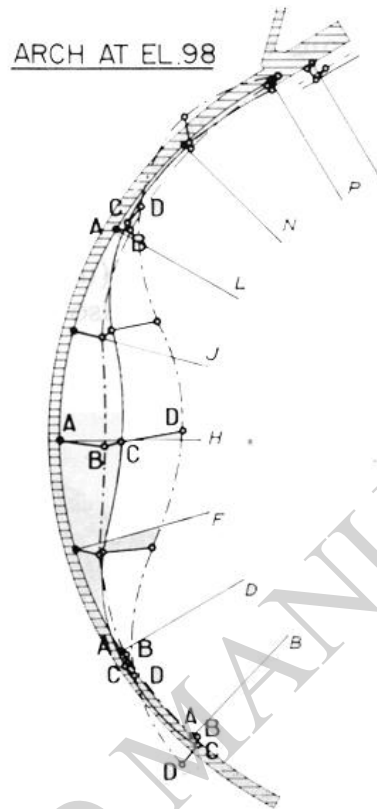
Fig. 13. Displacement measurements of the arch at elevation 98; bold letters ABCD mark dates of the measurements (4 triangles on fig. 5): the inclination towards left bank of vectors CD is conspicuous.

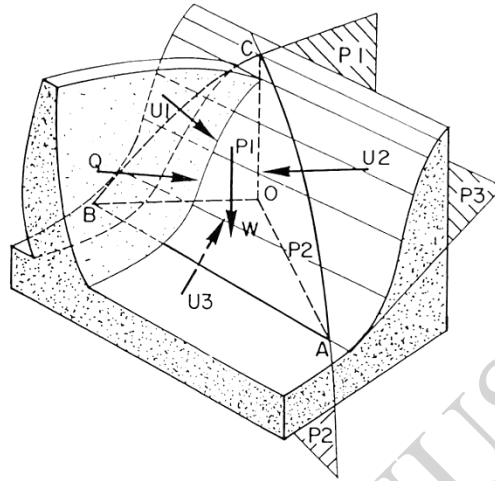
Fig. 15. Scheme of the forces acting on a tetrahedral rock block in the abutment of an arch dam: planes P_1 P_2 P_3 limit block ABC, block weight W , dam thrust Q , uplift pressures U_1 U_2 U_3 (after Londe 1973)

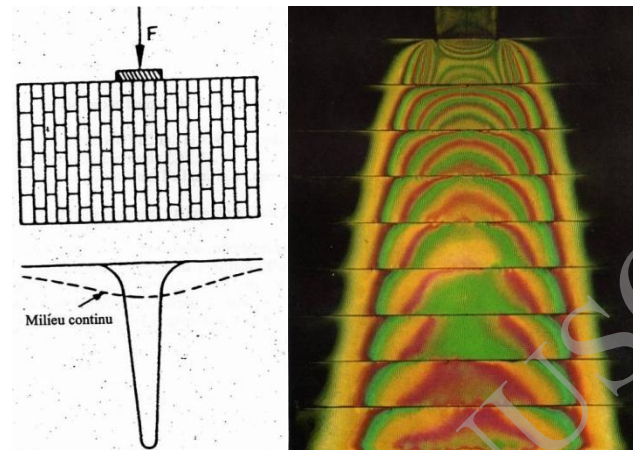
Polytechnique and various universities; Claude Louis worked at Karlsruhe, Germany, under Prof. Mueller, on water flow in rock mass fissures (Louis, 1968); Bernard Schneider worked at Grenoble on analysis of seismic signal (so called method “petite sismique”, 1967); Jean Bernaix (1967) and Vincent Maury (1973) worked at Polytechnique, on laboratory and model tests, the latter through photoelasticity (Fig. 16). Within less than 10 years Rock Mechanics had made tremendous progress!

Fig. 16 *Stress distribution under a punch; left on brickwork models by Bernaix; right, through photoelasticity by Maury (no friction between horizontal planes)*

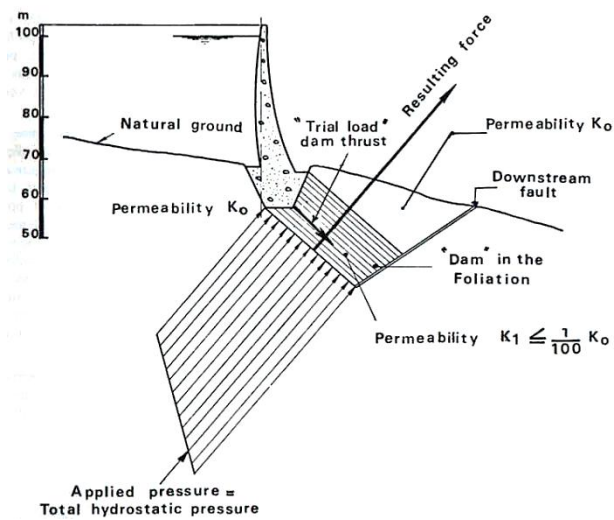
Three different enquiry commissions have worked on the trial, the first one commissioned by the government, both others by the tribunal, altogether involving 18 experts. The third commission was named because the first two could not agree on the issue of the failure's predictability. The new investigations in spring 1962 helped to make progress: Jean Bellier (1967) and Marcel Mary (1968) proposed the following mechanism (schematized Fig. 17 and 18), compatible with all investigations:

- i. Due to the thrust of the dam, the permeability of the foundation rock was reduced by a factor of ten or even much more, so building a true underground dam.
- ii. Such thrust may move the dihedron along the fault, both upwards and towards left; the cantilevers on the left bank could no longer take support from the dihedron and the whole shell tried to obtain support from the thrust block.
- iii. Since the thrust block had not enough weight, it gave up after a 2 metres displacement, which ended any arch effect.
- iv. The whole dam shell burst, some parts in horizontal bending some other ones in vertical bending.

Fig. 17. Cross-section of the dam and foundation at mid height of left side: the full hydrostatic pressure on the “underground dam” created by the arch dam thrust can push the dihedron upwards along the fault (adapted from Mary, 1968)

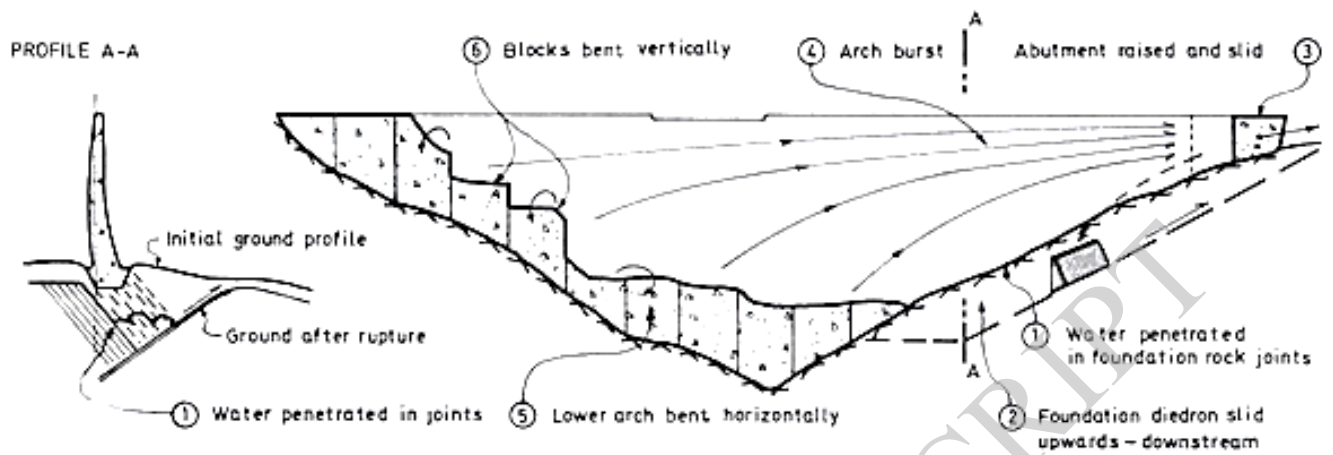
Fig. 18. *Phases of failure on downstream view and profile A-A. (1) Water penetrates in the traction fissure along the dam heel; (2) the foundation dihedron is pushed along the fault, upwards and rightwards; (3) the whole arch thrust concentrates on the thrust block, which cannot afford it and gives way; (4) deprived from arch effect, the shell burst; 5-6: the right bank cantilevers fail in bending.*
