# Three-Dimensional Characterization of Cracks in a Columnar Thermal Barrier Coating System for Gas Turbine Applications

Anne Dennstedt, Fabrice Gaslain, Marion Bartsch, Vincent Guipont, Vincent Maurel

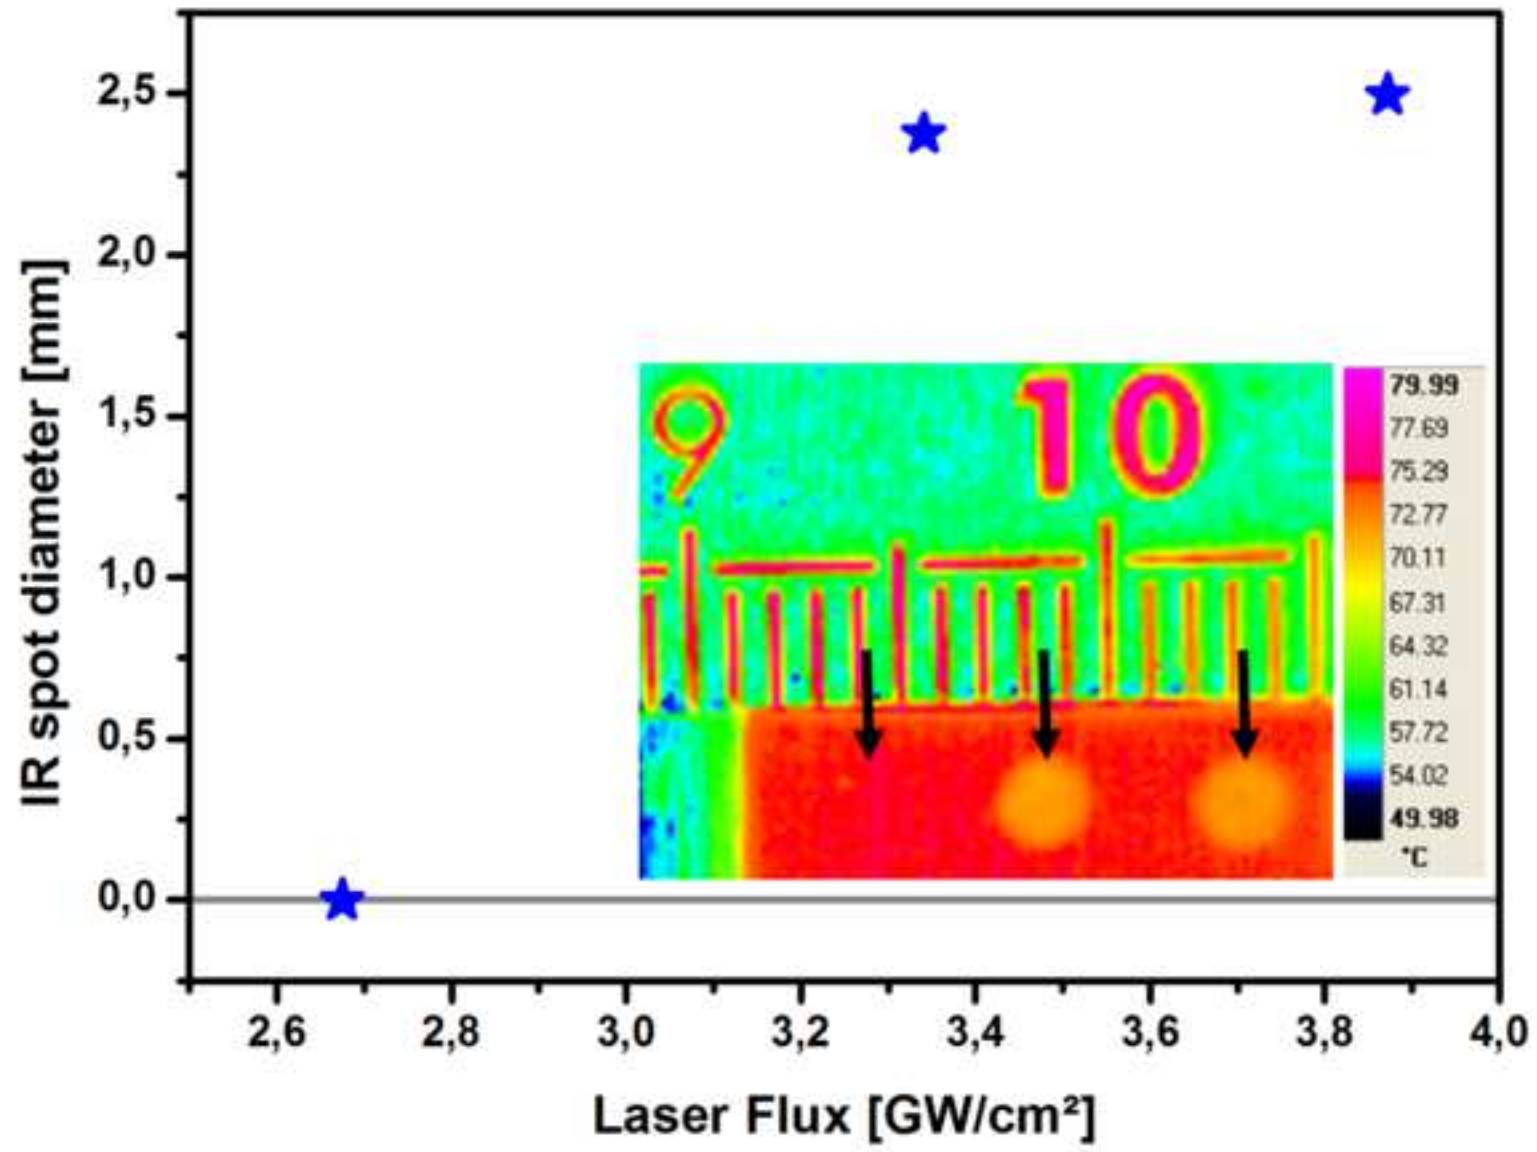
28  
29 Figure 1: Measurement of the debonded diameter as a function of laser flux; insert shows a temperature  
30 field obtained by infra-red thermography (IRT) after LASAT. (Temperatures are defined by the assigned  
31 color)

35 Visual inspection of the coating after the laser shock experiment can give evidence of the damages: at  
36 the created delamination the coating looks brighter than at the undamaged regions. The white color of the  
37 coating is unchanged if there is no delamination. In contrast, a spallation of the TC exposes dark regions  
38 of the underlying material [21]. Alternatively, the sample is put with the metallic substrate onto a heating  
39 plate set to 50 °C while the temperature change is monitored by an IR camera (Titanium 520SB GeminiBB  
40 MW F/3 (InSb) with a 320 x 256 pixel large detector). This thermography method yields a cold region  
41 when there is an interfacial crack limiting the heat flow from the substrate to the ceramic coating [19, 20].  
42 The thermography was used in this study.  
43  
44

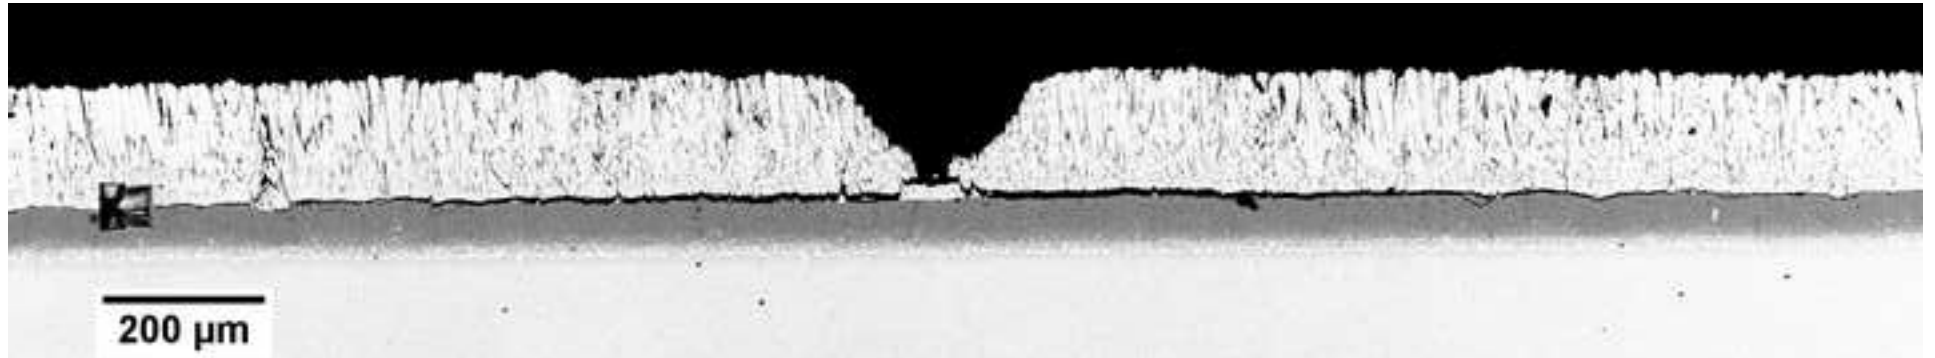
32 Figure 2: (a) Micrograph of the sample cross section by scanning electron microscopy using a backscatter  
33 electron detector (BSE) (b) Location of the virtual volume extracted by means of FIB slice and view process.  
34 The numbers 1 to 12 refer to individually analyzed sub-volumes (compare Figs. 8 - 10)

31 off" defects of different size [23, 24]. Because of the laser shock, some small dense pinched off regions are  
32 detached from the delaminated ceramic layer, staying attached to the TGO. The accidental central defect  
33 within the ceramic layer, visible in Fig. 2a, is far enough from the crack tip not to generate any artifact on  
34 the morphology of the crack tip process zone. Further SEM investigations at higher magnifications verified  
35 that gaps and cracks in the TC and TC-TGO interfacial region are well infiltrated by the resin, confirming  
36 that the observed cracks were generated before sample preparation. Because this cross-section image was  
37 collected after the FIB-slice and view procedure, the position of the volume extracted is visible in the left  
38 part of the image. The position was chosen to have a volume that contains parts of ceramic coating, TGO,  
39 and bond coat as well as the crack tip process zone, Fig. 2b. Fig. 3a and b show examples of the BSE

12 Considering the location of sub-volumes with the global debonded area by LASAT is of interest, Fig. 2b.  
13 At the global level the crack could be viewed to "enter" and "exit" the volume worth of investigation, namely  
14 the crack enters sub-volume #1, along the side #1, 2, 3 (or corner #1, 2, 4), and exits on #12, along the  
15 corner (#9, 11, 12). Consistently, the associated voids distribution is larger on crack enter (sub-volumes  
16 #1, 2, 3 in Fig 9) than on crack exit (sub-volumes #11, 12 in Fig 9). This could be induced by local  
17 increase in roughness, but should be observed together with the TGO distribution. Because, the span of  
18 TGO distribution is almost constant when comparing enter and exit location, it appears that the crack is  
19 more opened when entering than when exiting the volume analyzed.  
20  
21

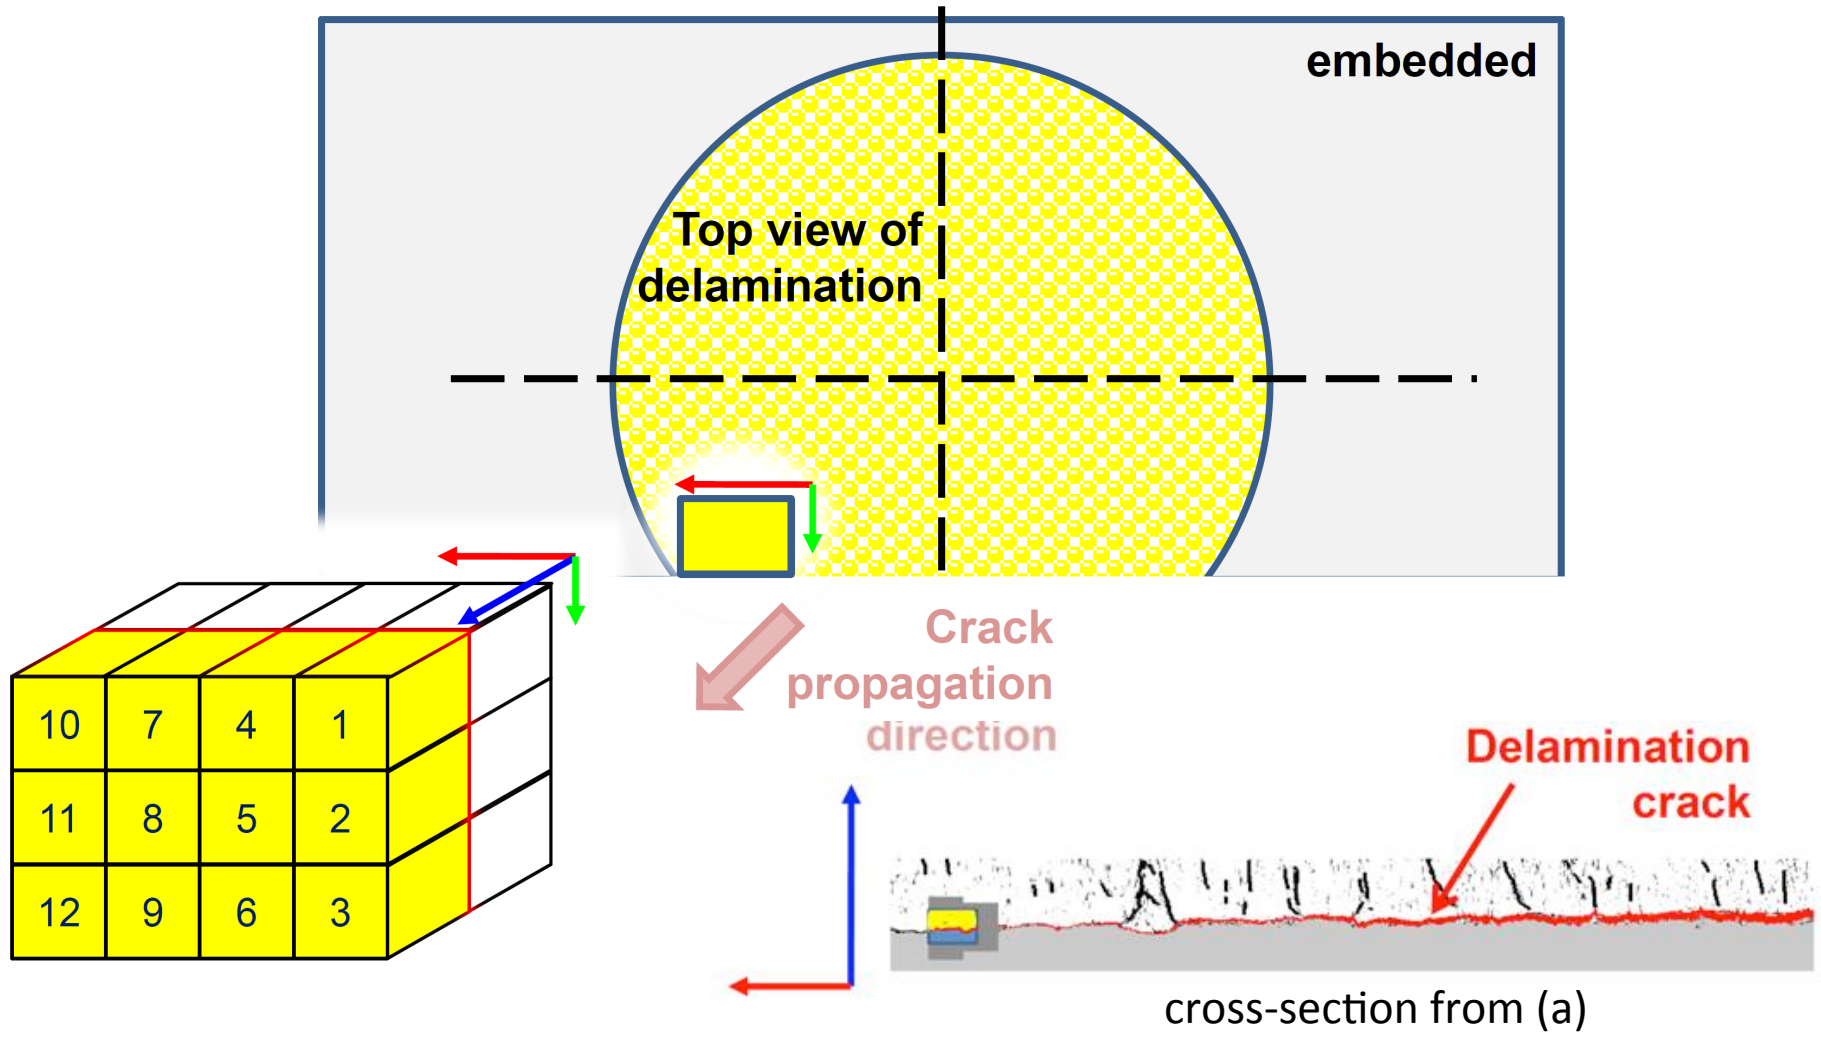
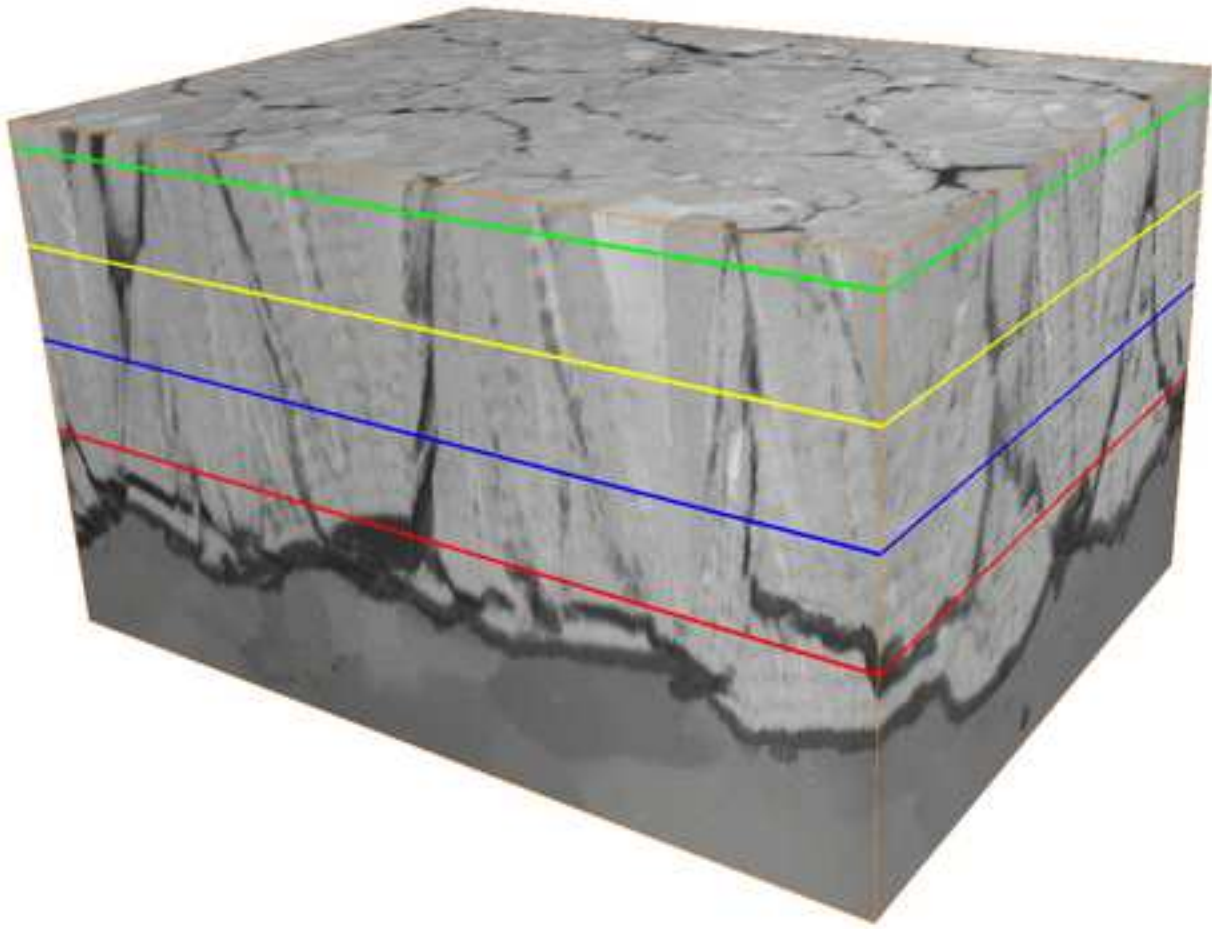
Figure 3b

35 Figure 3: SEM micrographs displaying a snap-shot of a slice from the region of interest during progressive  
36 FIB-slicing in (a) BSE mode and (b) SE mode.

40 and SE SEM images, respectively that are collected during the FIB slice and view procedure. Both images  
41 show the same slice surface, BSE image highlighting contrast in composition, which is helpful for discerning  
42 different phases, and SE image highlighting contrasts in morphology, which is helpful for crack analysis. In  
43 BSE mode, the TGO appears dark and it is difficult to differentiate between cracks and TGO. In SE mode  
44 cracks appear darker than the TGO which allows discerning both.  
45  
46

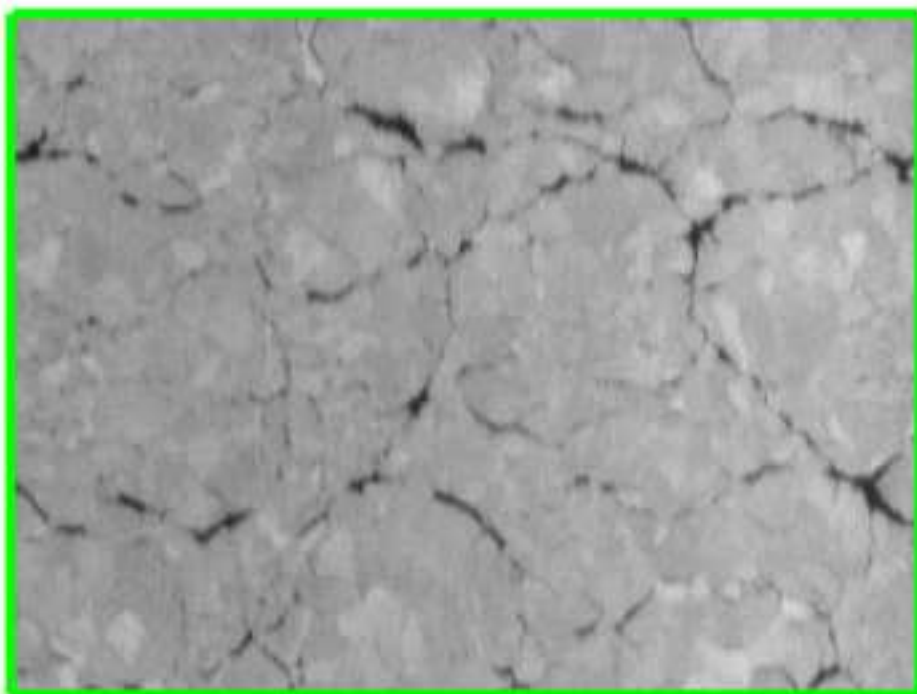
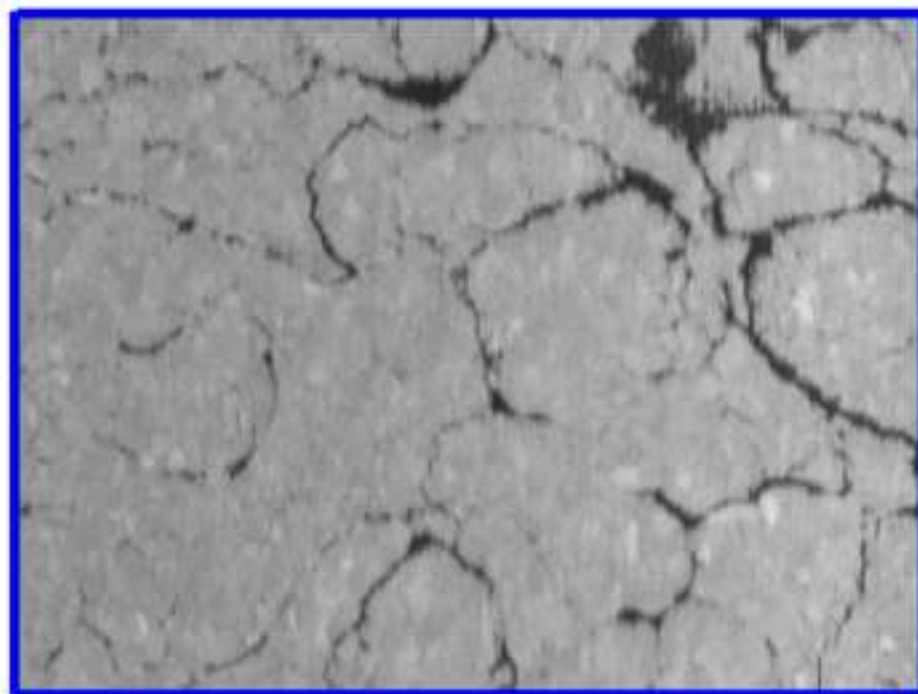
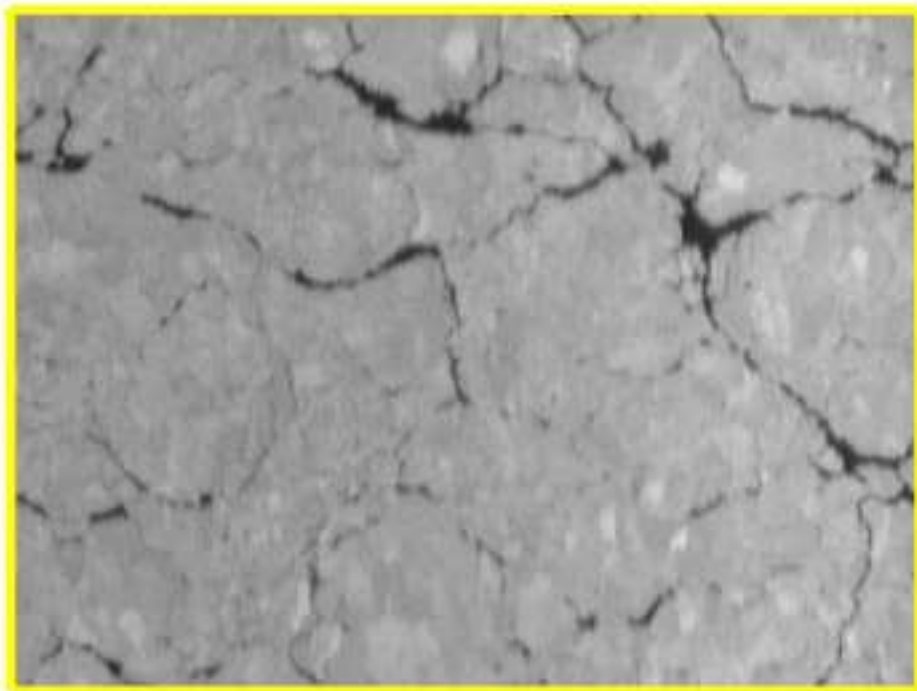
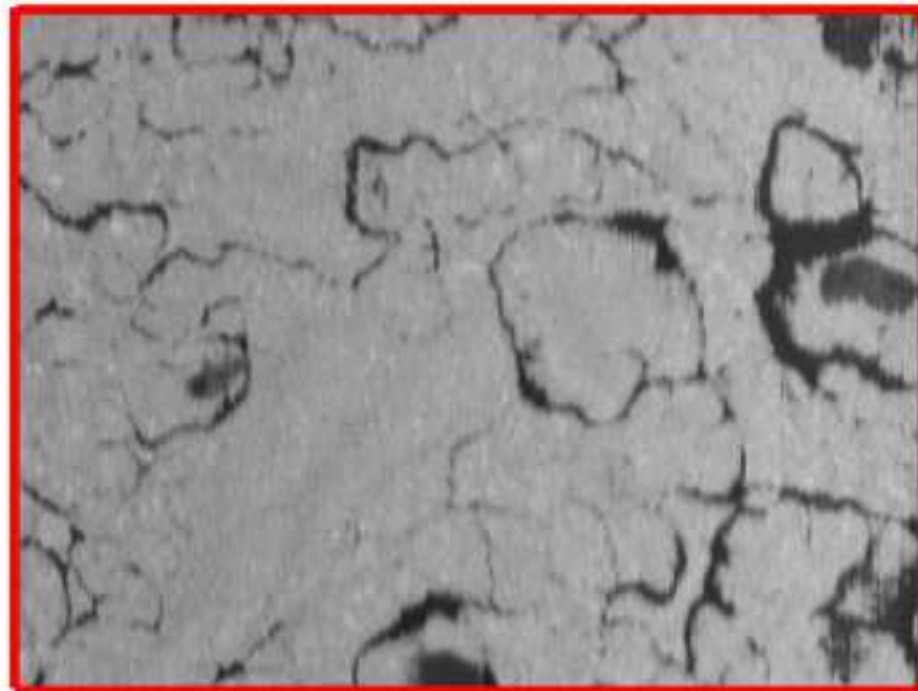
37 Figure 4: Reconstructed volume from FIB slice and view process, (a) perspective 3D view and (b) view  
38 of slices parallel to the coating plane.

48  
49 The aligned stack of BSE images is shown in Fig. 4a. Four virtual cross sections of the TC are shown  
50 in Fig. 4b. The colored lines in Fig. 4a indicate the positions of the different virtual cross sections by their  
51 colored frames. These cross sections of the ceramic coating show both the columns of the ceramic in bright  
52 gray as well as in dark gray the gaps between the columns. In the cross sections near to the BC (red and  
53 blue frame) larger dark colored areas occur in addition to the fine dark lines indicating the gaps between  
54 the columns. These areas are related to the crack system at the TC-TGO interface. The combination of  
55 all resin or air filled regions in the TC and at the interfaces within the TBC system is called voids and is  
56 estimated as one phase during the segmentation procedure described in the following. Moreover, internal  
57 porosity due to the feather-like structure of columns is visible in Fig. 3 and appears blurred in Fig. 4a.

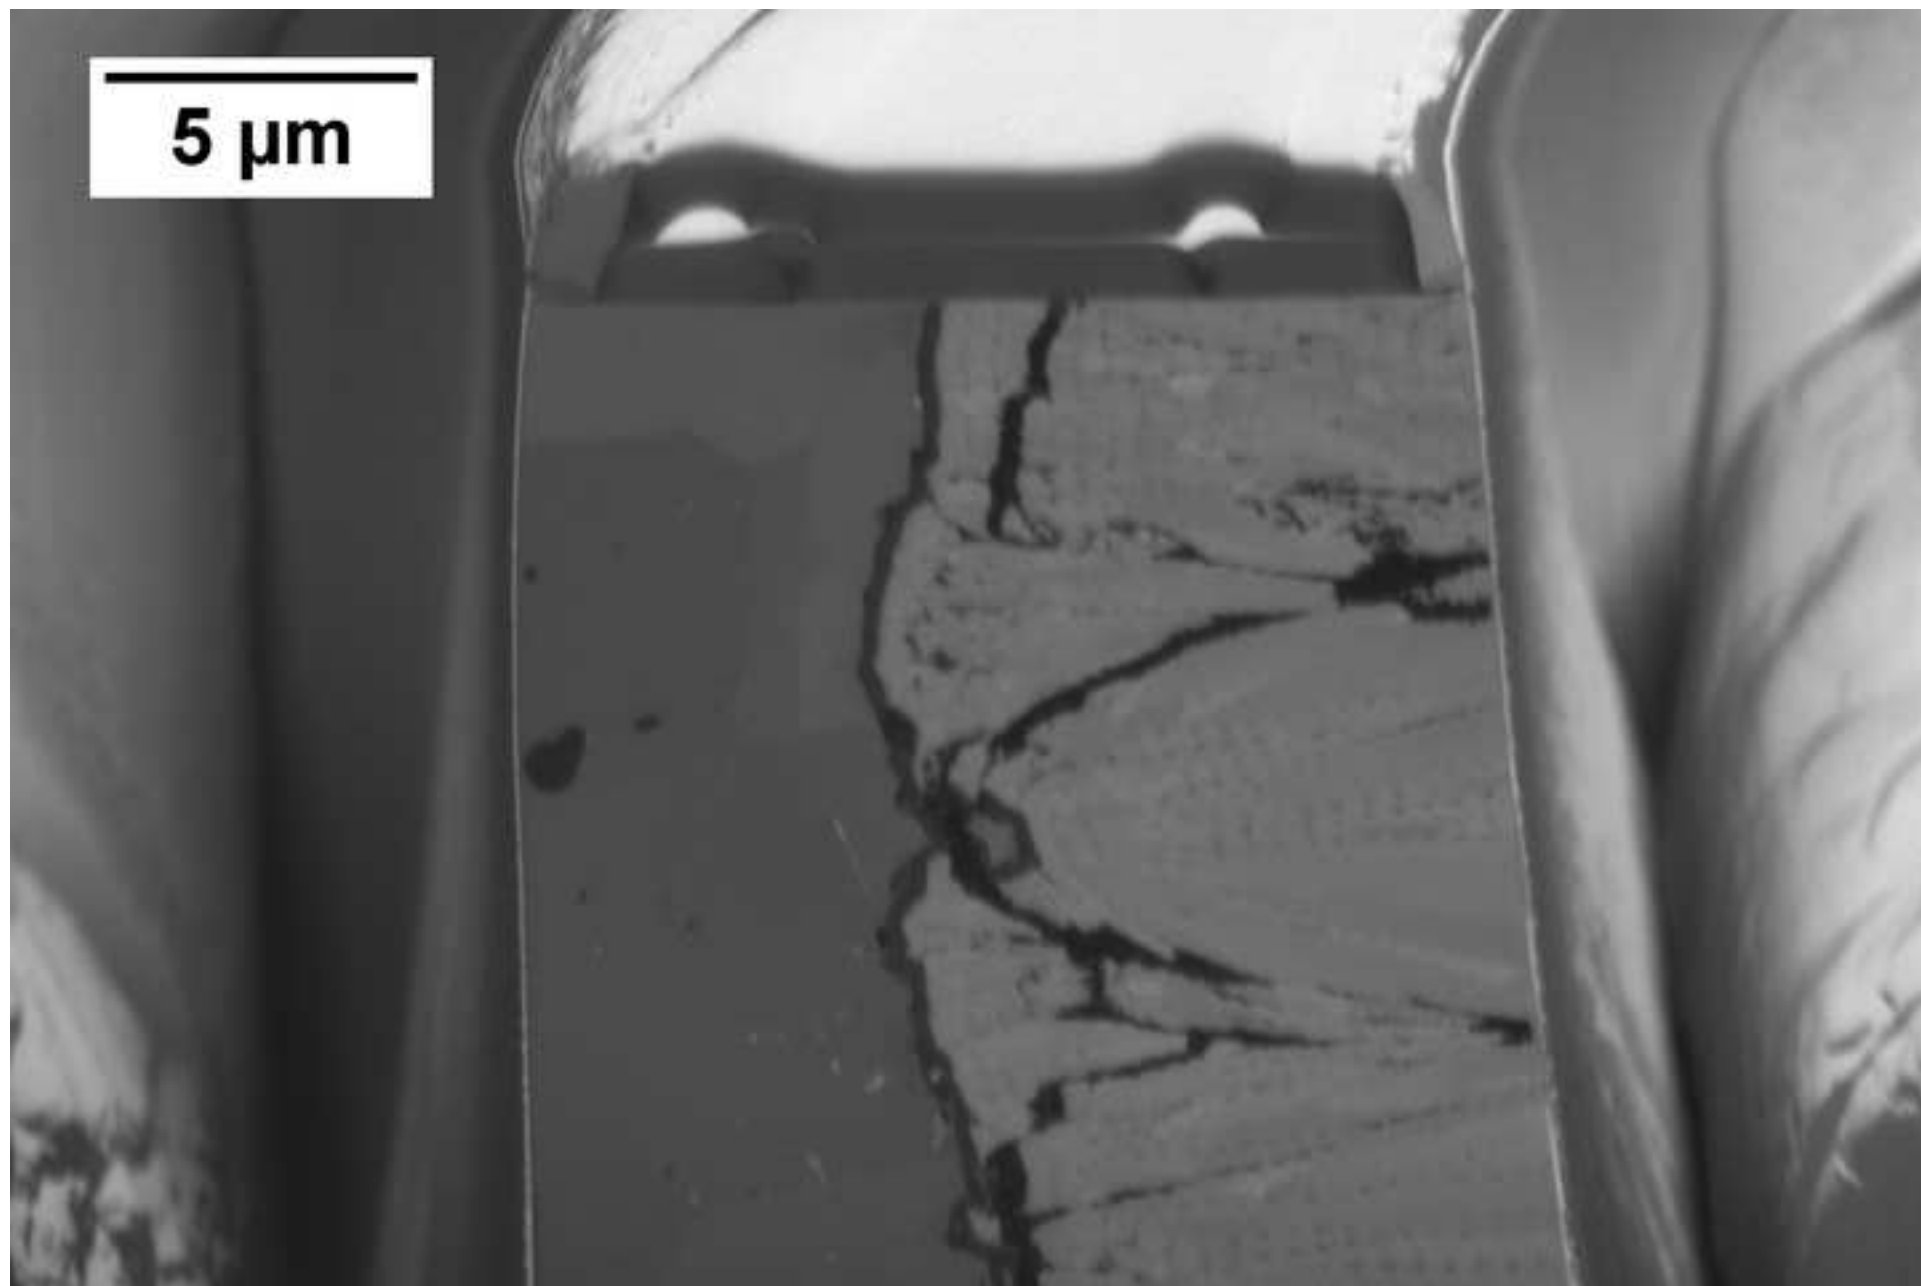
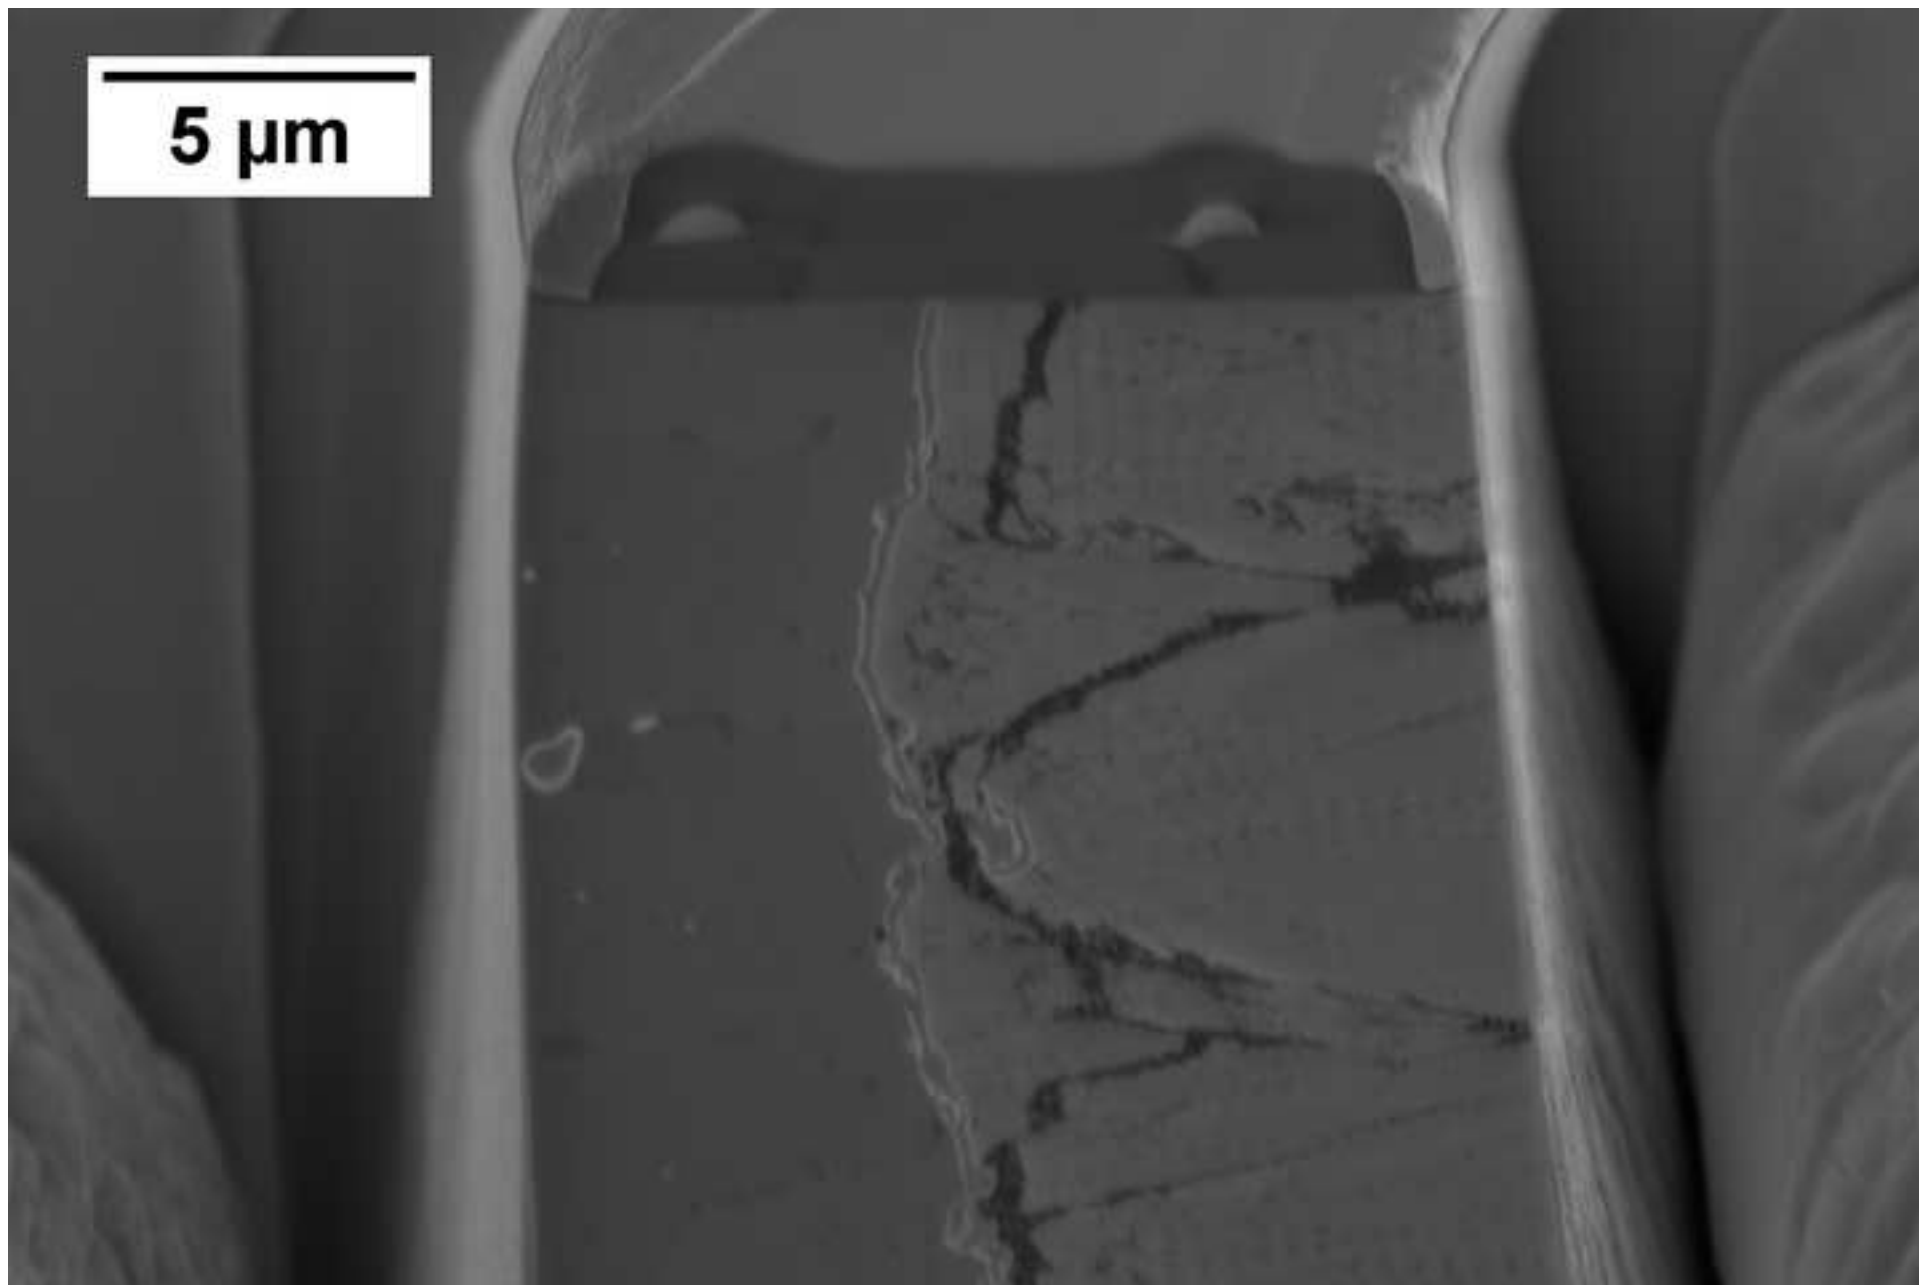
39 Figure 5: Segmentation methodology with subsequent processing steps. (a) Image stack of slices in  
40 BSE-mode (left) and SE-mode (right), (b) assigning volumes, which are dark grey in BSE and SE-mode as  
41 well to BC (in red), (c) assigning volumes shown bright in BSE and SE as well to YSZ- TC (dark blue), (c)  
42 segmentation of the remaining volume by means of the SE image into TGO (bright grey) and void (dark  
43 grey), (d) all volumes assigned (BC in red, TGO in bright blue, inter-columnar gaps in green, and the TC  
44 transparent to allow for viewing the structure of inter-columnar gaps).

7 In AVIZO [26], firstly, a three-dimensional median filter is applied to both image stacks that are loaded  
8 with a voxel size of  $20 \times 20 \times 20 \text{ nm}^3$ . Thereafter, the segmentation procedure starts, as explained in Fig.  
9 5. For the segmentation both image stacks shown in Fig. 5a are used. In a first step, the regions which are  
10 dark grey in the BSE and the SE image stack as well are assigned to BC (Fig. 5b). The second step is the  
11 assignment of the YSZ TC (Fig. 5c), which appears bright in SE and BSE mode as well. The remaining  
12 voxels have to be assigned either to TGO or to voids. In the SE image stack shown in the right part of Fig.  
13 5c, these two regions can be differentiated very well because the TGO appears as bright voxels whereas the  
14 voids appear as dark voxels. Thus, with this last step, the assignment shown in Fig. 5d is obtained. The  
15 BC is shown in red, the TGO as light blue, the voids in green, and the voxels of YSZ are left transparent to

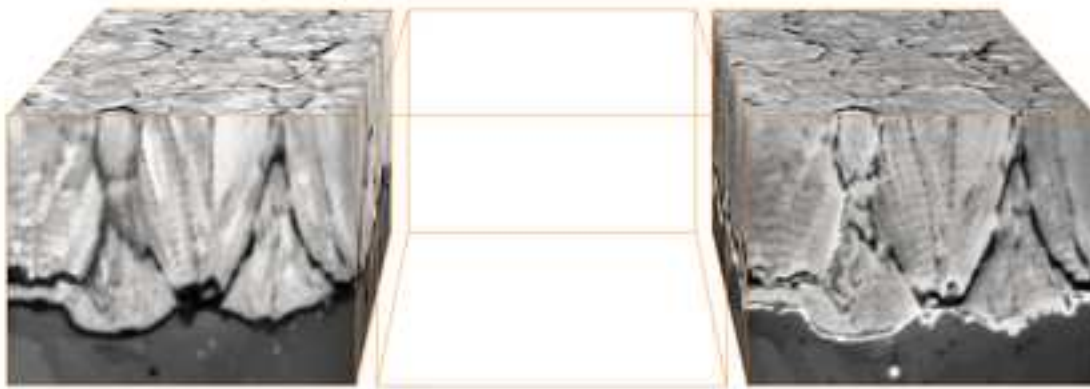
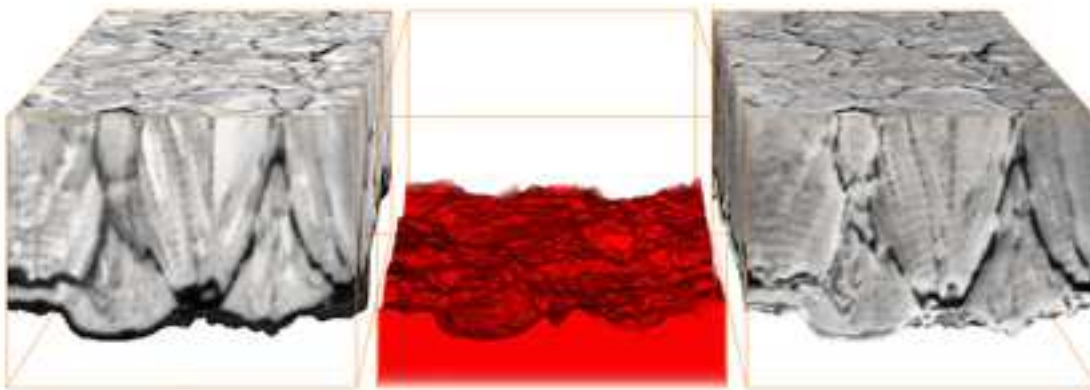
45 Figure 6: Segmented TGO (dark blue) and voids (green), (a) top-view, (b) side-view, and (c) bottom  
46 view.

20 The aim of this study is to determine precisely the shape of cracks within the complex morphology of  
21 the TBC system. It is thus straightforward to isolate the oxide layer and voids, highlighted in blue and  
22 green, respectively in Fig. 6. In the sequel top view refers to view from TC side, whereas bottom view  
23 refers to view from the BC side; consistently, above and below TGO correspond respectively to TGO/TC  
24 and BC/TGO interfaces. The side and top views show the difficulty inherent to the fact that interfacial  
25 crack and inter-columnar voids are segmented in a single phase, Fig. 6 a and b. However, at the TGO  
26 layer the interfacial crack can be discerned from the inter-columnar gaps when it is between TGO and BC  
27 (Fig. 6c) and when it is crossing the TGO layer (Fig. 6b). Assuming that the interfacial crack is mainly  
28 oriented parallel to the interface and following the crack path from the BC/TGO interface through the TGO

29 also some part of the void volume between TGO and TC can be assigned to the interfacial crack, being  
30 above (see labels 1 and 3) and below the TGO (see label 2), Fig. 6b (see also Fig. 5d). From the top-view  
31 (Fig. 6a), crack and gap areas are visible, but with different features, which can be identified if comparing  
32 different views. Some void volumes are clearly part of the interfacial crack area above the TGO (labels 1  
33 and 3), some others belong to cracks located within the TC but are oriented parallel to the interface (label  
34 4), Fig. 6a and b. Besides, the areas showing the TGO surface (blue color) represent the intact interfaces  
35 between either BC and TGO (bottom view in Fig. 6 c) or TGO and TC (top view in Fig. 6 a, label 5).  
36 Void volumes belonging to structures with planes oriented perpendicular to the interface are visible in the  
37 side view (Fig. 6b) and belong to the inter-columnar gaps. The dynamic rotation of this image facilitates

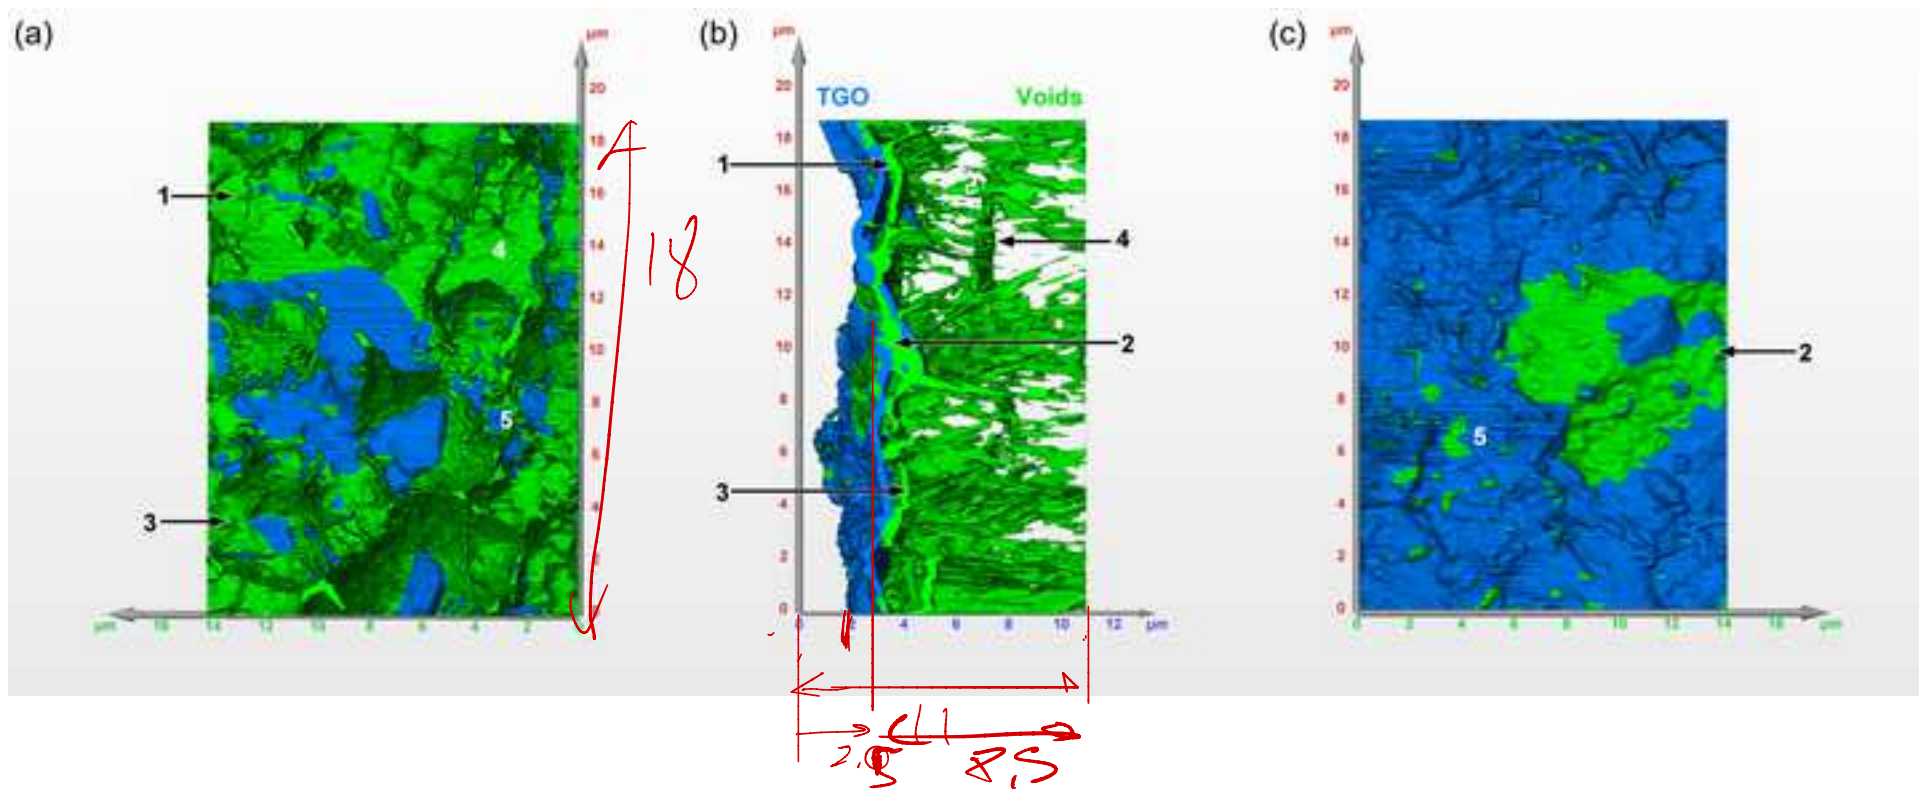
47 Figure 7: (a) Perspective view of the virtual volume achieved by FIB slice and view with TGO (dark  
48 grey) and voids (green) where sections 1 to 5 have been superimposed, (b) top-view of associated sections 1  
49 to 5, and (c) phase volume fractions along the direction of image numbering starting from the BC towards  
50 the TC.

44 The chosen approach for a quantitative characterization of the interfacial region and especially the crack  
45 system is described in Fig. 7. The segmented volume is shown in Fig. 7a using the same colors as before  
46 (Fig. 5 and 6) and further the positions of the virtual cross sections are given which are shown in Fig. 7b.  
47 In the sections the ceramic coating is represented as dark grey area. In addition, Fig. 7a displays an arrow  
48 indicating the numbering direction of the cross section images. The first images to be analyzed are located  
49 at the bottom of the volume; they contain completely the BC phase. But, already in virtual cross section #  
50 1, shown in Fig. 7b, fractions of TGO and void phase are visible. The virtual cross section #2 contains all  
51 four phases that were assigned before. The virtual cross section #3 shows the YSZ as dominant phase, but  
52 also some voids are visible due to the inter-columnar gaps in the TC. A phase fraction analysis of all single

53 virtual cross sections is processed to get quantitative information from this 3D image. A plot showing the  
54 phase fractions as function of the location represented by the image number is presented in Fig. 7c, using  
55 red, blue, dark grey and green as in Fig. 7a and b. Near to the bottom plane of the reconstructed volume,  
56  
57

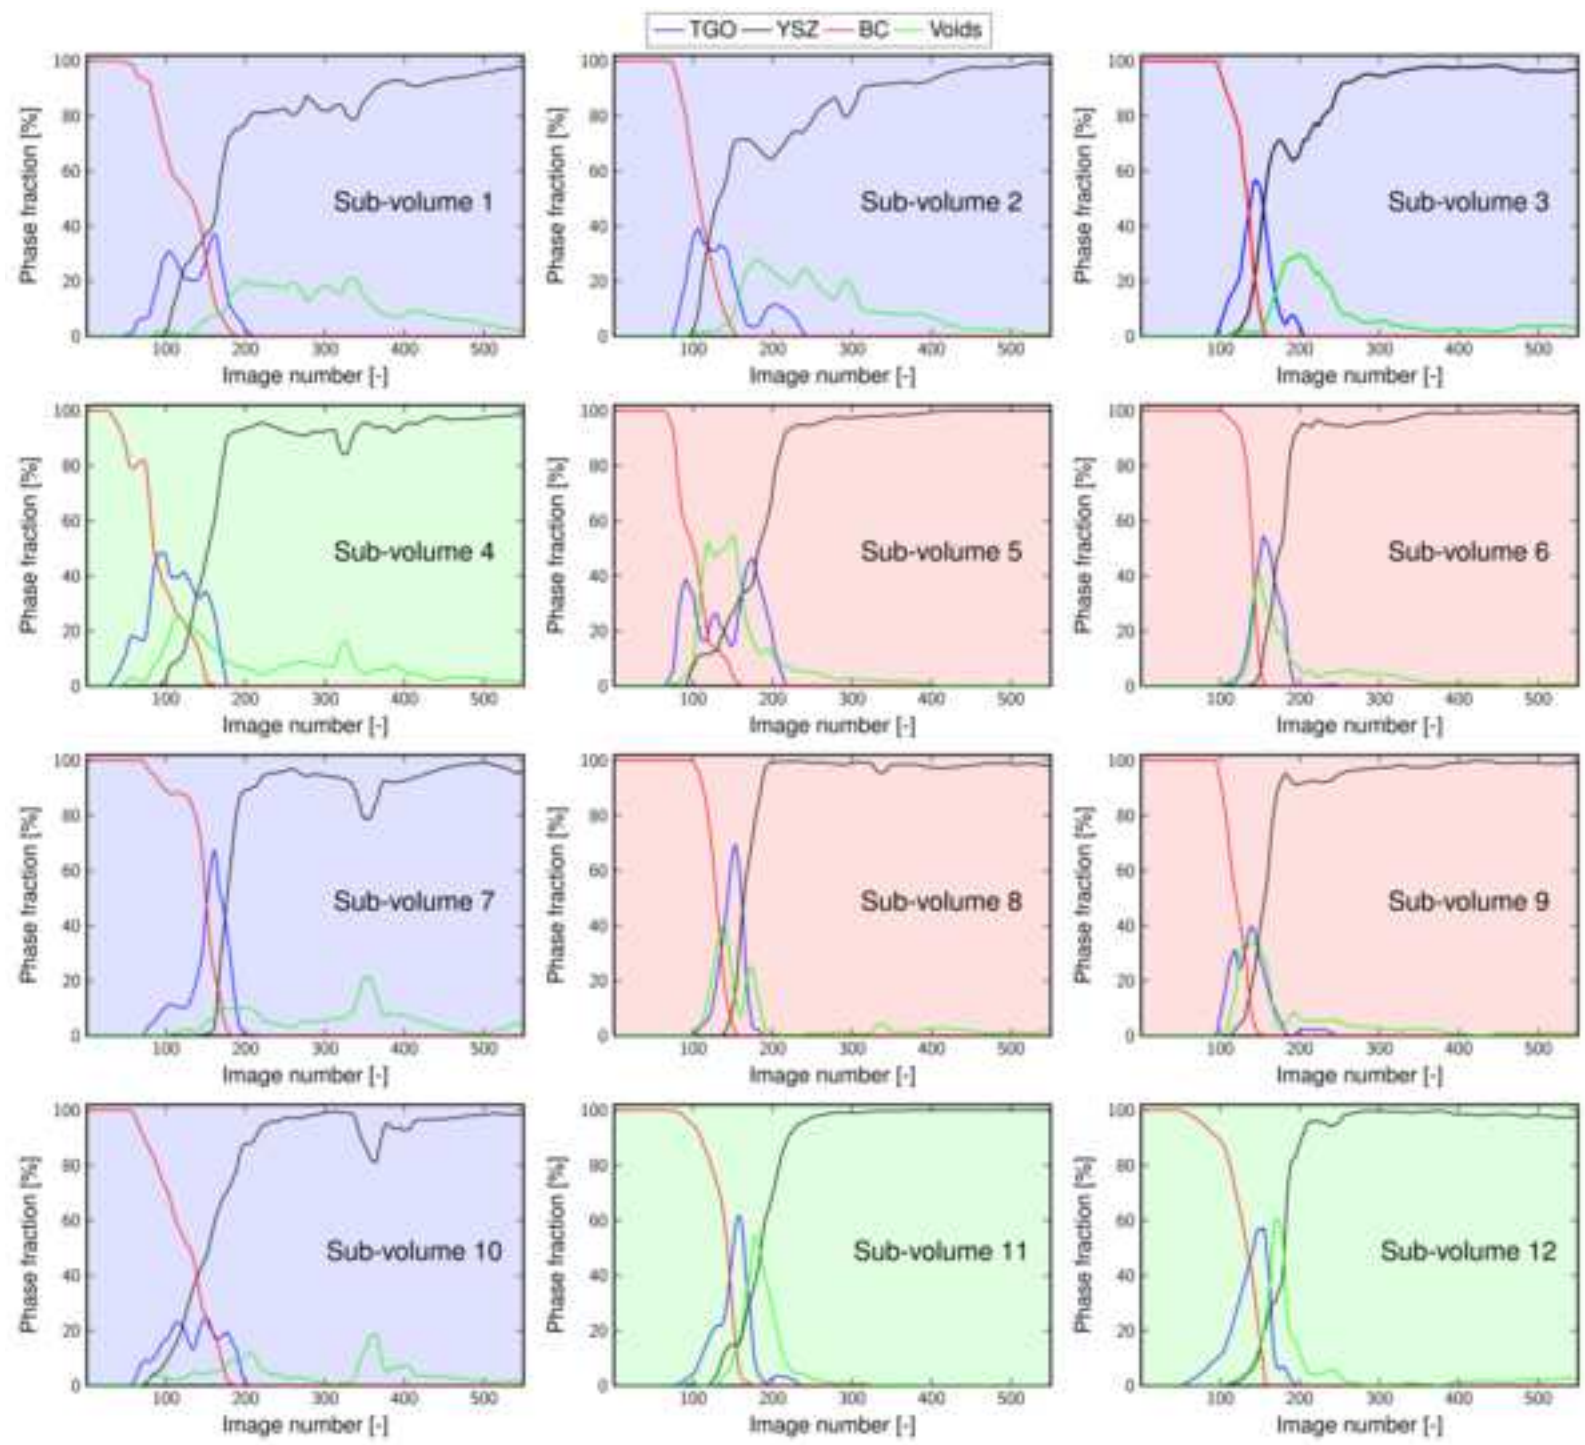
Figure 9

53 Figure 9: Phase fraction analysis as derived from the 12 sub-volumes of the FIB-sliced volume as displayed  
54 in Fig. 8 with image numbering starting in each diagram from BC towards TC. The sub-volumes are assigned  
55 to three groups (compare Fig. 10), indicated by colored background: group 1 with red background (sub-  
56 volumes 5, 6, 8, 9), group 2 with green background (sub-volumes 4, 11, 12), and group 3 with blue background  
57 (sub-volumes 1, 2, 3, 7, 11).

28 The plots of the single sub-volume show significant differences, which are not discernible if the entire  
29 volume is evaluated. For example, in four sub-volumes the maximum of crackVoid volume fraction occurs  
30 more close to the BC than the respective maximum of the TGO phase, indicating interfacial crack at the  
31 BC/TGO interface, while by averaging only the presence of some crack volume before considerable volume  
32 fraction of TC material occurs, indicates cracking either at the BC/TGO interface or within the TGO. In  
33 different sub-volumes also the width of the volume fraction distribution of crackVoid and/or TGO can differ  
34 significantly, providing quantitative information on the amplitude of interface roughness. Further, some  
35 plots in Fig. 9 display isolated maxima of void volume within in the TC corresponding with a minimum  
36 of YSZ (sub-volumes 1, 2, 4, 7, and 10). These maxima can be associated to cracks parallel to the coating
