# Three-Dimensional Characterization of Cracks in a Columnar Thermal Barrier Coating System for Gas Turbine Applications

Anne Dennstedt, Fabrice Gaslain, Marion Bartsch, Vincent Guipont, Vincent Maurel

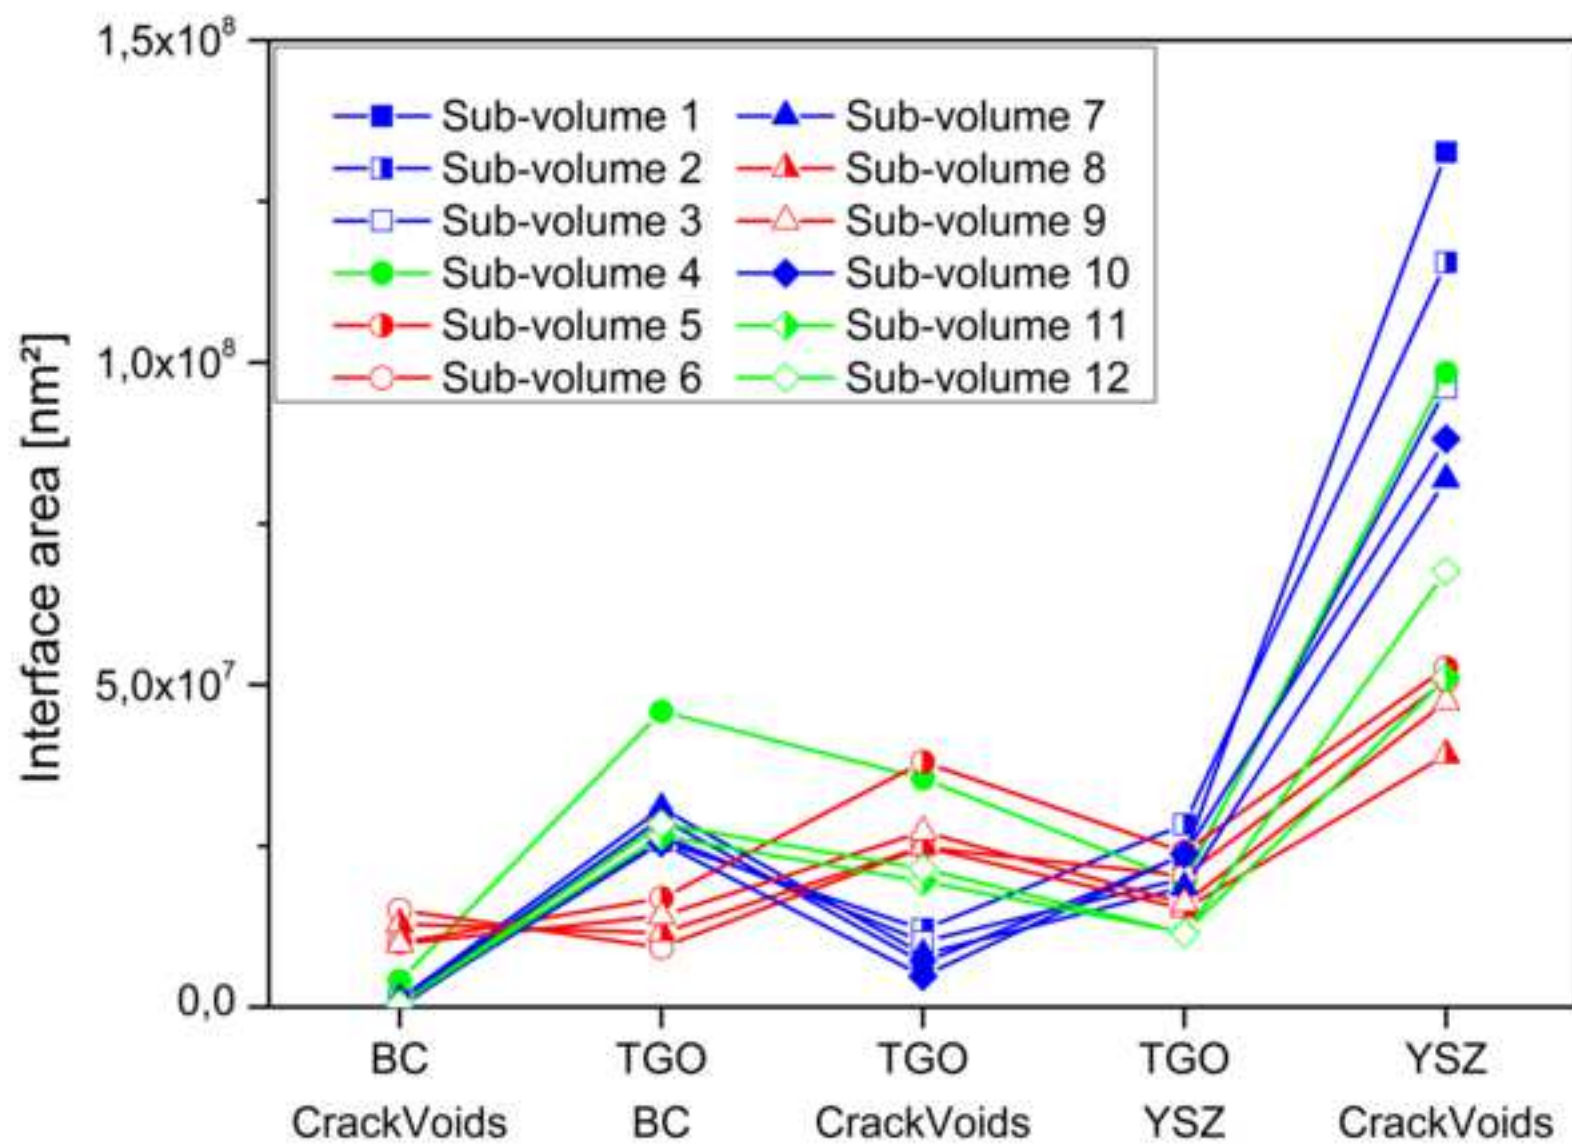
1  
2  
3  
4 Figure 10: Fractions of different interface areas in the sub-volumes of Fig. 8. Due to characteristics in the  
5 distribution of interface area fractions, 3 groups of sub-volumes were defined as indicated by the colors. The  
6 same colors are used as background color in Figure 9 indicating to which group the respective sub-volume  
7 belongs.

39 For analyzing the path of delamination cracks, the interfacial region along BC/TGO and TGO/TC  
40 interfaces is characteristic while contact areas between voids and the YSZ of the TC can either be part of an  
41 interfacial delamination crack or part of the inter-columnar gaps within the TC. Focusing on the interfacial  
42 region, four phases are involved, BC, TGO, YSZ (TC), and crack. Due to the layered structure of the  
43 coating system five types of interface can emerge between these four phases: BC-CrackVoids, BC-TGO,  
44 TGO-CrackVoids, TGO-YSZ, and YSZ-CrackVoids. The area of the different interfaces can be extracted  
45 from the respective virtual sub-volume. In Fig. 10 the different interface areas of all sub-volumes are  
46 summarized. By comparing the areas and fractions of their different interface types the sub-volumes can be  
47 assigned to three groups: (1) considerable fraction of cracks between BC and TGO with correspondingly

48 reduced intact interface area between BC and TGO (sub-volumes 5, 6, 8, and 9); (2) no considerable cracking  
49 between BC and TGO but between TGO and YSZ (sub-volume 4, 11, and 12); (3) no considerable cracking  
50 neither between BC and TGO nor between TGO and YSZ but contact areas between YSZ and voids (sub-  
51 volumes 1, 2, 3, 7, and 10). As mentioned before, comparing the interfacial areas between YSZ and voids  
52 provides limited information about the interfacial crack path, since the ceramic TC has a priori a large  
53 interface to CrackVoids because of its columnar microstructure. However, it is eye-catching that in group  
54 one the interfacial area between YSZ and CrackVoids is relatively small. In Fig. 10 the graphs belonging to  
55 one group are plotted in the same color, and assignment of sub-volumes to these three groups is highlighted  
56 by associated background colors in the plots of Fig. 9. The results derived from the phase fraction analysis

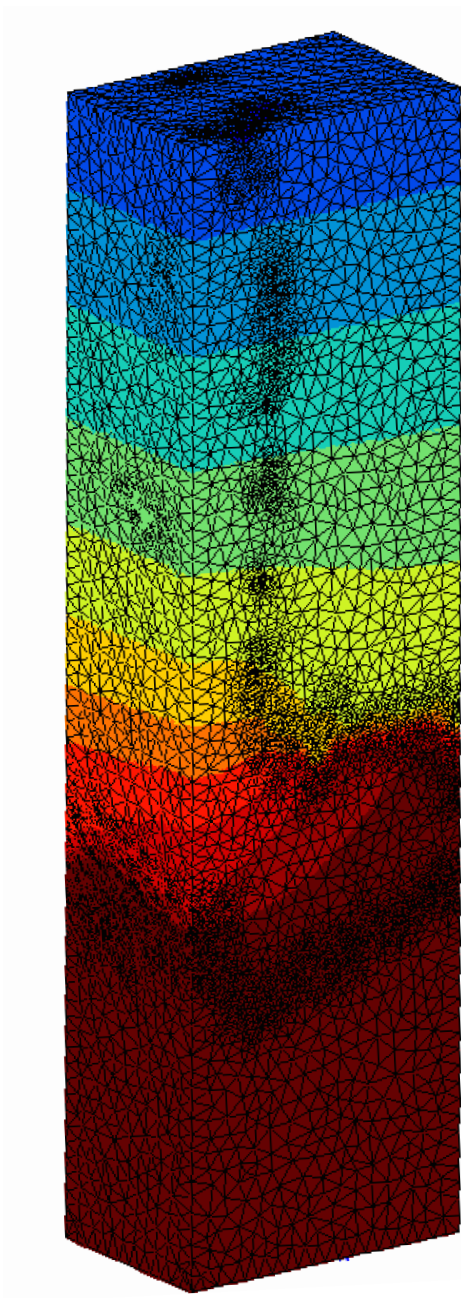
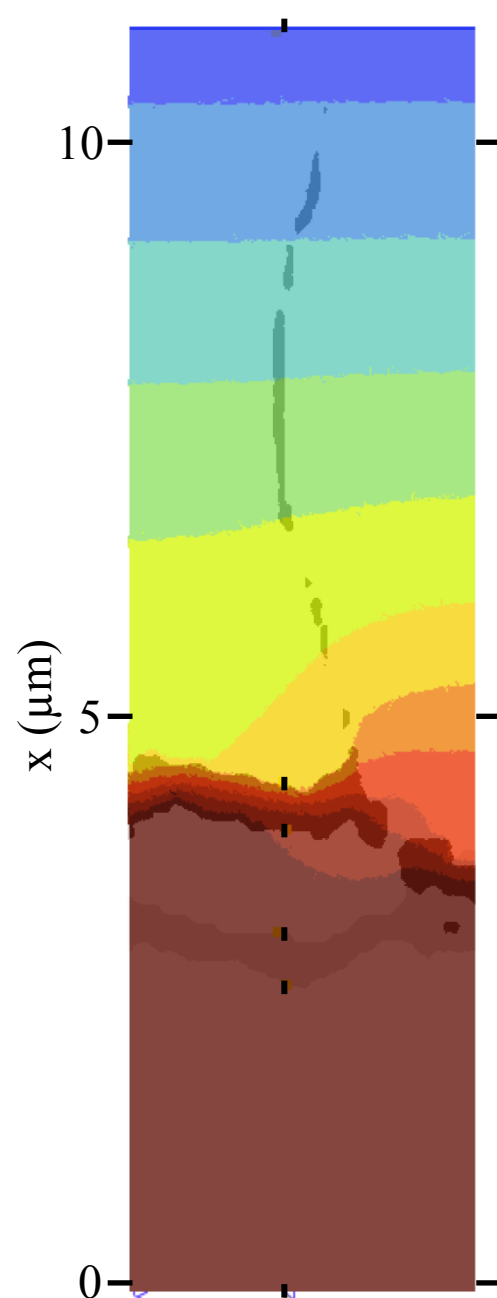
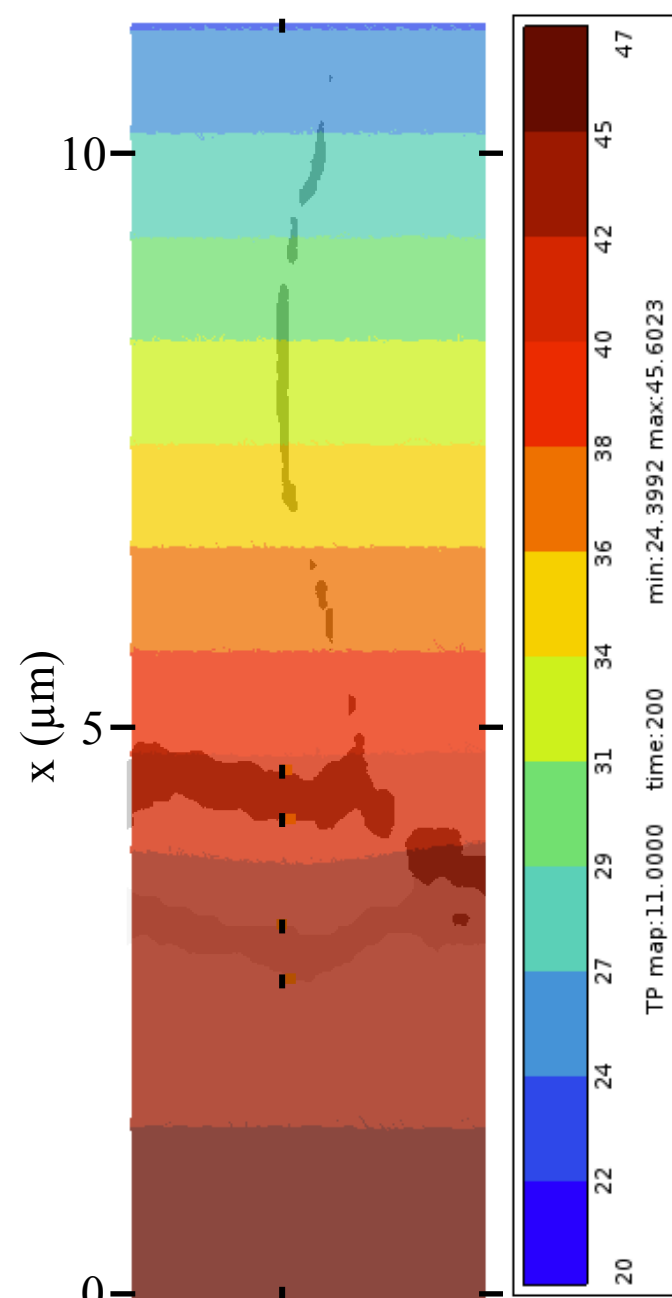
8 Figure 11: (a) Meshed FE-Model of a sub-volume from the virtual volume extracted by FIB slice and  
9 view process with an overview of the temperature distribution for case A / IRT condition, (b) vertical slice of  
10 the model showing the temperature field for the case of air filled voids (interfacial cracks and inter-columnar  
11 gaps in the TC) superposed to the element sets in the mesh corresponding to (from the bottom to top) BC,  
12 TGO, crack, and YSZ with vertical gap, (c) the same vertical slice but the temperature field corresponding  
13 to the case of YSZ filled cracks and gaps.

1  
2  
3 summarized in Table 2. Two cases have been analyzed. Case A / IRT condition corresponds to the condition  
4 used for infrared thermography (IRT): at the BC heat flux is prescribed with an external temperature ( $T_e$ )  
5 set to 50 ° C, whereas the TC side is cooled to RT and  $T_e$  set to 20 ° C. Case B / HT condition corresponds  
6 to representative high temperature gradient condition for internally cooled components: at the TC side heat  
7 flux is prescribed with  $T_e$  set to 1000 ° C, whereas at the BC side  $T_e$  is set to 700 ° C. Cases A and B have  
8 been modeled using distinct thermal properties for each phase, BC, TGO, YSZ, and voids, including cracks  
9 and inter-columnar gaps considered as air, referred as to "Voids" in the sequel. For case A / IRT condition,  
10 the resulting temperature field shows that the presence of the complex interfacial crack strongly modifies

11 the thermal flux (Fig. 11a). The most affected zone appears to be the ceramic TC layer, whereas the  
12 higher conductivity of the metallic BC leads to a short range influence of interfacial defect. For the chosen  
13 sub-volume, the amplitude of interface roughness is about 1.3  $\mu\text{m}$ . The area of thermal flux modification  
14 is about 2.8  $\mu\text{m}$  in height, for a crack opening of about 200 nm. To get more into details, cases A and B  
15 have been analyzed along a set of points crossing each layer (BC, TGO, crackVoids, and TC), highlighted  
16 in black in Fig. 11b and c. The temperature field calculated for case A is displayed in Fig. 12b. Besides,  
17 for comparison purpose, cases A and B have been modeled using distinct thermal properties for each phase,  
18 BC, TGO, and YSZ, but considering cracks and inter-columnar gaps as YSZ, referred as to "Filled". For  
19 Filled condition, the obtained gradients correspond to a reference case where temperature gradients arise

20 from bulk properties of each phase, BC, TGO, and YSZ for case A and B thermal tests. Fig. 11c displays  
21 the temperature field for the case A with "filled condition". In this case, the transition of thermal properties  
22 within the TGO slightly modifies the iso-lines of temperature, but they remain almost parallel to each other.  
23 In the presence of voids, a considerable temperature jump is evidenced when crossing the crack and smaller  
24 temperature jump when crossing the TGO, for both cases A and B, compare Fig. 12a and b, respectively.  
25 Besides, it appears that the thermal inertia is modified by the presence of voids, since the temperatures at  
26 top and bottom of the model are slightly modified increasing the global temperature difference in presence  
27 of a crack. In case B / HT condition, the TC is globally hotter in presence of a crack than considering the  
28 filled condition, Fig. 12b. This is consistent with an acceleration of HT damaging when interfacial cracking

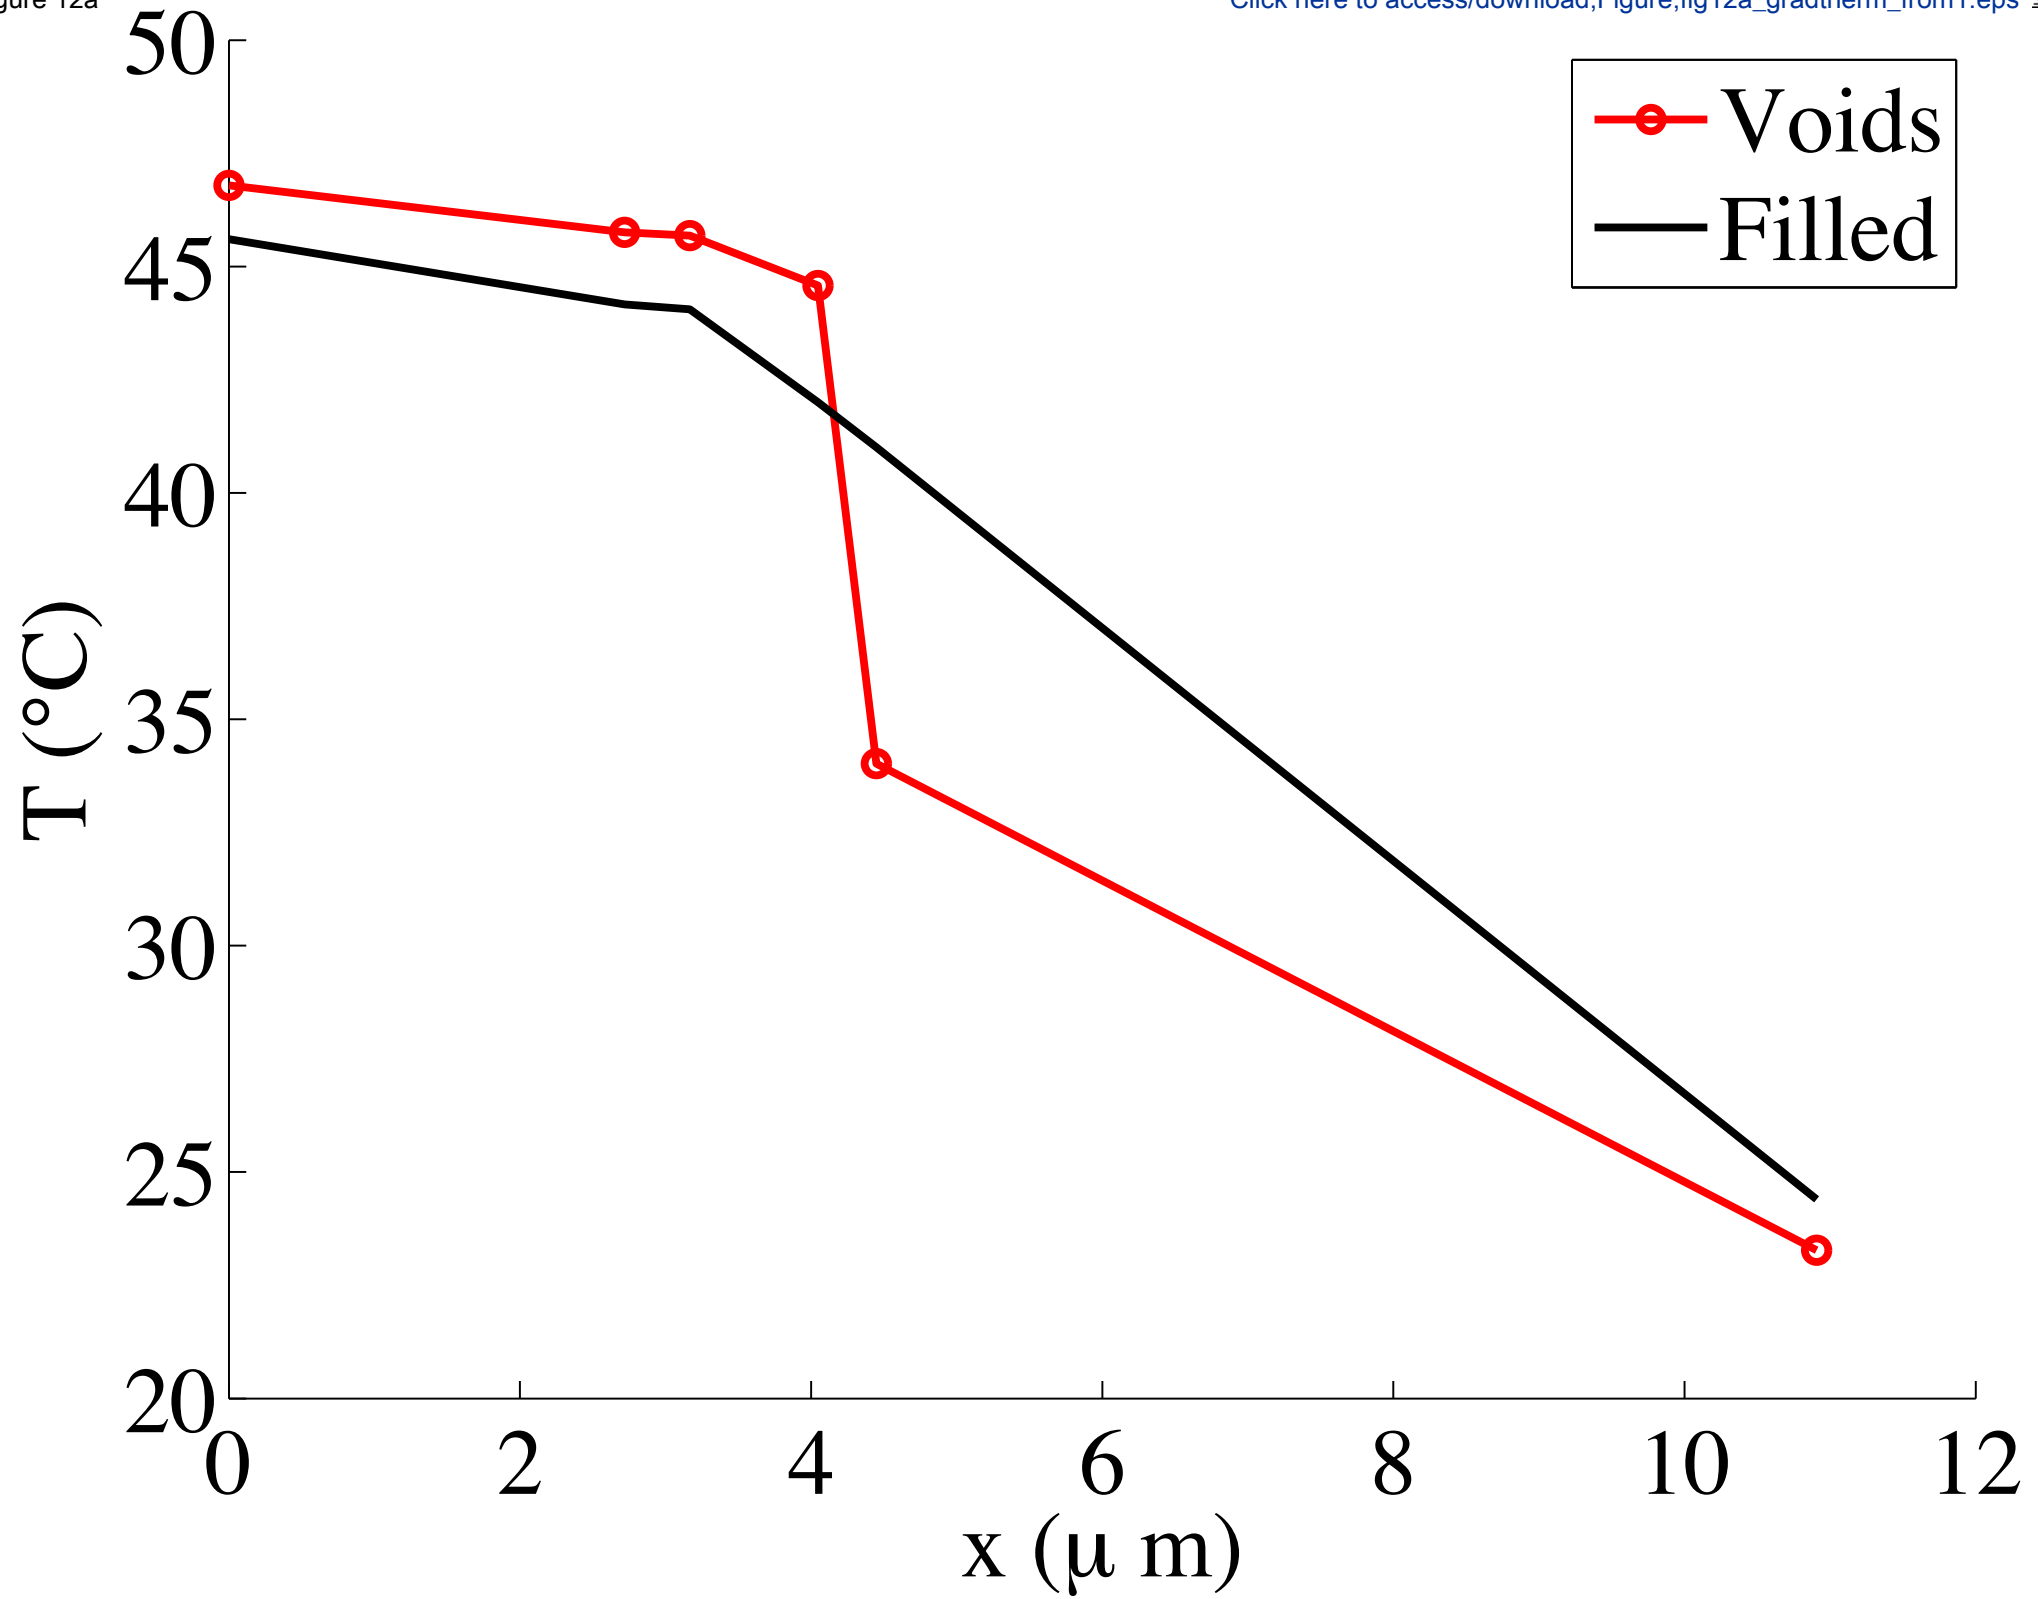
Figure 12a

14 Figure 12: Temperature evolution from FEA extracted along a vertical line at points highlighted in black  
15 in Fig 11(b) and (c); (a) temperature distribution for case A / IRT condition, (b) temperature distribution  
16 for case B / HT condition. "Voids": air properties in voids and "Filled": YSZ properties in voids  
17
