## Geology, Engineering & Humanities: 3 sciences behind the Malpasset dam failure (France, Dec. 2, 1959)

P. Duffaut, Justin Larouzée

P. Duffaut, Justin Larouzée. Geology, Engineering & Humanities: 3 sciences behind the Malpasset dam failure (France, Dec. 2, 1959). Quarterly Journal of Engineering Geology and Hydrogeology, In press, 10.1144/qjegh2018-186 . hal-02278064

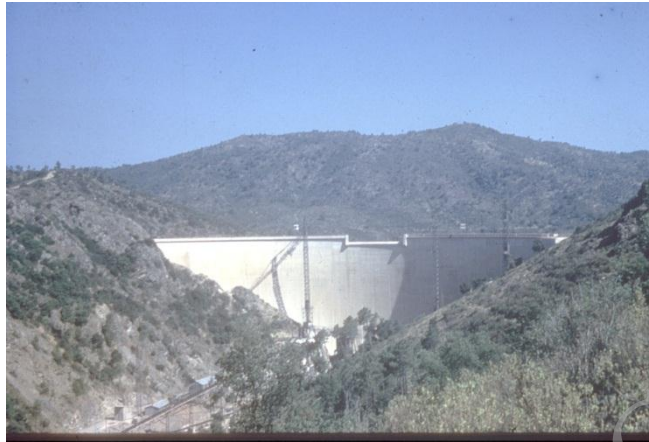
Fig. 1. *Downstream view of Malpasset dam close to end of construction: the thrust block appears at right (on the left bank), the spillway weir in the centre (photo COB, summer 1954)*

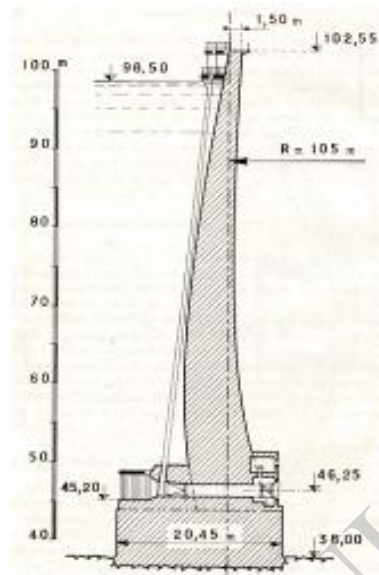
The dam was made of 16 cantilevers separated by 15 joints. The thrust block was comprised of two more monoliths. In order to leave a passage for the river flow during the construction works, the base of a joint was widened; a bottom valve was provided to control the reservoir's level through the central cantilever (Fig. 4).

Fig. 4. Vertical section of the dam along cantilever IJ; the foundation block is thicker to encase the conduit of the bottom valve and its control cabinet downstream (at right)

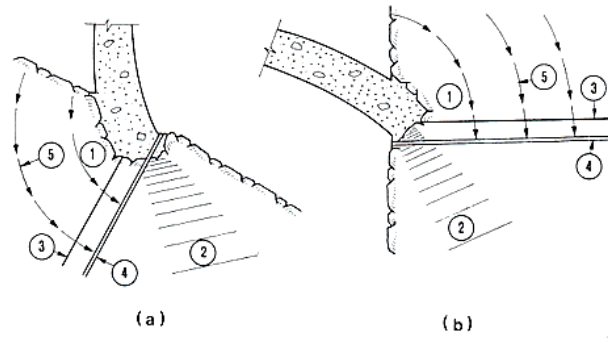
Pierre Habib suspected the permeability of this rock could be sensitive to compression by the thrust of the dam. He tested the radial permeability and found its variation with stress was very high, far more than for any other rock tested the same way (Habib, 2010). Immediately, this unsuspected property was ascribed as the main cause for the failure, as it could build a deep underground barrier below the dam, upon which an extended water head could push upwards the dihedron (see below, Fig. 14 & 17).

Fig. 14. Vertical (a) and horizontal (b) cross-sections of arch dam rock foundation showing 1 flow lines; 2 compressed zone; 3 grout curtain; 4 drainage curtain (after Londe and Sabarly, 1966).

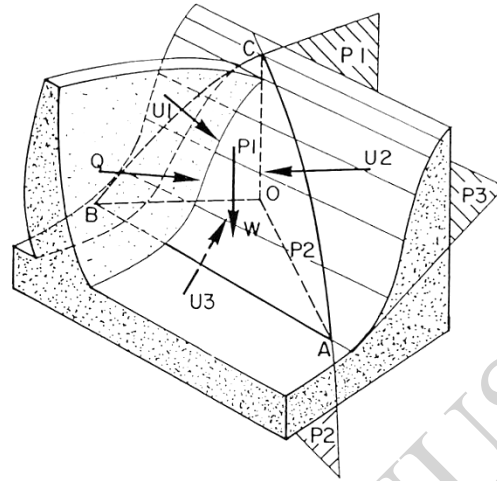
André Coyne having died a few months after the failure, the task of researching deeper and deeper on dam foundations is taken by Pierre Londe, a clever engineer of the Bureau Coyne & Bellier who was later to chair the International Commission of large dams. Londe began to discuss the position of classical drainage and grout curtains (Fig. 14, Londe et Sabarly, 1966) and devised a method to check the stability of mega blocks just under the dam (Fig. 15, Londe, 1973). Together with Pierre Habib, he launched four PhD in connexion with Ecole

Fig. 15. Scheme of the forces acting on a tetrahedral rock block in the abutment of an arch dam: planes  $P_1$   $P_2$   $P_3$  limit block ABC, block weight  $W$ , dam thrust  $Q$ , uplift pressures  $U_1$   $U_2$   $U_3$  (after Londe 1973)

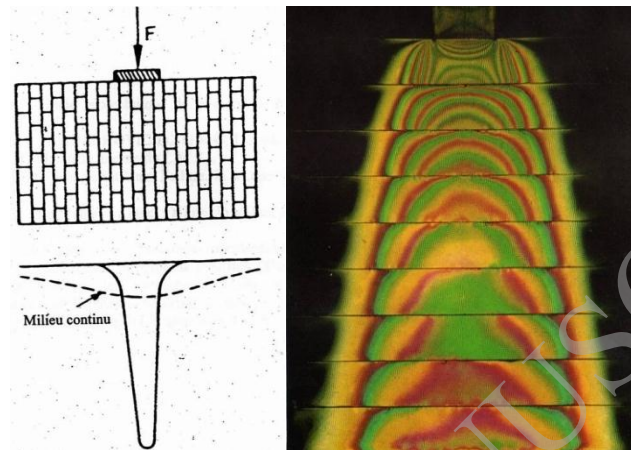
Polytechnique and various universities; Claude Louis worked at Karlsruhe, Germany, under Prof. Mueller, on water flow in rock mass fissures (Louis, 1968); Bernard Schneider worked at Grenoble on analysis of seismic signal (so called method “petite sismique”, 1967); Jean Bernaix (1967) and Vincent Maury (1973) worked at Polytechnique, on laboratory and model tests, the latter through photoelasticity (Fig. 16). Within less than 10 years Rock Mechanics had made tremendous progress!

Fig. 16 Stress distribution under a punch; left on brickwork models by Bernaix; right, through photoelasticity by Maury (no friction between horizontal planes)
