# Local crack arrestability and deformation microstructure evolution of hydrogen-related fracture in martensitic steel

Akinobu Shibata, Ivan Gutierrez-Urrutia, Akiko Nakamura, Taku Moronaga, Kazuho Okada, Yazid Madi, Jacques Besson, Toru Hara

Akinobu Shibata, Ivan Gutierrez-Urrutia, Akiko Nakamura, Taku Moronaga, Kazuho Okada, et al.. Local crack arrestability and deformation microstructure evolution of hydrogen-related fracture in martensitic steel. *Corrosion Science*, 2024, pp.112092. 10.1016/j.corsci.2024.112092 . hal-04563097

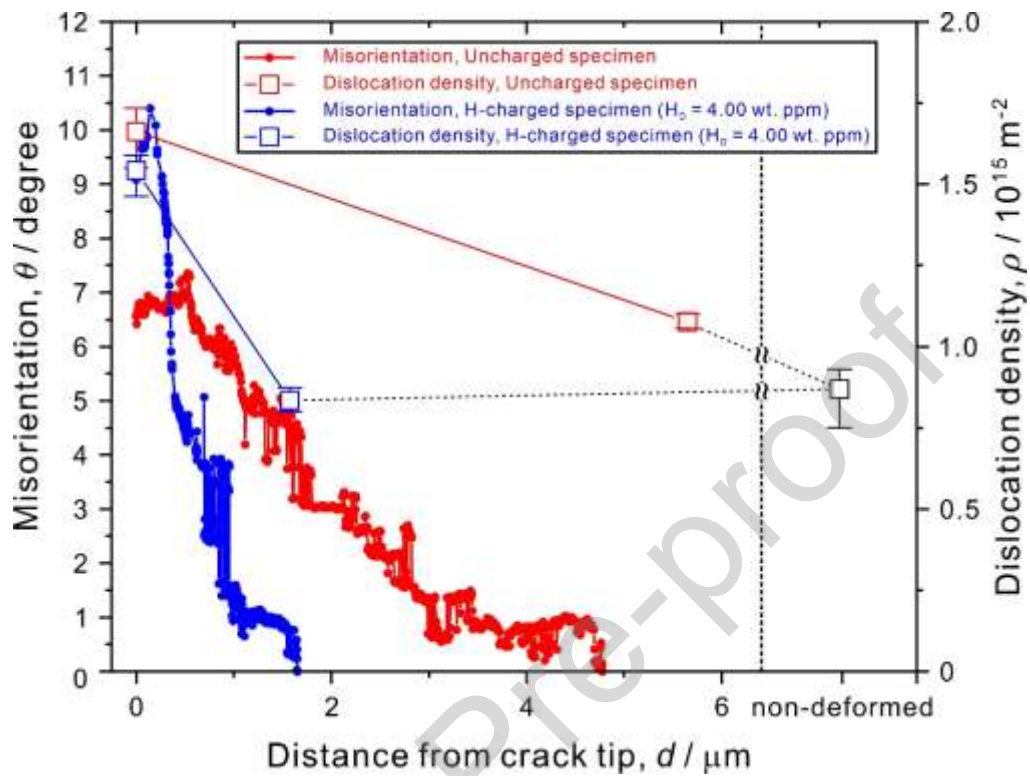
**Figure 13** Local misorientation and dislocation density plotted as a function of distance from the crack tip in the uncharged specimen (red) and the hydrogen-charged specimen with  $H_D = 4.00$  wt ppm (blue).
