USE OF ACOUSTIC EMISSION TO DISCRIMINATE DAMAGE MODES IN CARBON FIBRE REINFORCED EPOXY LAMINATE DURING TENSILE AND BUCKLING LOADING

P. Nimdum^{*}, J. Renard

Centre des matériaux P. M. Fourt, Mines-Paris Tech, CNRS UMR 7633, BP 87, F-91003 Evry cedex *pongsak.nimdum@mines-paristech.fr

Keywords: acoustic emission, buckling loading, damage mechanisms

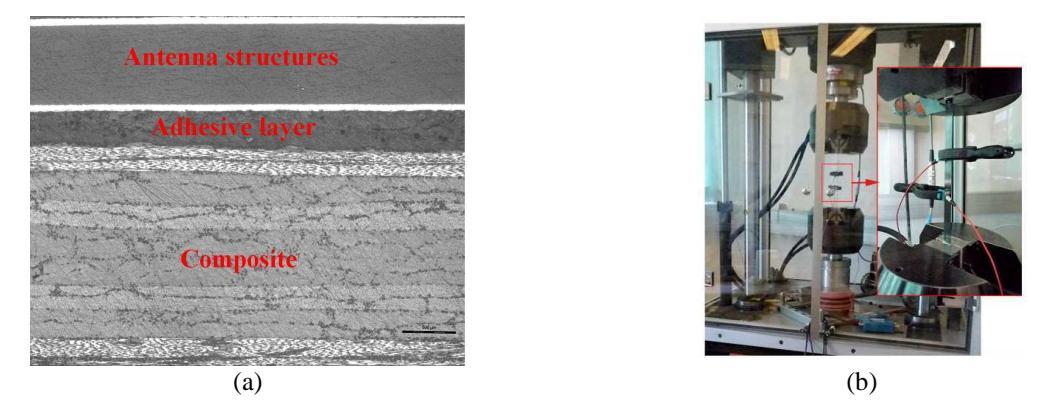
Figure 1. (a) Composite-antenna-structures and (b) experimental setup in tensile loading

In this study, two types of material have been investigated: composite material, compositeantenna-structure. First, the composite material was carried out on carbon (T700)/epoxy (M21). The density of carbon fibre is 1.8 g/cm3 and that of the epoxy resin is 1.2 g/cm3. The volume fraction of carbon fibre was 58%. All of the specimens in tensile test of (0°_8) , (90°_8) , (45°_8) , $(0^{\circ}_{2,\pm}90^{\circ}_{2})_s$, $(90^{\circ}_{2,0},\pm20^{\circ}_{2})_s$, $(90^{\circ}_{2,\pm}45^{\circ}_{2,0},0^{\circ}_{2})_s$ and $(0^{\circ}_{2,\pm}45^{\circ}_{2,9},90^{\circ}_{2})_s$ laminated with 0.125 mm for one ply thickness were $20x250 \text{ mm}^2$. Each of these types is expected to generate preferentially certain damage modes during applied loading: fibre breakage, debonding between fibre and matrix, matrix cracking, delamination. All of the specimens were cut from plates $(300x300 \text{ mm}^2)$ using a diamond wheel saw. The specimens were used aluminium tab in order to reduce the signal from the gripe during loading. In the same manner as tensile test, the similar dimension of $(0^{\circ}_{2,\pm}45^{\circ}_{2,}90^{\circ}_{2})_s$ laminated without aluminium tab was perform in buckling test. A second material was the composite-antennastructure. This material compose of $(0^{\circ}_{2,\pm}45^{\circ}_{2,}90^{\circ}_{2})_s$ laminated and antenna system (metamaterial) (Fig. 1(a)). The similar dimension as the tensile test was studied to subject to buckling loading.

First, the composite tensile tests were performed at room temperature using hydraulic machine with low crosshead speed (0.2 mm/min) in order to avoid the saturation of EA system. Step loading was performed by using CDD camera and two sensors Micro-80 of AE with 60 mm distance in order to monitor progressive damages accumulation (Figure 1(b)). A continuous loading was also performed to investigate the loading effect condition. Before each test, the edges of specimens were polished.

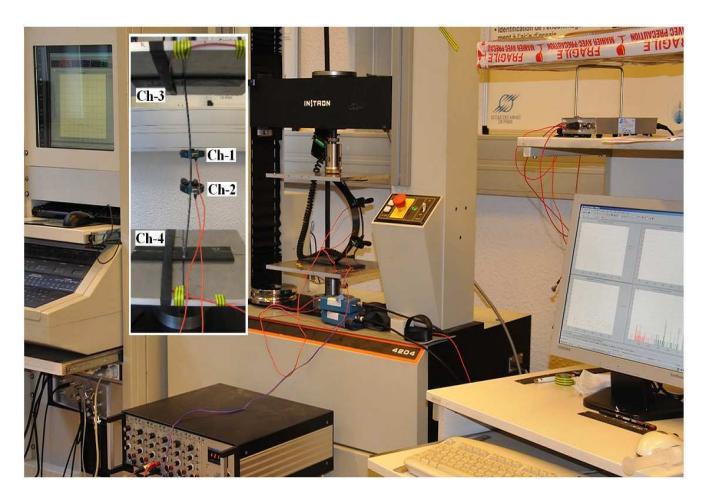
Figure 2. Experimental setup in buckling loading

In case of bending loading case, buckling tests were performed in order to avoid parasite signals due to contact load point during three or four point bending flexural test. When specimen is subjected to longitudinal forced, it will suddenly shift to one side and buckle before attaining the admissible compressive strain (Figure 2). Besides, the rubber plate was mounted on metal plate to reduce the parasite noise due to contact load point. In the similar manner with bending loading, the buckling test occur one side of specimen in tensile and another side in compression. Buckling test in composite and composite-antenna-structures specimens were performed with cross-head speed 1 mm/min with four sensors of Micro-80. Two sensors (Ch-3 and Ch-4) mounted on rubber material nearly the end of specimen were used to detect signal due to the friction between the specimen and rubber material. While two sensors (Ch-1 and Ch2) were used to detect the AE events of damage developed.

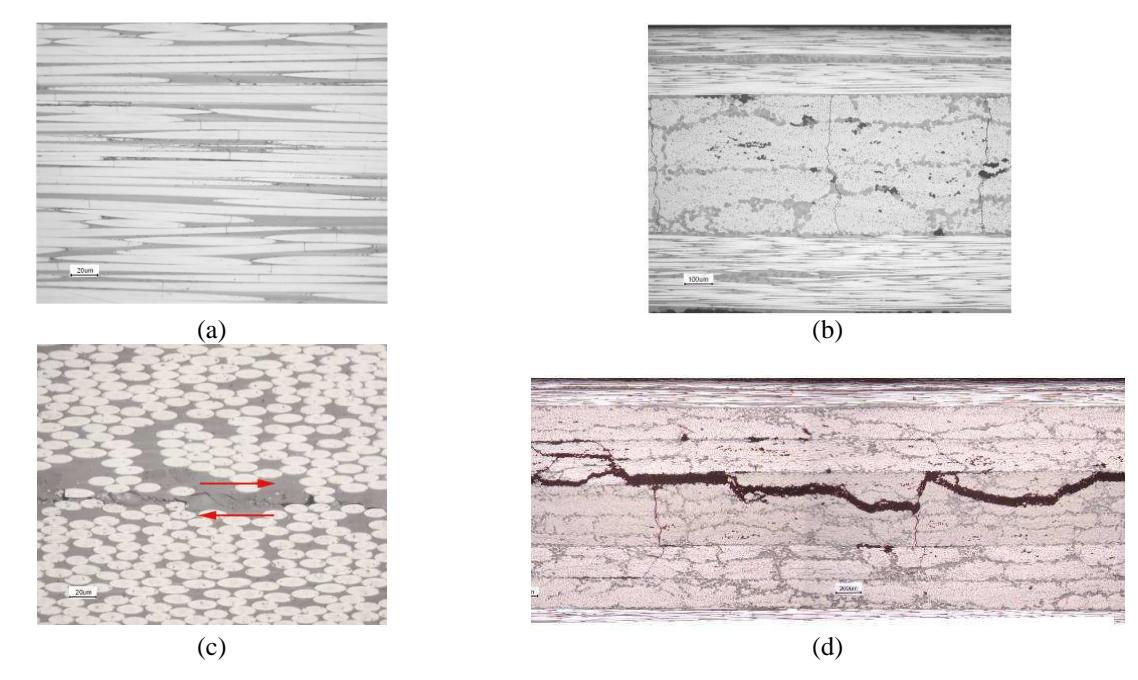
Figure 3. Damages observed under tensile test: (a) fibre breakage in (0_8) laminate, (b) ply cracking in $(0_2^{\circ}, 90_2^{\circ})_s$ laminate, (c) delamination in $(0_{2,\pm}^{\circ}20_{2,\pm}^{\circ})_s$ laminate and (d) damages developed in $(0_{2,\pm}^{\circ}45_{2,\pm}^{\circ}90_{2,\pm}^{\circ})_s$ laminate

By previous study [9] showed that the mechanical behaviour of composite material obtained by tensile loading showed quasi-linear up to failure. This raison is quit difficult to understand damage mechanism when we consider only stress-strain relation. Consequently, AE response during tensile loading were analysed and we found that a good agreement between damage evolution obtained by experimental observation and AE hits accumulated on (0_8) , (90°_8) , (45°_8) , $(0^\circ_2,90^\circ_2)_S$, $(90^\circ_2,0^\circ_2)_S$, $(0^\circ_2,\pm45^\circ_2,90^\circ_2)_S$ and $(90^\circ_2,\pm45^\circ_2,0^\circ_2)_S$ laminates. Matrix cracking, fibre breakage, fibre/matrix debonding and delamination can be found (Figure 3). The fibre breakage and the delamination occured primary in (0°_8) and $(0^\circ_2,\pm20^\circ_2)_S$ laminates, respectively. While, $(0^\circ_2,90^\circ_2)_S$ and $(90^\circ_2,0^\circ_2)_S$ laminates provoked the matrix cracking. Finally, all of the damages in above can be observed in $(0^\circ_2,\pm45^\circ_2,90^\circ_2)_S$ and $(90^\circ_2,\pm45^\circ_2,0^\circ_2)_S$ laminates. The more detail of damages and AE results in tensile loading of composite material were presented in ref. [9]. Concerning to buckling test, the similar damage can be found as the tensile test. We found that damage mechanisms were developed not only in tensile side but also in compression side (Figure 4). Moreover, other damages such as splitting also occurred during buckling loading.

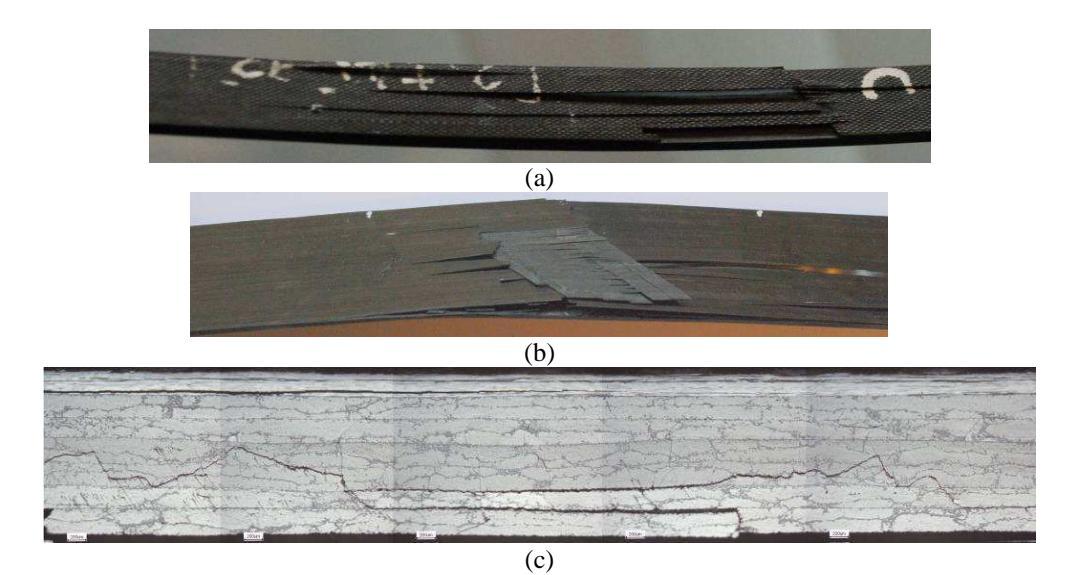
Figure 4. Damage mechanisms in buckling loading: (a) compression side and (b) tension side (c) damage in thickness direction

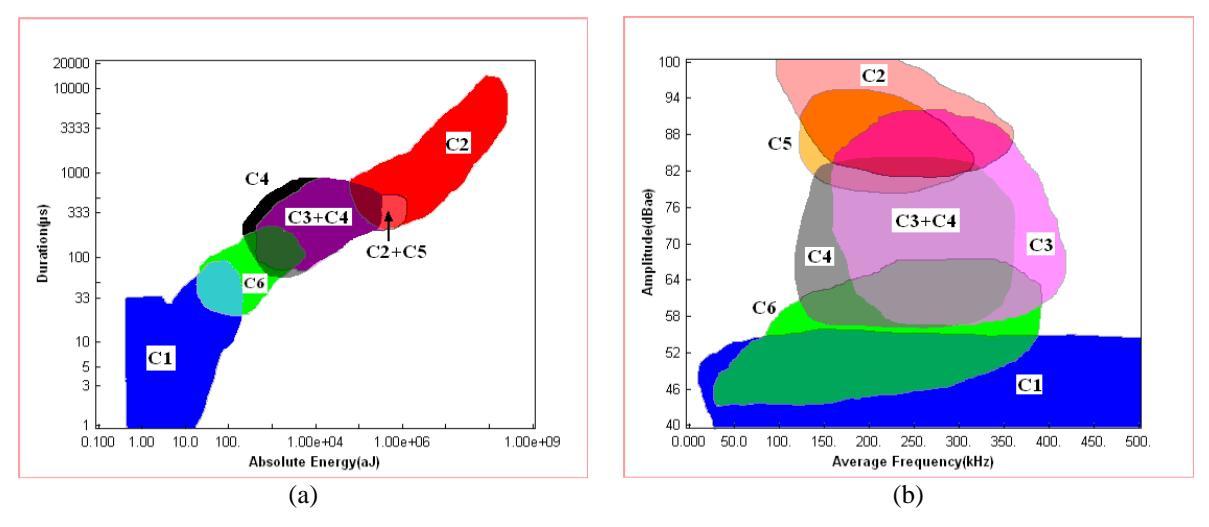
Figure 5. Classifications of damage in composite material by using tensile loading

Fig. 5 shows the classification of AE parameters for each damage in composite material: fibre breakage (C1), matrix macro-cracking (C2), matrix micro-cracking (C3), micro-delamination

or delaminate onset (C4), macro delamination and longitudinal matrix cracking (C5) and interfacial debonding (C6). Note that the splitting in bucking test represents between C2 and C5 class. We found that similar nature of AE signals of composite material can be found during tensile and buckling loading (Figure 6(a)). Also, most of them have the peak frequency which is higher than 300 kHz (Figure 7). We found that the fibre break showed low amplitude (<60dB), while ply cracking, macro delamination and splitting showed high amplitude (>80dB). The delamination onset and the fibre/matrix debonding showed intermediate amplitude. Note that AE signals with high amplitude also represented high peak power.

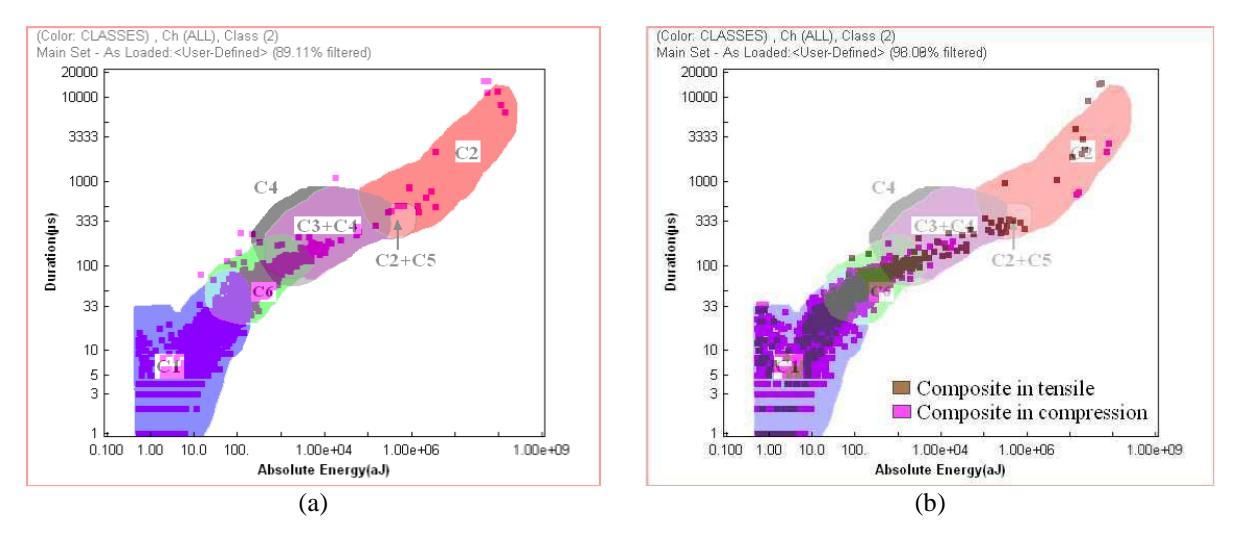
Figure 6. AE signal response of buckling test of composite material (a) and buckling test in composite-antennasystem under tensile in composite side (b) to comparison with tensile loading

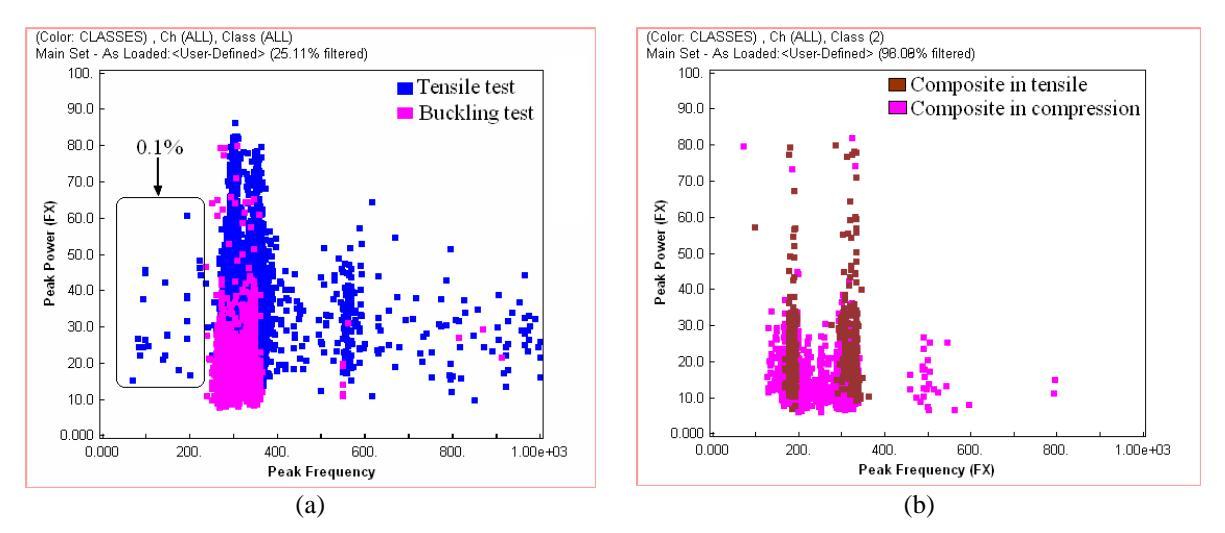
Figure 7. Peak frequency under tensile and buckling loading in composite case (a) and buckling loading in composite-antenna-system (b)

The multivariable method is available to discriminate on each damage in composite material both tensile test and bucking test. Finally, the validation of AE clustering has been carried out on composite antenna specimen under buckling loading. The fibre breakage represented low amplitude, absolute energy and duration while the matrix cracking, the macro delamination and the splitting showed high amplitude, absolute energy and duration. Damage modes of AE clustering showed a good correlation with experimental results. In addition, low peak frequency was found in buckling test of composite-antenna-systems. We suppose that this low peak frequency is corresponding to adhesive debonding of composite and antenna systems..

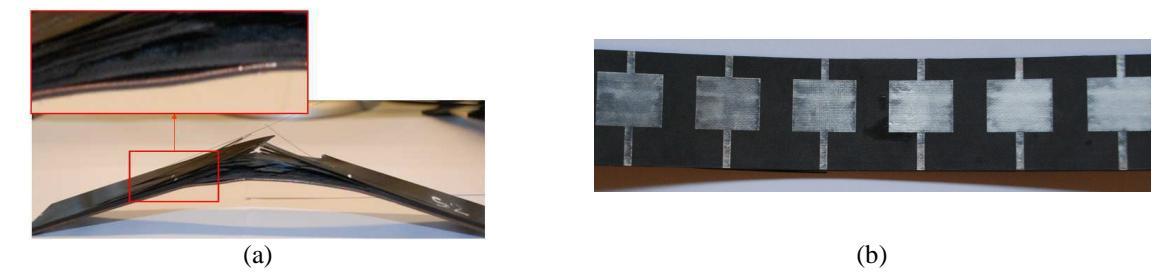
Figure 8. Damages developed of composite-antenna-structures under buckling loading: (a) debonding occurred in tensile side and (b) no damage occur in compression side

In composite-antenna-structure specimen subjected in buckling test, only composite side (in tensile or compression) can be observed the damage developed (Figure 8). These damages are similar with the composite specimen. Furthermore, composite/antenna systems debonding also occurred in both case (see in Figure 8 for composite in tensile). Although AE response of absolute energy as a function of duration in composite-antenna-systems is similar with composite material under tensile and buckling loading (Figure 6(b)), but peak frequency is different. In present of antenna systems joined by adhesive layer provoked the low peak frequency (<300 kHz). We found that 25% and 50% of AE events represent in low peak frequency in tensile and compression side, respectively. Due to high attenuation in polymer material; consequently, no signal can not be detect during damage occurred in polymer. In this reason, we suppose that the low peak frequency signal provide from the debonding between composite and antenna systems. However, this hypothesis is able to verify in adhesive joint test by using special fixture so called Arcan-Mines fixture. Beside, in case of composite in tensile side, more detected signals can obtain to compare with another one. This phenomenon is corresponding to damage developed which many damage occurred when the composite specimen subjected in tensile side. While, the splitting associated with cluster of fibre break were primary in case of composite in compression side.
