Effect of friction stir weld defects on fatigue lifetime of an Al-Cu-Li alloy (AA-2198)

T. Le Jolu, T.F. Morgeneyer, A.F. Gourgues-Lorenzon
MINES ParisTech, Centre des Matériaux, CNRS UMR 7633, BP 87, 91003 Evry
cedex, France

ABSTRACT

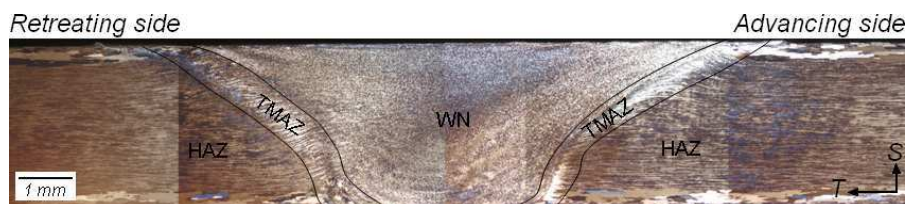
Fig. 4: Light optical micrograph of a JLR-free weld

The base material showed pancake shaped grains lying in the L-T plane (Fig. 3). Thicker recrystallised grains were observed close to the sheet surfaces. Three zones were identified in the weld from optical microscopy observations (Fig. 4): the Weld Nugget (NG) is composed of fine equiaxed grains of typical size between 5 and 10 μm ; the Thermo-Mechanically Affected Zone (TMAZ) is composed of highly deformed grains; the Heat Affected Zone (HAZ) has the same grain structure as the base material.

In the JLR-free weld (Fig. 4), no defect, such as JLR, porosity or cracks was observed at any weld location. In the material welded after natural oxidation, a JLR can be seen (Fig. 5) as a discontinuous zigzag curve of oxide particles through the sheet thickness.
