Henri-Alexandre Cayzac, Lucien Laiarinandrasana, Sébastien Joannès. Experimental investigation and finite element modelling of microstructural composite material. ECCM 15 - 15th European Conference on Composite Materials, Jun 2012, Venice, Italy. 8 p. hal-01103975

## EXPERIMENTAL INVESTIGATION AND FINITE ELEMENT MODELLING OF MICROSTRUCTURAL COMPOSITE MATERIAL

H.A. Cayzac<sup>1\*</sup>, L. Laiarinandrasana<sup>1</sup>, S. Joannes<sup>1</sup>

<sup>1</sup>Mines Paristech, Centre des Matériaux, CNRS UMR 7633, BP 87, 91003 Evry Cedex, France

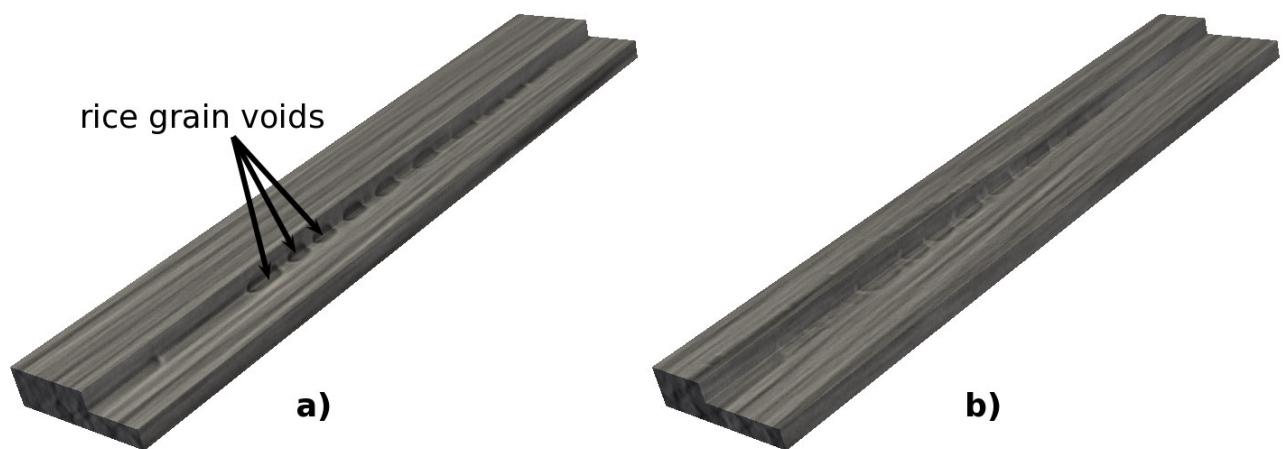
Laminography experiments [2] were set up on bands of 1.5 mm thick. Specimens were notched either in the longitudinal direction or in the transverse one. Initiation and propagation of cracks are due to a device allowing a displacement between the two edges of the notch [2]. The experiment consists in scanning the initial microstructure, applying a displacement between the notch edges in order to propagate cracks, scanning the microstructure and so on up to the total failure of the specimen. Therefore in situ damage can be characterized in transverse and longitudinal directions.

**Figure 3.** X-ray tomography images. (a) Initial microstructure with voids; (b) Microstructure after deformation: void growth.

Initial scans corresponding to undamaged material were assessed with the help of SEM inspections. Indeed voids exhibit "rice grain" shape and dimension along fibres can be much higher than diametrical dimensions. Whatever the implantation of the notch, parallel or perpendicular to the fibre direction, the main crack always propagates through the matrix in the fibre direction due to the high isotropy of the material. Fig.3(a) represents initial voids in the composite material. This volume is located far from the notch root. These voids are probably due to a lack of matrix polymer between fibres. Fig.3(b) shows the same volume after deformation of the sample. Voids have clearly grown and are likely to coalesce to lead to a cylindrical crack. The space between voids gets smaller, thin polymer walls are separating voids. It is assumed that damage mechanism in the matrix under such solicitation is based on void growth.
