# Use of acoustic emission to discriminate damage modes in carbon fibre reinforced epoxy laminate during tensile and buckling loading

Pongsak Nimdum, Jacques Renard

Pongsak Nimdum, Jacques Renard. Use of acoustic emission to discriminate damage modes in carbon fibre reinforced epoxy laminate during tensile and buckling loading. ECCM 15 - 15th European Conference on Composite Materials, Jun 2012, Venise, Italy. 8 p. hal-01109533

Keywords: acoustic emission, buckling loading, damage mechanisms

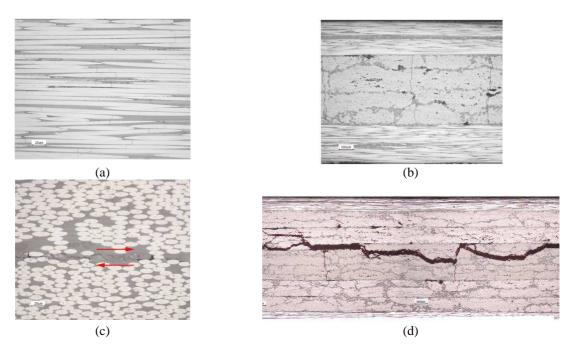
**Figure 3.** Damages observed under tensile test: (a) fibre breakage in  $(0_8)$  laminate, (b) ply cracking in  $(0_2^\circ, 90_2^\circ)_S$  laminate, (c) delamination in  $(0_2^\circ, \pm 20_2^\circ)_S$  laminate and (d) damages developed in  $(0_2^\circ, \pm 45_2^\circ, 90_2^\circ)_S$  laminate

By previous study [9] showed that the mechanical behaviour of composite material obtained by tensile loading showed quasi-linear up to failure. This raison is quit difficult to understand damage mechanism when we consider only stress-strain relation. Consequently, AE response during tensile loading were analysed and we found that a good agreement between damage evolution obtained by experimental observation and AE hits accumulated on  $(0_8)$ ,  $(90^\circ_8)$ ,  $(45^\circ_8)$ ,  $(0^\circ_2,90^\circ_2)_8$ ,  $(90^\circ_2,0^\circ_2)_8$ ,  $(0^\circ_2,\pm45^\circ_2,90^\circ_2)_8$  and  $(90^\circ_2,\pm45^\circ_2,0^\circ_2)_8$  laminates. Matrix cracking, fibre breakage, fibre/matrix debonding and delamination can be found (Figure 3). The fibre breakage and the delamination occurred primary in  $(0^\circ_8)$  and  $(0^\circ_2,\pm20^\circ_2)_8$  laminates, respectively. While,  $(0^\circ_2,90^\circ_2)_8$  and  $(90^\circ_2,0^\circ_2)_8$  laminates provoked the matrix cracking. Finally, all of the damages in above can be observed in  $(0^\circ_2,\pm45^\circ_2,90^\circ_2)_8$  and  $(90^\circ_2,\pm45^\circ_2,0^\circ_2)_8$  laminates. The more detail of damages and AE results in tensile loading of composite material were presented in ref. [9]. Concerning to buckling test, the similar damage can be found as the tensile test. We found that damage mechanisms were developed not only in tensile side but also in compression side (Figure 4). Moreover, other damages such as splitting also occurred during buckling loading.

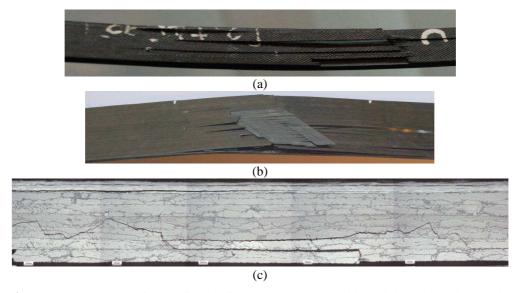
**Figure 4.** Damage mechanisms in buckling loading: (a) compression side and (b) tension side (c) damage in thickness direction

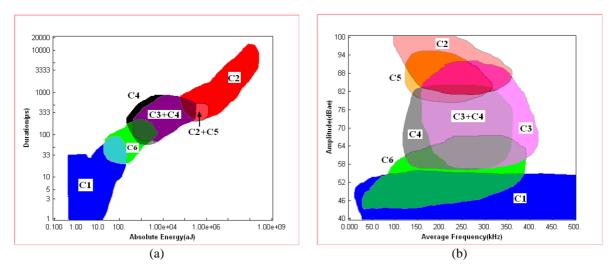
Figure 5. Classifications of damage in composite material by using tensile loading

Fig. 5 shows the classification of AE parameters for each damage in composite material: fibre breakage (C1), matrix macro-cracking (C2), matrix micro-cracking (C3), micro-delamination

or delaminate onset (C4), macro delamination and longitudinal matrix cracking (C5) and interfacial debonding (C6). Note that the splitting in bucking test represents between C2 and C5 class. We found that similar nature of AE signals of composite material can be found during tensile and buckling loading (Figure 6(a)). Also, most of them have the peak frequency which is higher than 300 kHz (Figure 7). We found that the fibre break showed low amplitude (<60dB), while ply cracking, macro delamination and splitting showed high amplitude (>80dB). The delamination onset and the fibre/matrix debonding showed intermediate amplitude. Note that AE signals with high amplitude also represented high peak power.

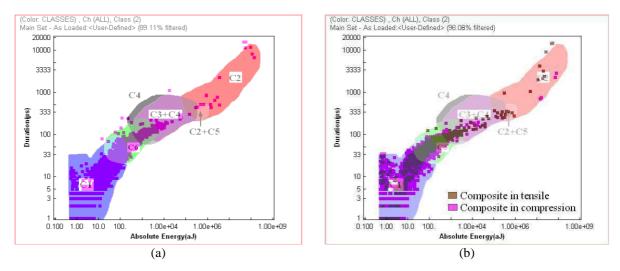
**Figure 6.** AE signal response of buckling test of composite material (a) and buckling test in composite-antennasystem under tensile in composite side (b) to comparison with tensile loading

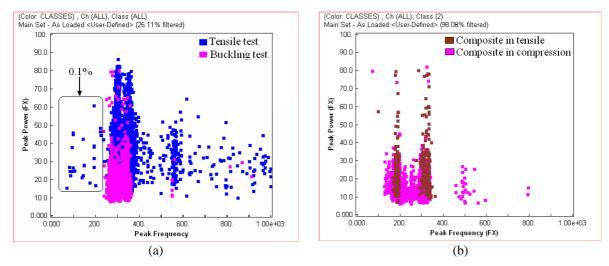
**Figure 7.** Peak frequency under tensile and buckling loading in composite case (a) and buckling loading in composite-antenna-system (b)

The multivariable method is available to discriminate on each damage in composite material both tensile test and bucking test. Finally, the validation of AE clustering has been carried out on composite antenna specimen under buckling loading. The fibre breakage represented low amplitude, absolute energy and duration while the matrix cracking, the macro delamination and the splitting showed high amplitude, absolute energy and duration. Damage modes of AE clustering showed a good correlation with experimental results. In addition, low peak frequency was found in buckling test of composite-antenna-systems. We suppose that this low peak frequency is corresponding to adhesive debonding of composite and antenna systems..
