# **Characterization of oxide scales formed on Alloy 82 in nominal PWR primary water at 340°C and in hydrogenated steam at 400°C**

## **ABSTRACT**

Alloy 82, used as weld metal in Pressurized Water Reactor (PWR), is exposed to hydrogenated steam at 400°C and to simulated primary water at 340°C. A comparative study of the oxide layer formed on the alloy surface in both environments is performed to confirm that steam conditions are representative of accelerated primary water conditions. For this purpose, the oxidation products are investigated at a nanometer scale using Scanning Electron Microscopy (SEM), X-ray Photoelectron Spectrometry (XPS) and Transmission Electron Microscopy (TEM). Results obtained in both conditions are compared and the influences of heat treatment, test duration and surface preparation are studied.

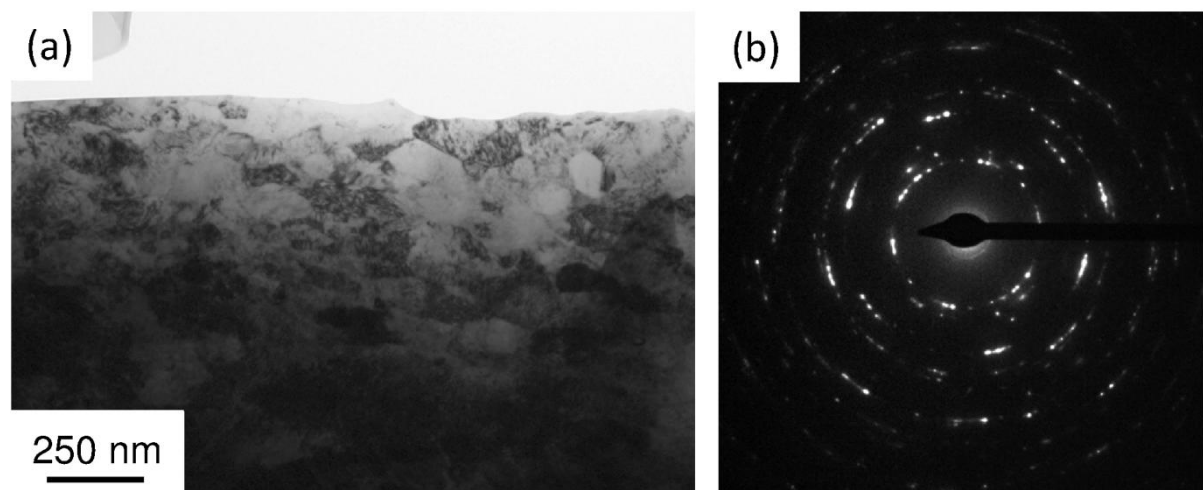
**Figure 14**

**Figure 14.** (a) Surface state of an as-prepared non-oxidized sample and (b) associated electron diffraction pattern revealing the nanograined structure.
