## Characterization of oxide scales formed on alloy 82 in nominal PWR primary water at 340 °C and in hydrogenated steam at 400 °C

# Characterization of oxide scales formed on Alloy 82 in nominal PWR primary water at 340°C and in hydrogenated steam at 400°C

Alloy 82, used as weld metal in Pressurized Water Reactor (PWR), is exposed to hydrogenated steam at 400°C and to simulated primary water at 340°C. A comparative study of the oxide layer formed on the alloy surface in both environments is performed to confirm that steam conditions are representative of accelerated primary water conditions. For this purpose, the oxidation products are investigated at a nanometer scale using Scanning Electron Microscopy (SEM), X-ray Photoelectron Spectrometry (XPS) and Transmission Electron Microscopy (TEM). Results obtained in both conditions are compared and the influences of heat treatment, test duration and surface preparation are studied.

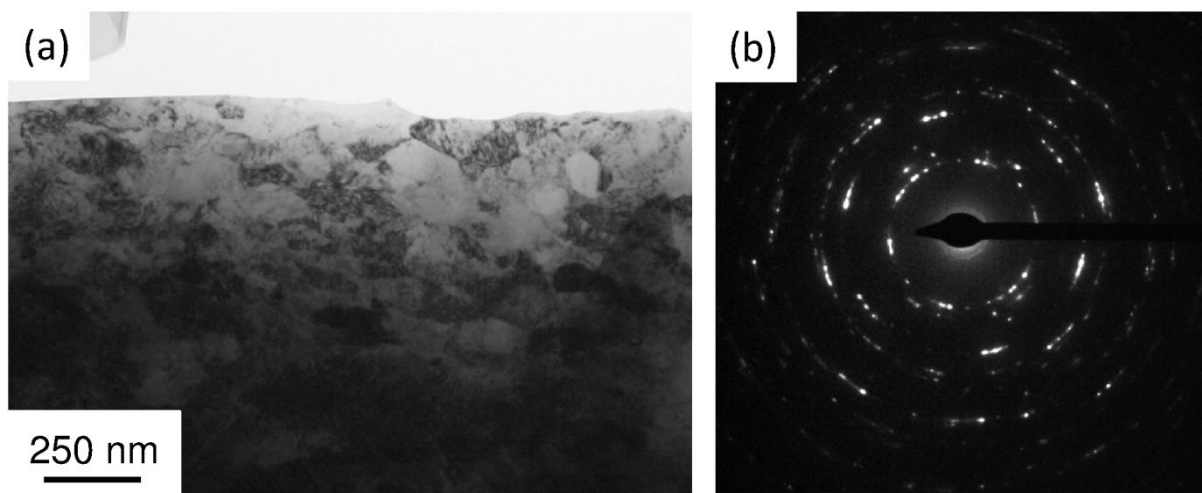
**Figure 14**

**Figure 14.** (a) Surface state of an as-prepared non-oxidized sample and (b) associated electron diffraction pattern revealing the nanograined structure.
